CONNECTICUT WESTERN COASTAL AREA  
GREENWICH, CONNECTICUT

PUTNAM RESERVOIR DAM  
CT 00041

PHASE I INSPECTION REPORT  
NATIONAL DAM INSPECTION PROGRAM

AUGUST 1978

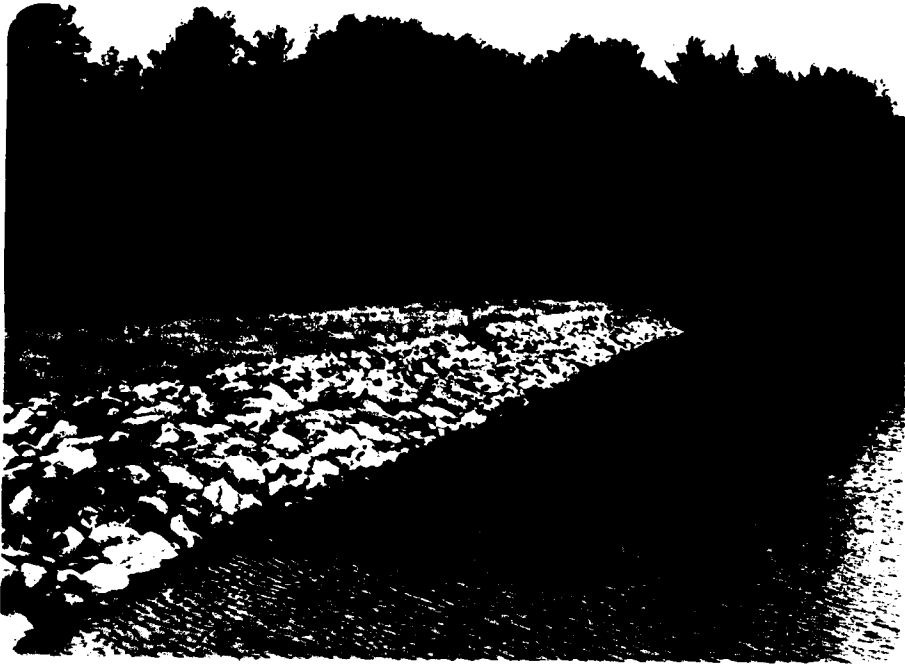
PHOTO #7: Riprap on Upstream Face of Dam, looking West from Intake Structure.

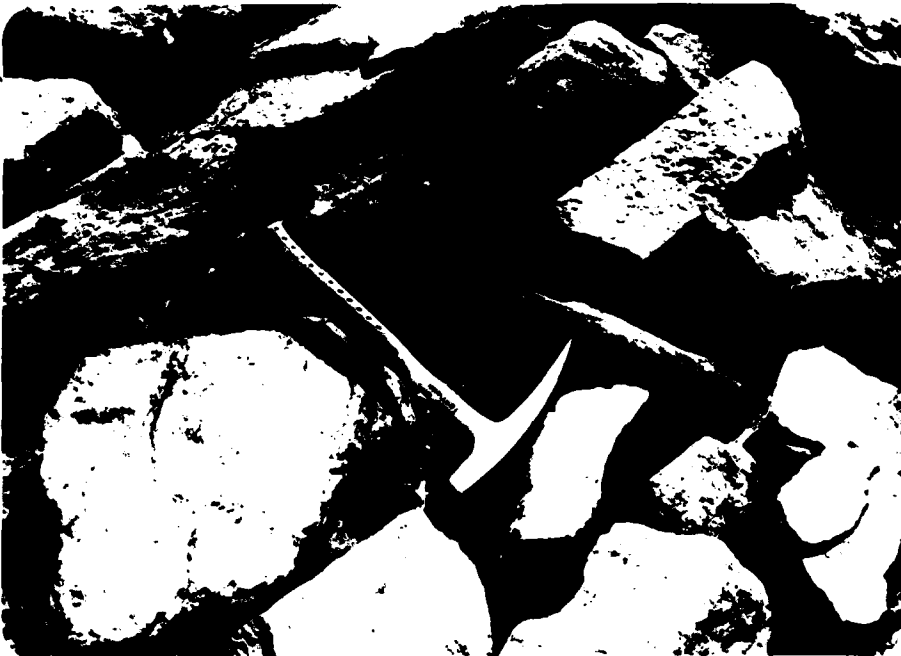
PHOTO #8: Riprap detail at Sta. 7+00. Note extent of coverage.
