DOT/FAA/CT-83/10

Evaluation of an Improved Flame Resistant Aircraft Window System

Final Report
May 1984

US Department of Transportation
Federal Aviation Administration
Technical Center
Atlantic City Airport, N.J. 08405

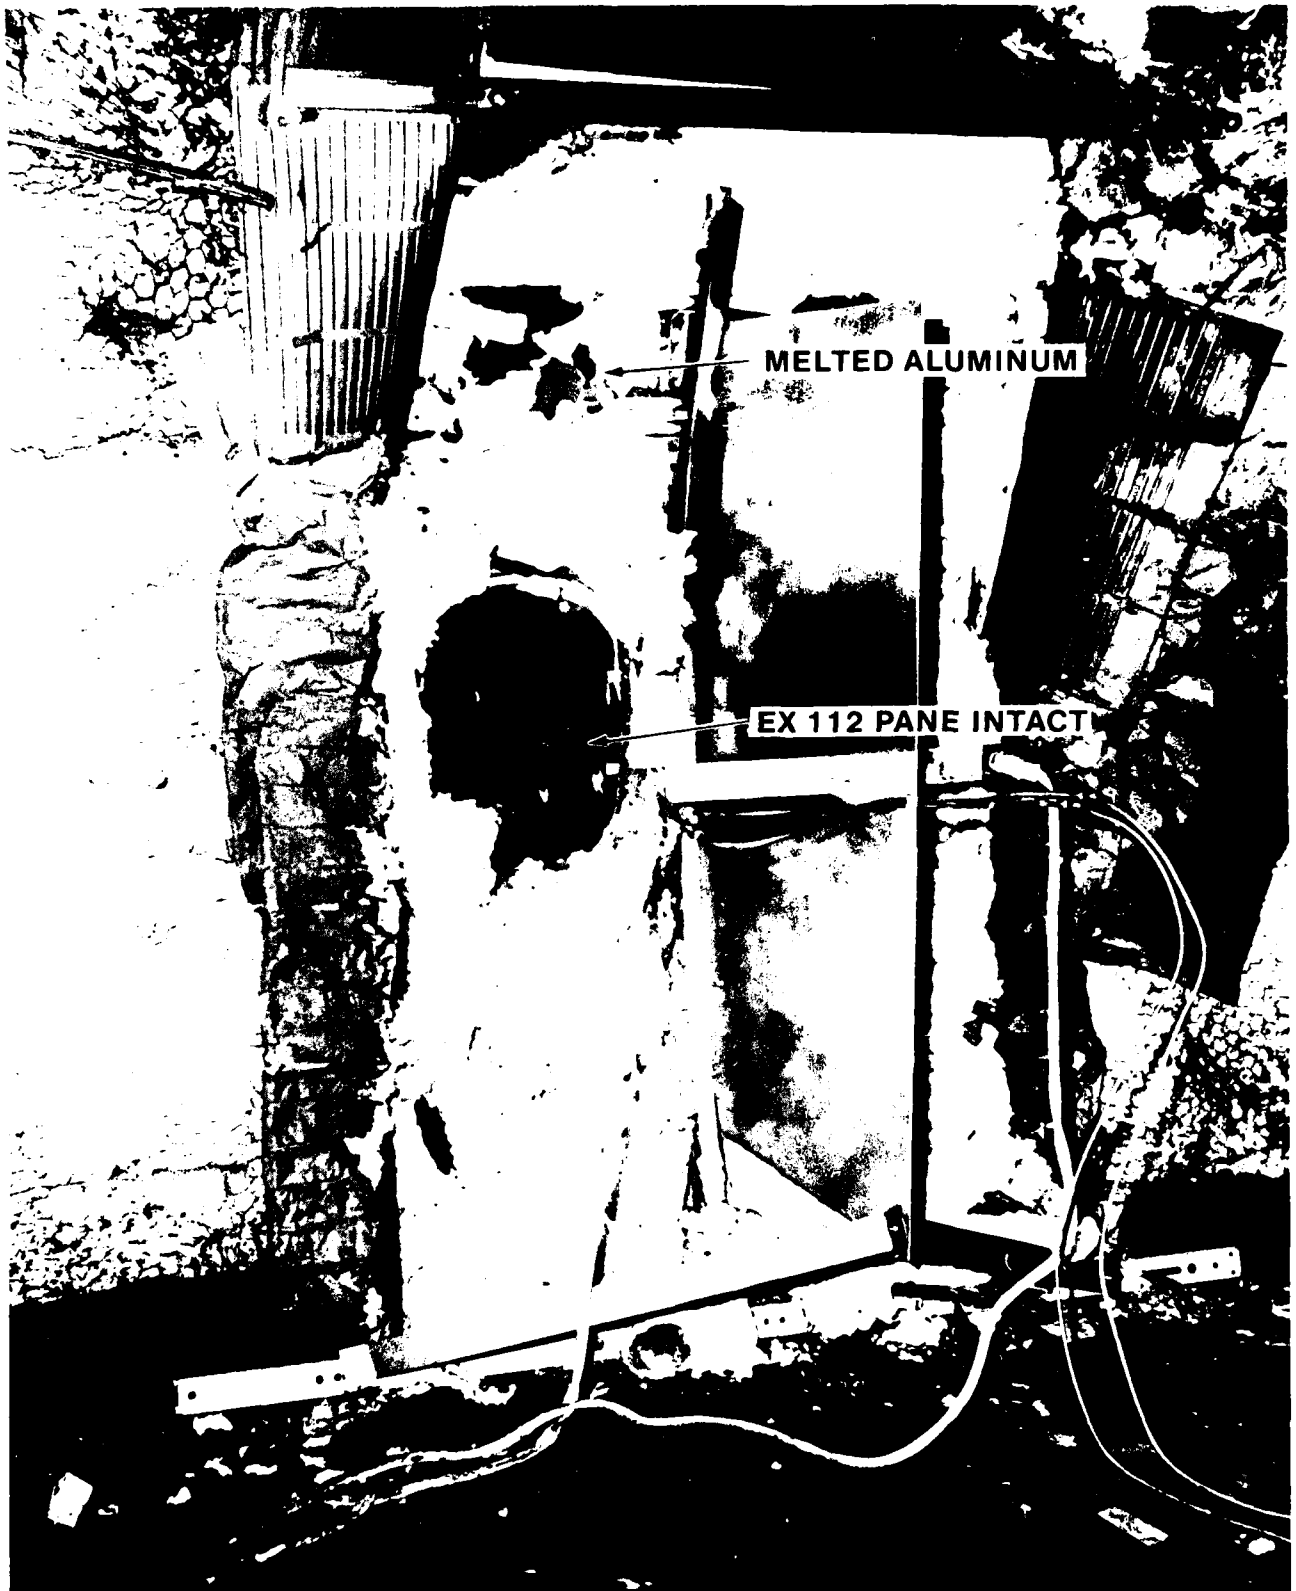
FIGURE 8. FIRE DAMAGE TO THE THERMALLY IMPROVED DC-10 WINDOW SYSTEM SHOWING THE FAIL-SAFE (EX 112) PANE IN PLACE (TEST 1)

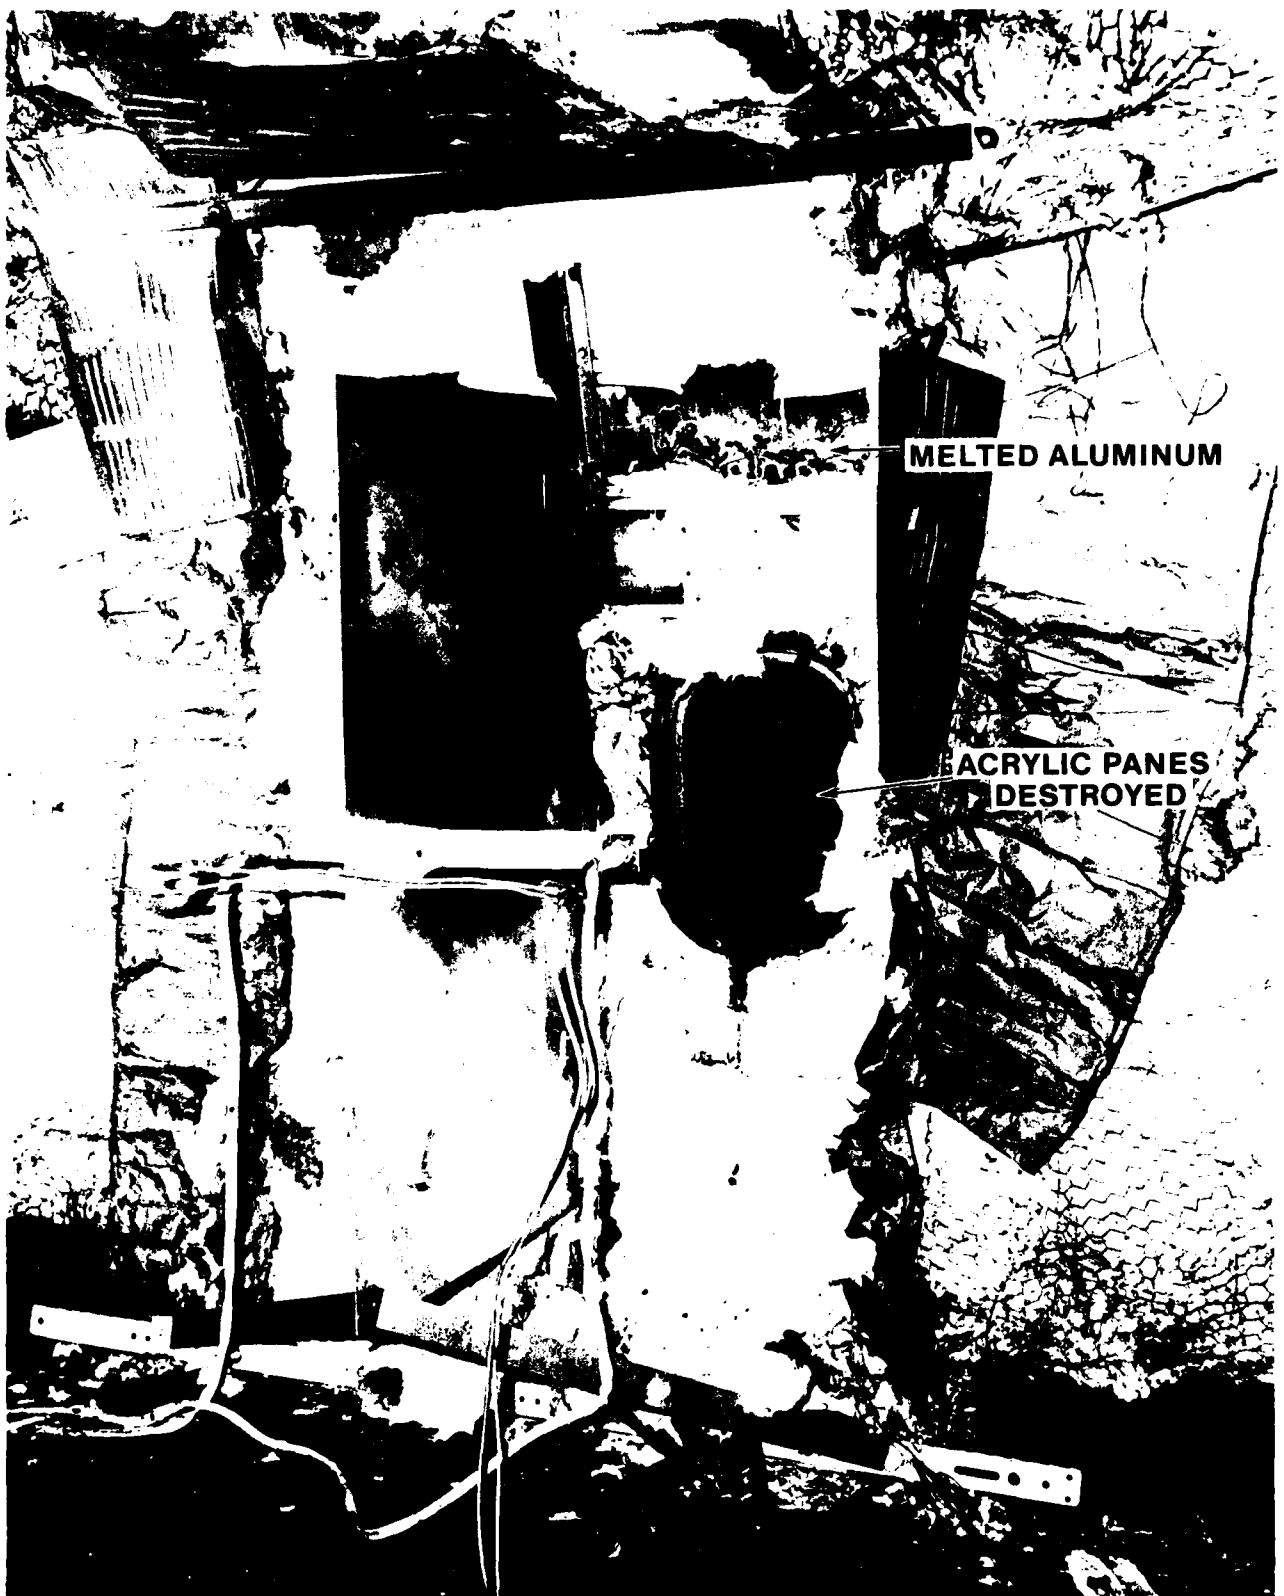
FIGURE 9. FIRE DAMAGE TO THE STANDARD DC-10 WINDOW SYSTEM SHOWING THE COMPLETE DESTRUCTION OF THE ACRYLIC WINDOW PANES (TEST 1)

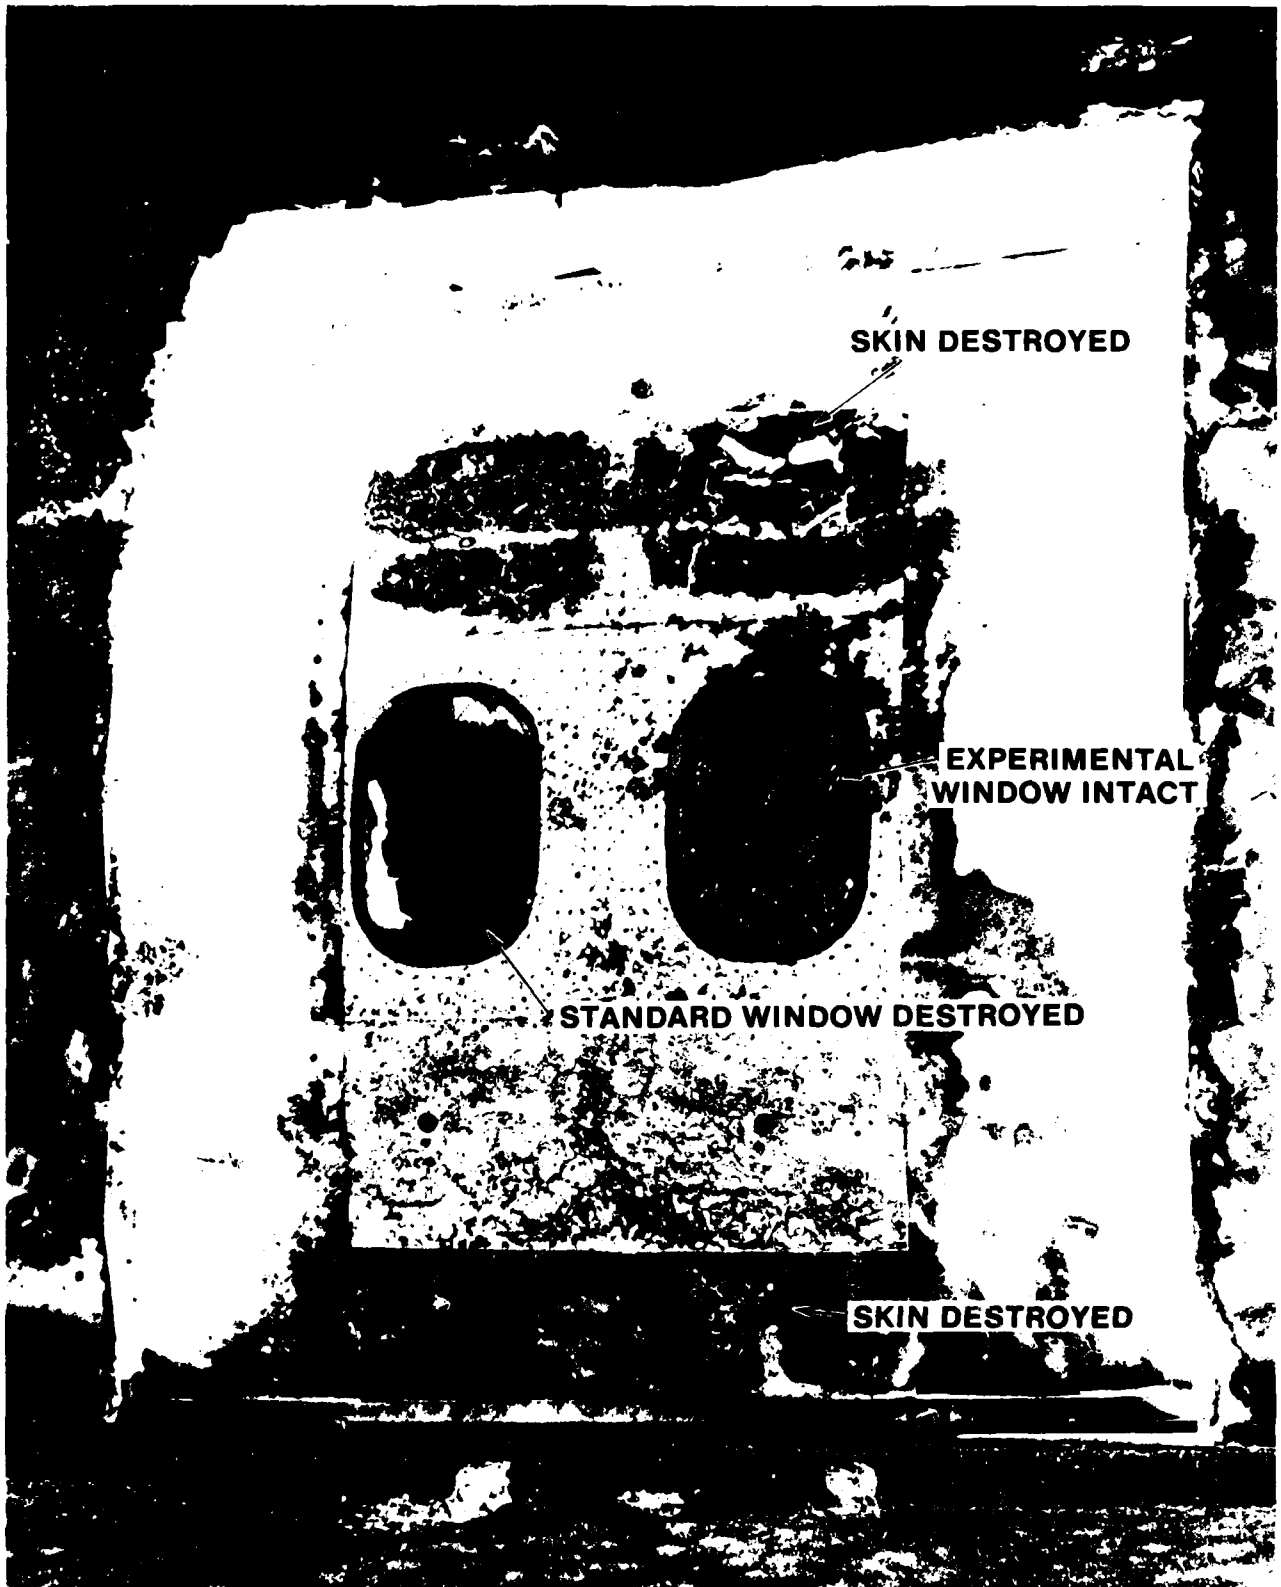
RESULTS: The temperature rise of the DC-10 fuselage segment during fire exposure in test 1 is indicated by the profiles presented in figure 7 for the aluminum skin and belt areas. These data show that the aluminum skin above the windows started to melt in 64 seconds (1.07 minutes) which was confirmed by an analysis of the photographic coverage. However, the skin below the windows and belt area did not reach the incipient melting temperature for aluminum of 900° F until 198 seconds (3.3 minutes) after fuel ignition. The fire damage to the skin above the improved (EX 112) window system is shown in figure 8 and above the acrylic window in figure 9. A more detailed interior view of the failure mode of the fuselage skin in these areas is presented in figure 10. An overall exterior view of the fire damage sustained by the DC-10 fuselage segment is presented in figure 11.

FIGURE 11. EXTERNAL FIRE DAMAGE TO THE DC-10 WINDOW SYSTEMS (TEST 1)

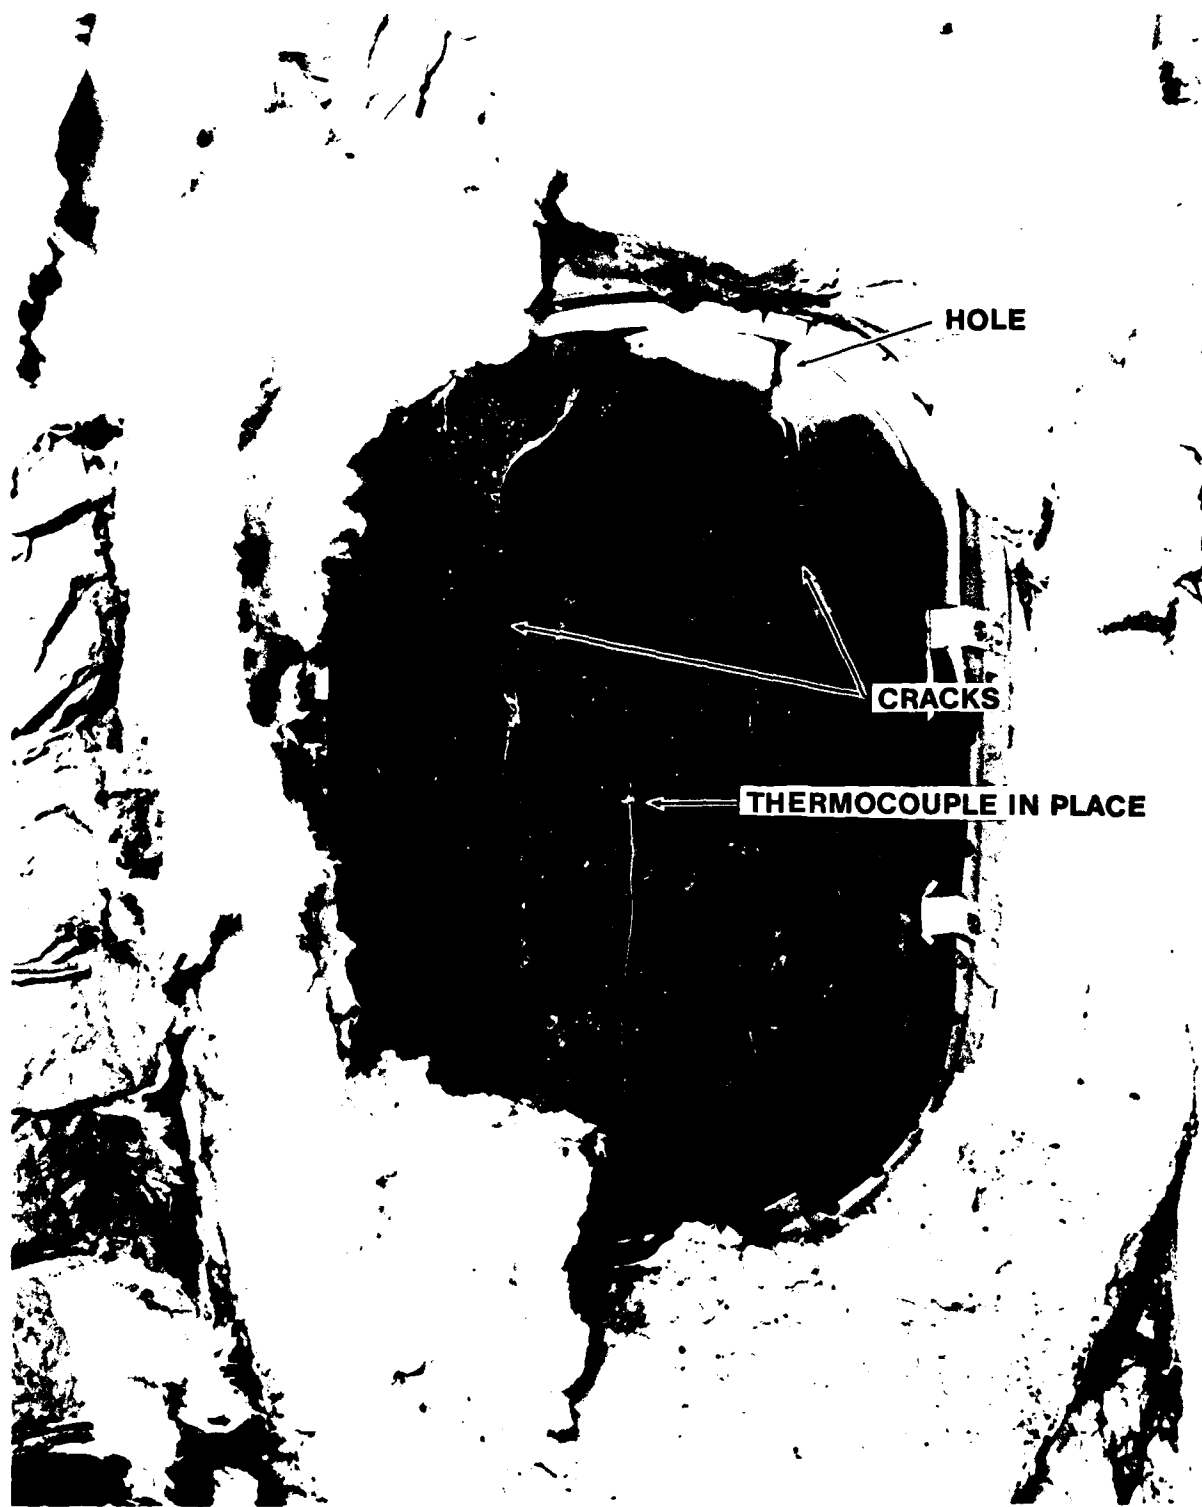
FIGURE 14. CLOSE-UP VIEW OF THE FIRE DAMAGE TO THE FAIL-SAFE (EX 112) WINDOW PANE (TEST 1)

SMALL CRACKS

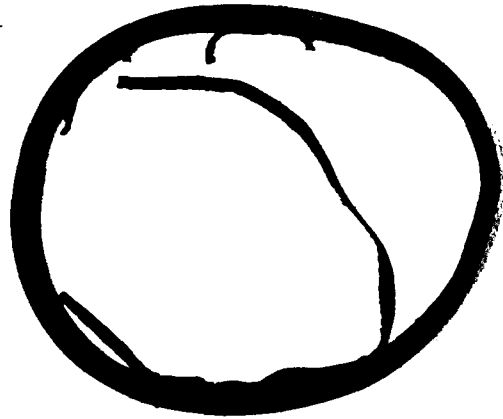
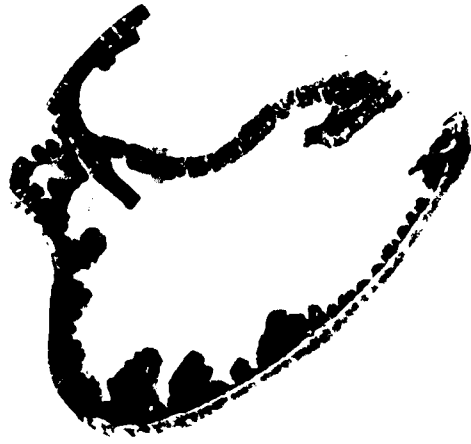
A detailed examination of the condition of the silicone gasket after it was removed from the window frame revealed it had retained a large part of its structural integrity and flexibility (figure 15). The thermal resistivity demonstrated by the gasket under severe fire exposure is noteworthy and its survival is attributable in part, to the thermal resistance of the EX 112 fail-safe pane, the relatively high specific heat of aluminum and the mass of metal comprising the belt system.

FAIL-SAFE EX 112
PANE WITH GASKET

FAIL-SAFE ACRYLIC PANE AND GASKET

FIGURE 15. FIRE DAMAGE SUSTAINED BY THE IMPROVED EX 112 FAIL-SAFE PANE AND THE STRETCHED ACRYLIC PANE (TEST 1)

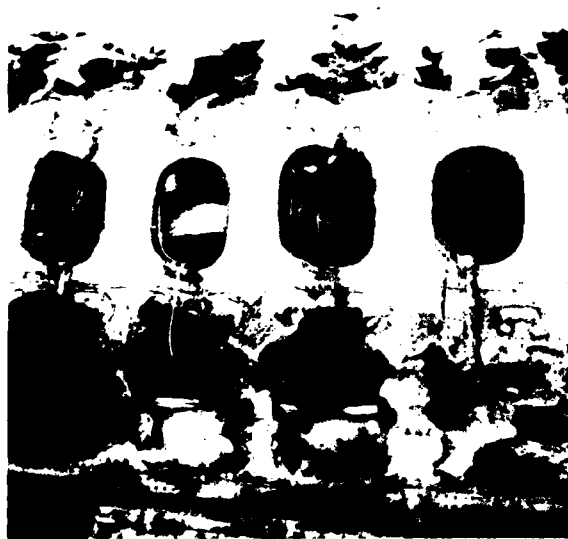
The higher heat resistance of the belt system over the fuselage skin is evident in the photographs presented in figure 17 of the Continental Airlines DC 10-10 accident on March 1, 1978 at the Los Angeles International Airport. This failure mode, in general, was consistent with that observed in the first and subsequent tests conducted in the C-133 fire test bed.

(a) General View of the Fuselage Damage

(b) Detailed View of the Belt System Area

FIGURE 17. FAILURE MODES OF THE CONTINENTAL AIRLINES DC-10 AIRCRAFT FUSELAGE SKIN AND WINDOW BELT SYSTEM

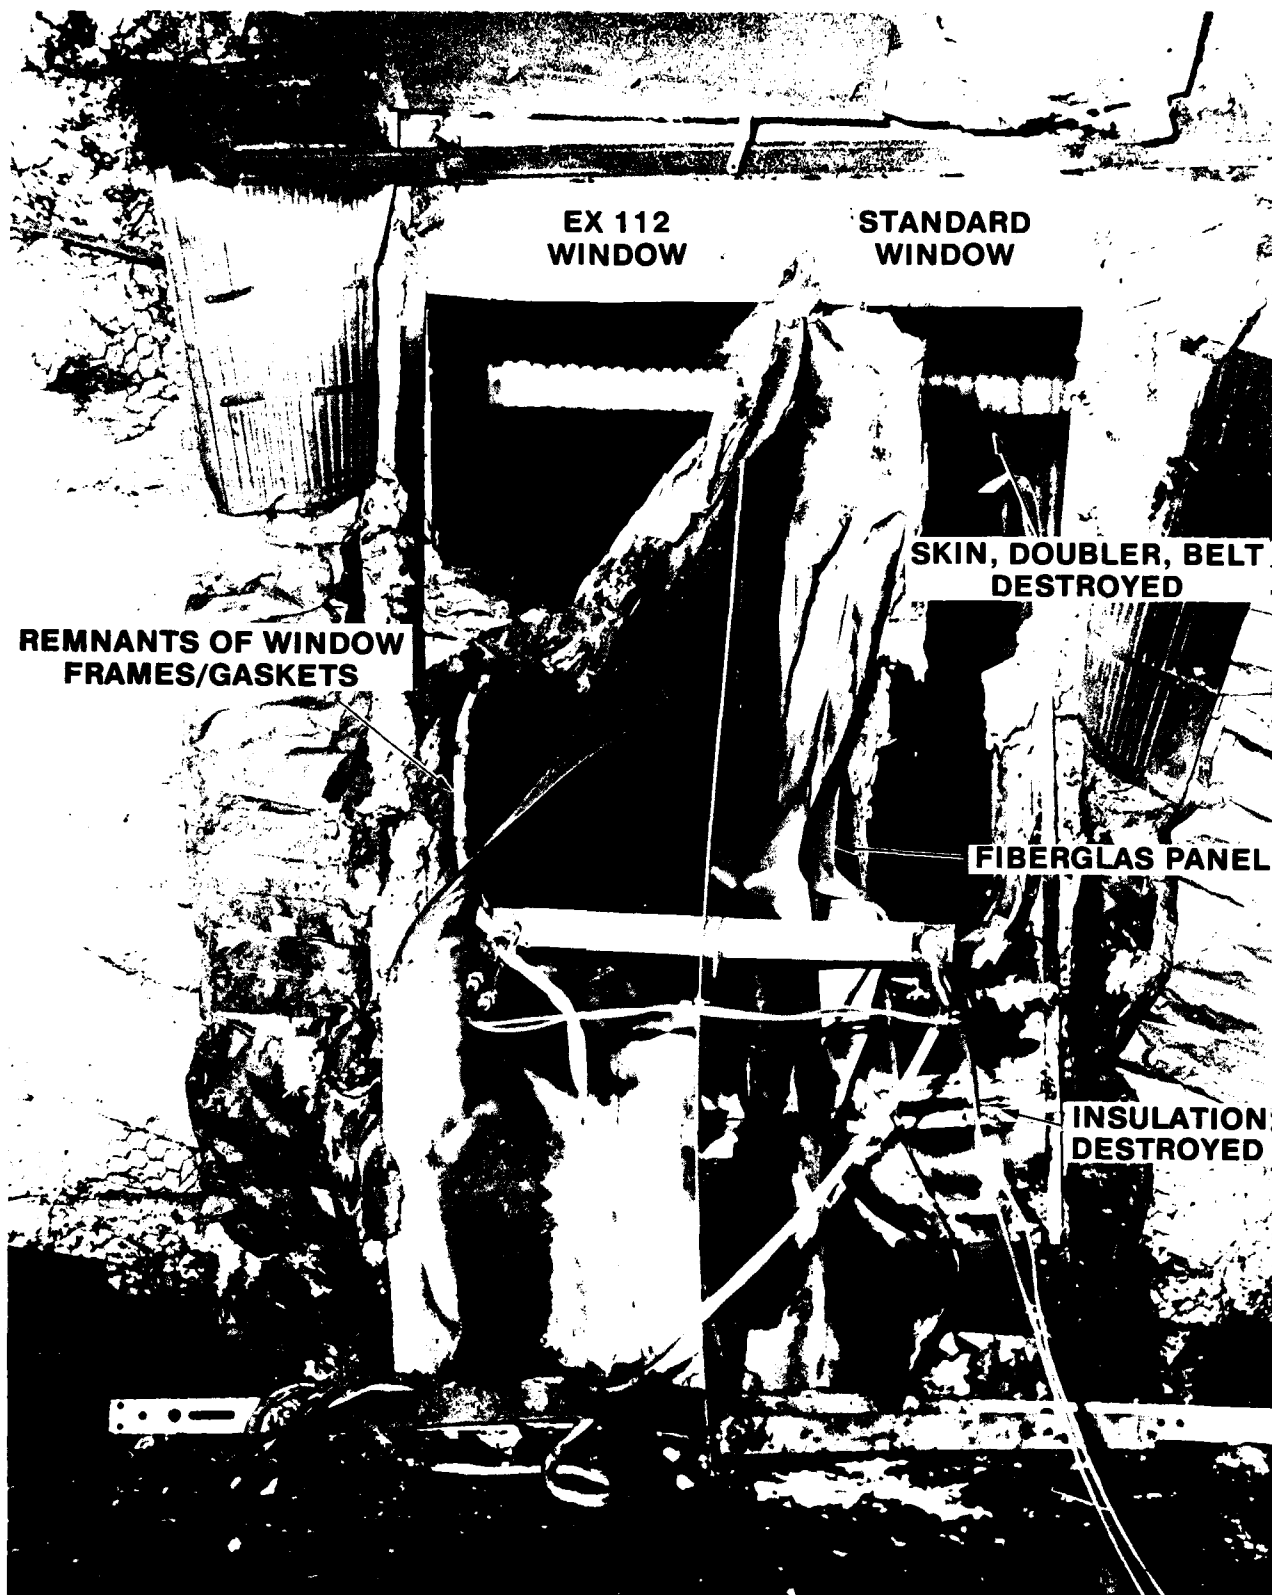
The visual fire damage to the aluminum fuselage structure around the thermally improved and standard window configuration is shown in figure 24. A more detailed interior view of the fire damage to the improved EX 112 window system is presented in figure 25. Figure 24 shows a portion (approximately 25 percent) of the silicone rubber gasket still mounted in position in the window opening around the thermally improved window system. From these photographs it is evident that the integrity of any window system comprising a pressure and fail-safe pane mounted in a rubber gasket is dependent heavily upon maintaining the structural and thermal integrity of the belt and window framing material.

FIGURE 24. FIRE DAMAGE TO THE STANDARD (ACRYLIC) AND IMPROVED (EXIT 112) WINDOWS (TEST 2)
