QUINNIPIAC RIVER BASIN
MERIDEN, CONNECTICUT
BRADLEY HUBBARD RESERVOIR DAM
CT 00132

PHASE I INSPECTION REPORT
NATIONAL DAM INSPECTION PROGRAM

SEPTEMBER, 1980

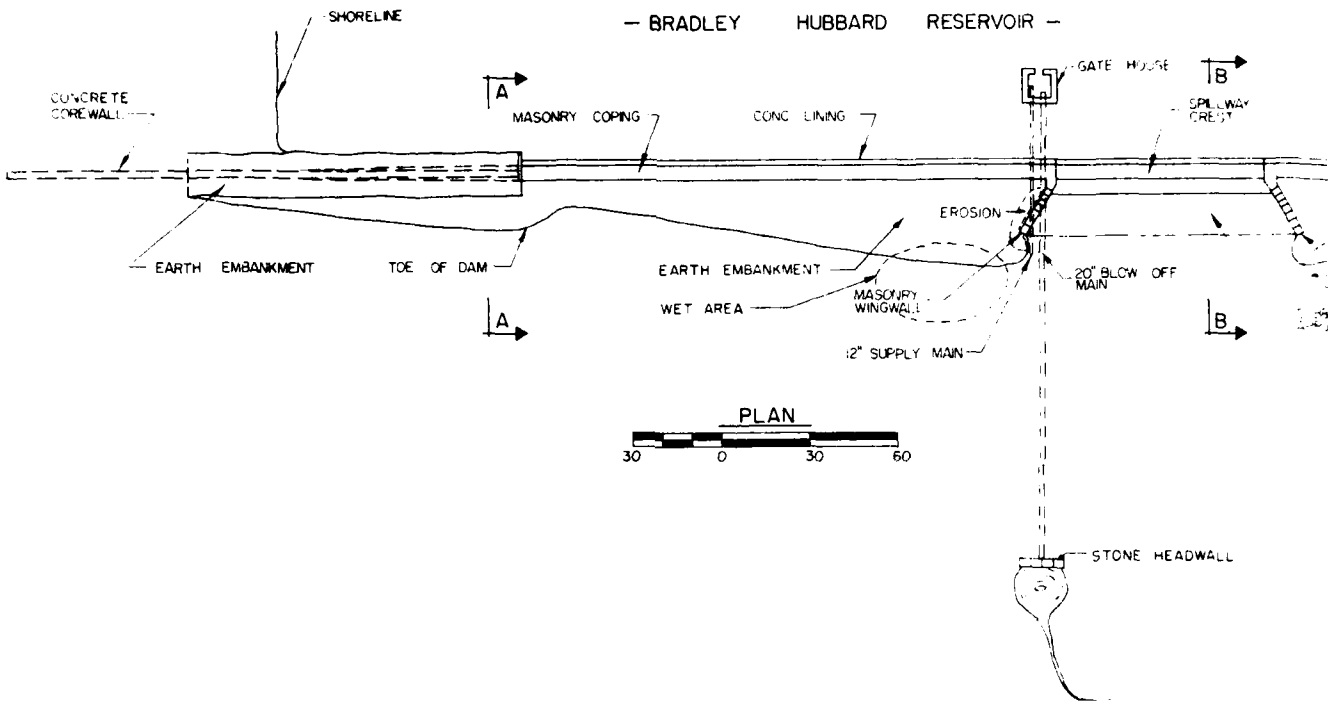
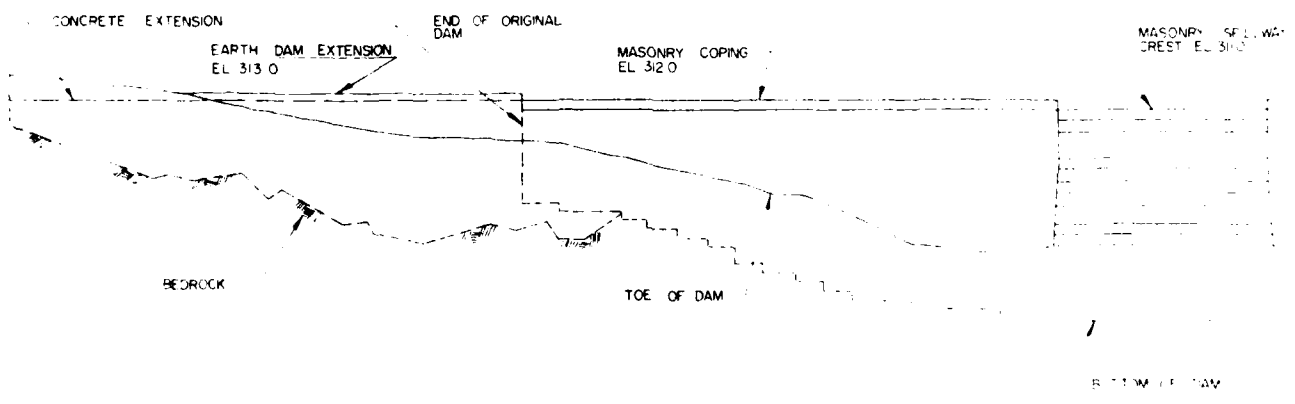
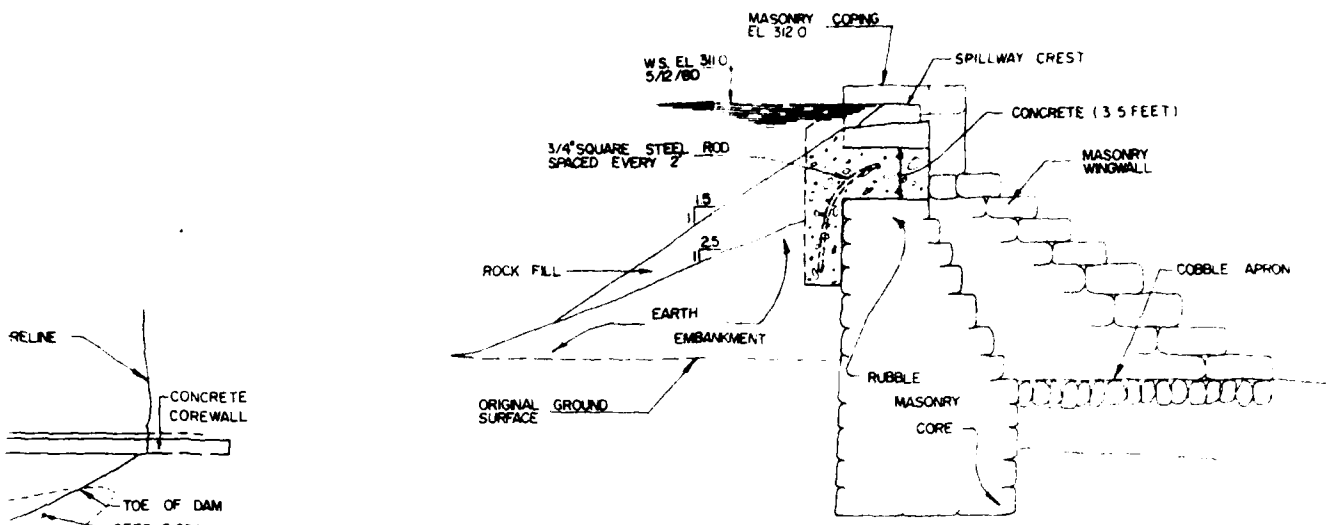
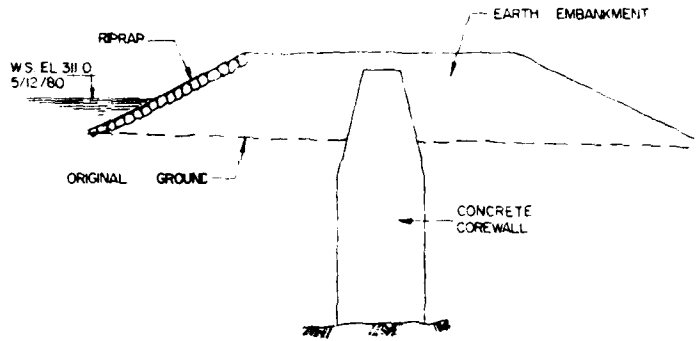
2. Vegetation growing through the masonry joints could lead to displacement and/or possible failure of the masonry.
3. Cracks between the newer concrete and the upstream face of the original masonry (See Sheet B-1), allow water to flow through the masonry section thus possibly leading to adverse seepage through the dam.

6. Sealing the cracks between the newer concrete section and the original masonry to prevent seepage through this area.
