THAMES RIVER BASIN
WINDHAM, CONNECTICUT

POTASH POND DAM
CT. 00193

PHASE I INSPECTION REPORT
NATIONAL DAM INSPECTION PROGRAM

JANUARY, 1981

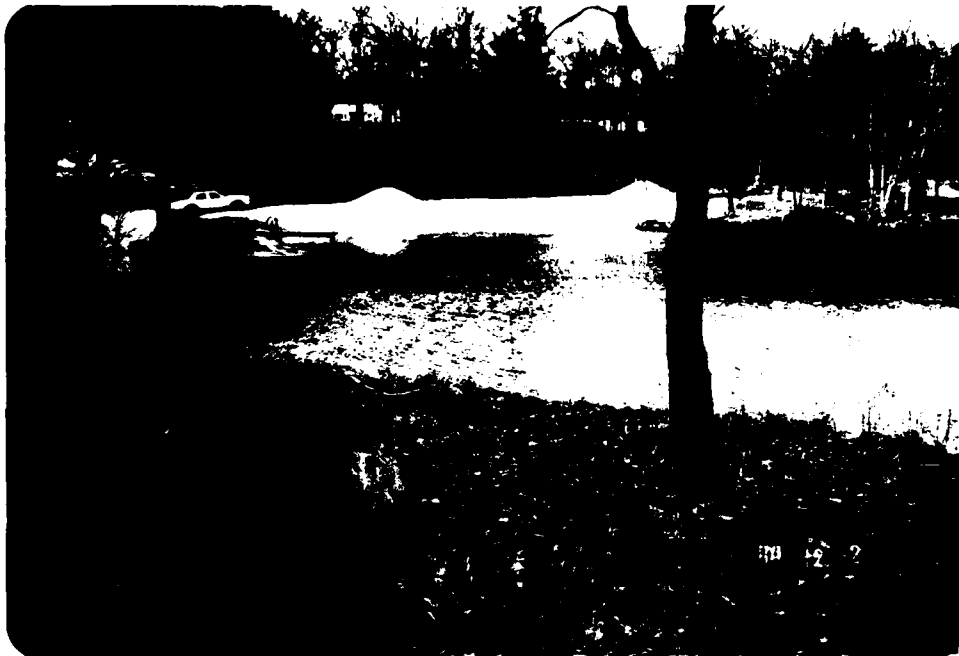
PHOTO C-1: Crest of dam and left abutment.

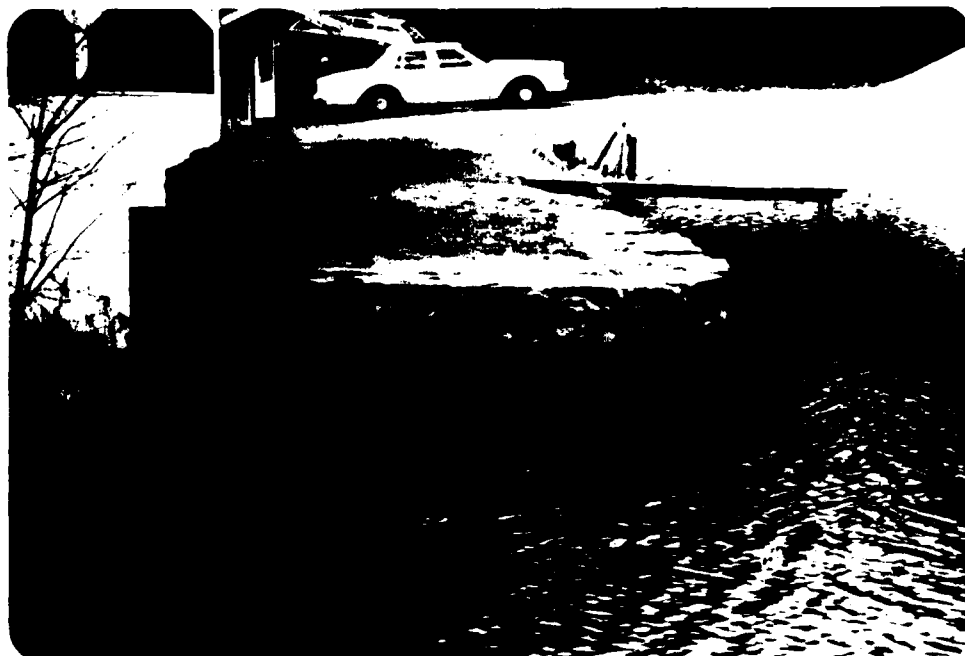
PHOTO C-2: Crest of dam and right abutment.
