LAKE NARANEKA DAM
CT 00223

PHASE I INSPECTION REPORT
NATIONAL DAM INSPECTION PROGRAM

DEPARTMENT OF THE ARMY
NEW ENGLAND DIVISION, CORPS OF ENGINEERS
WALTHAM, MASS. 02154

AUGUST 1981

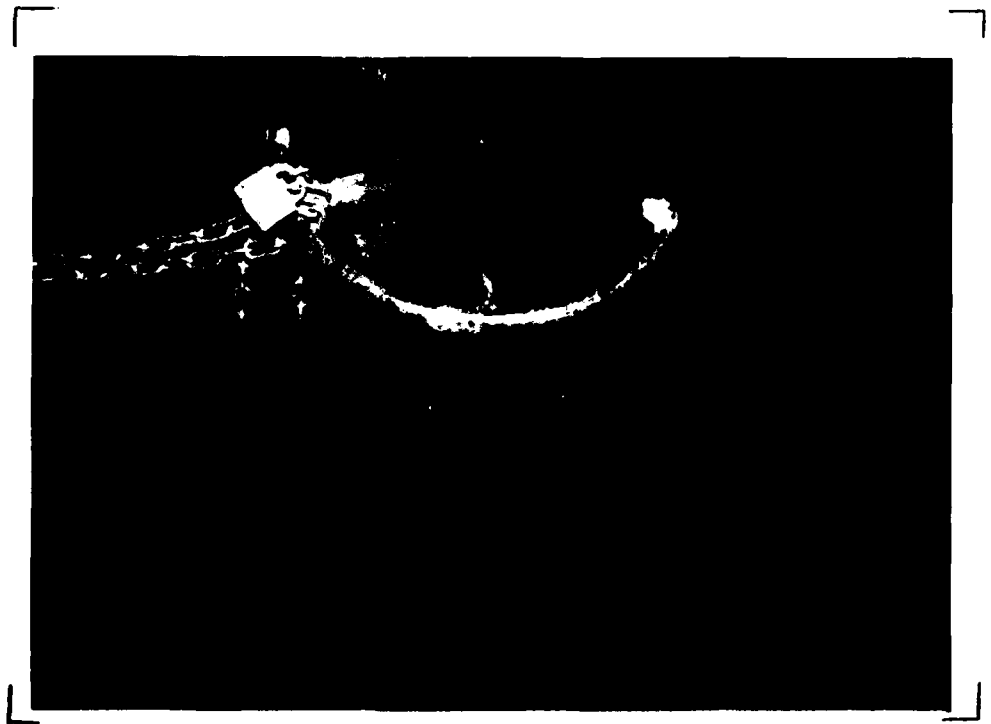
Photo 9 Hand operated gate valve in valve chamber.

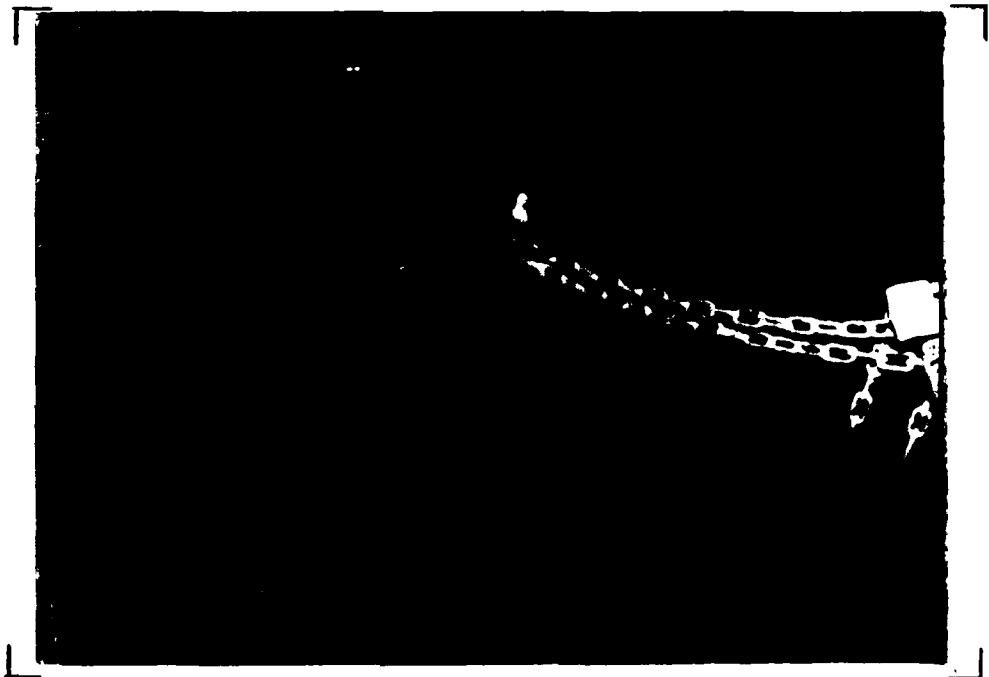
Photo 10 Hand operated gate valve in valve chamber.
