CONNECTICUT RIVER BASIN  
PORTLAND, CONNECTICUT

PORTLAND RESERVOIR DAM

CT 00149

PHASE I INSPECTION REPORT  
NATIONAL DAM INSPECTION PROGRAM

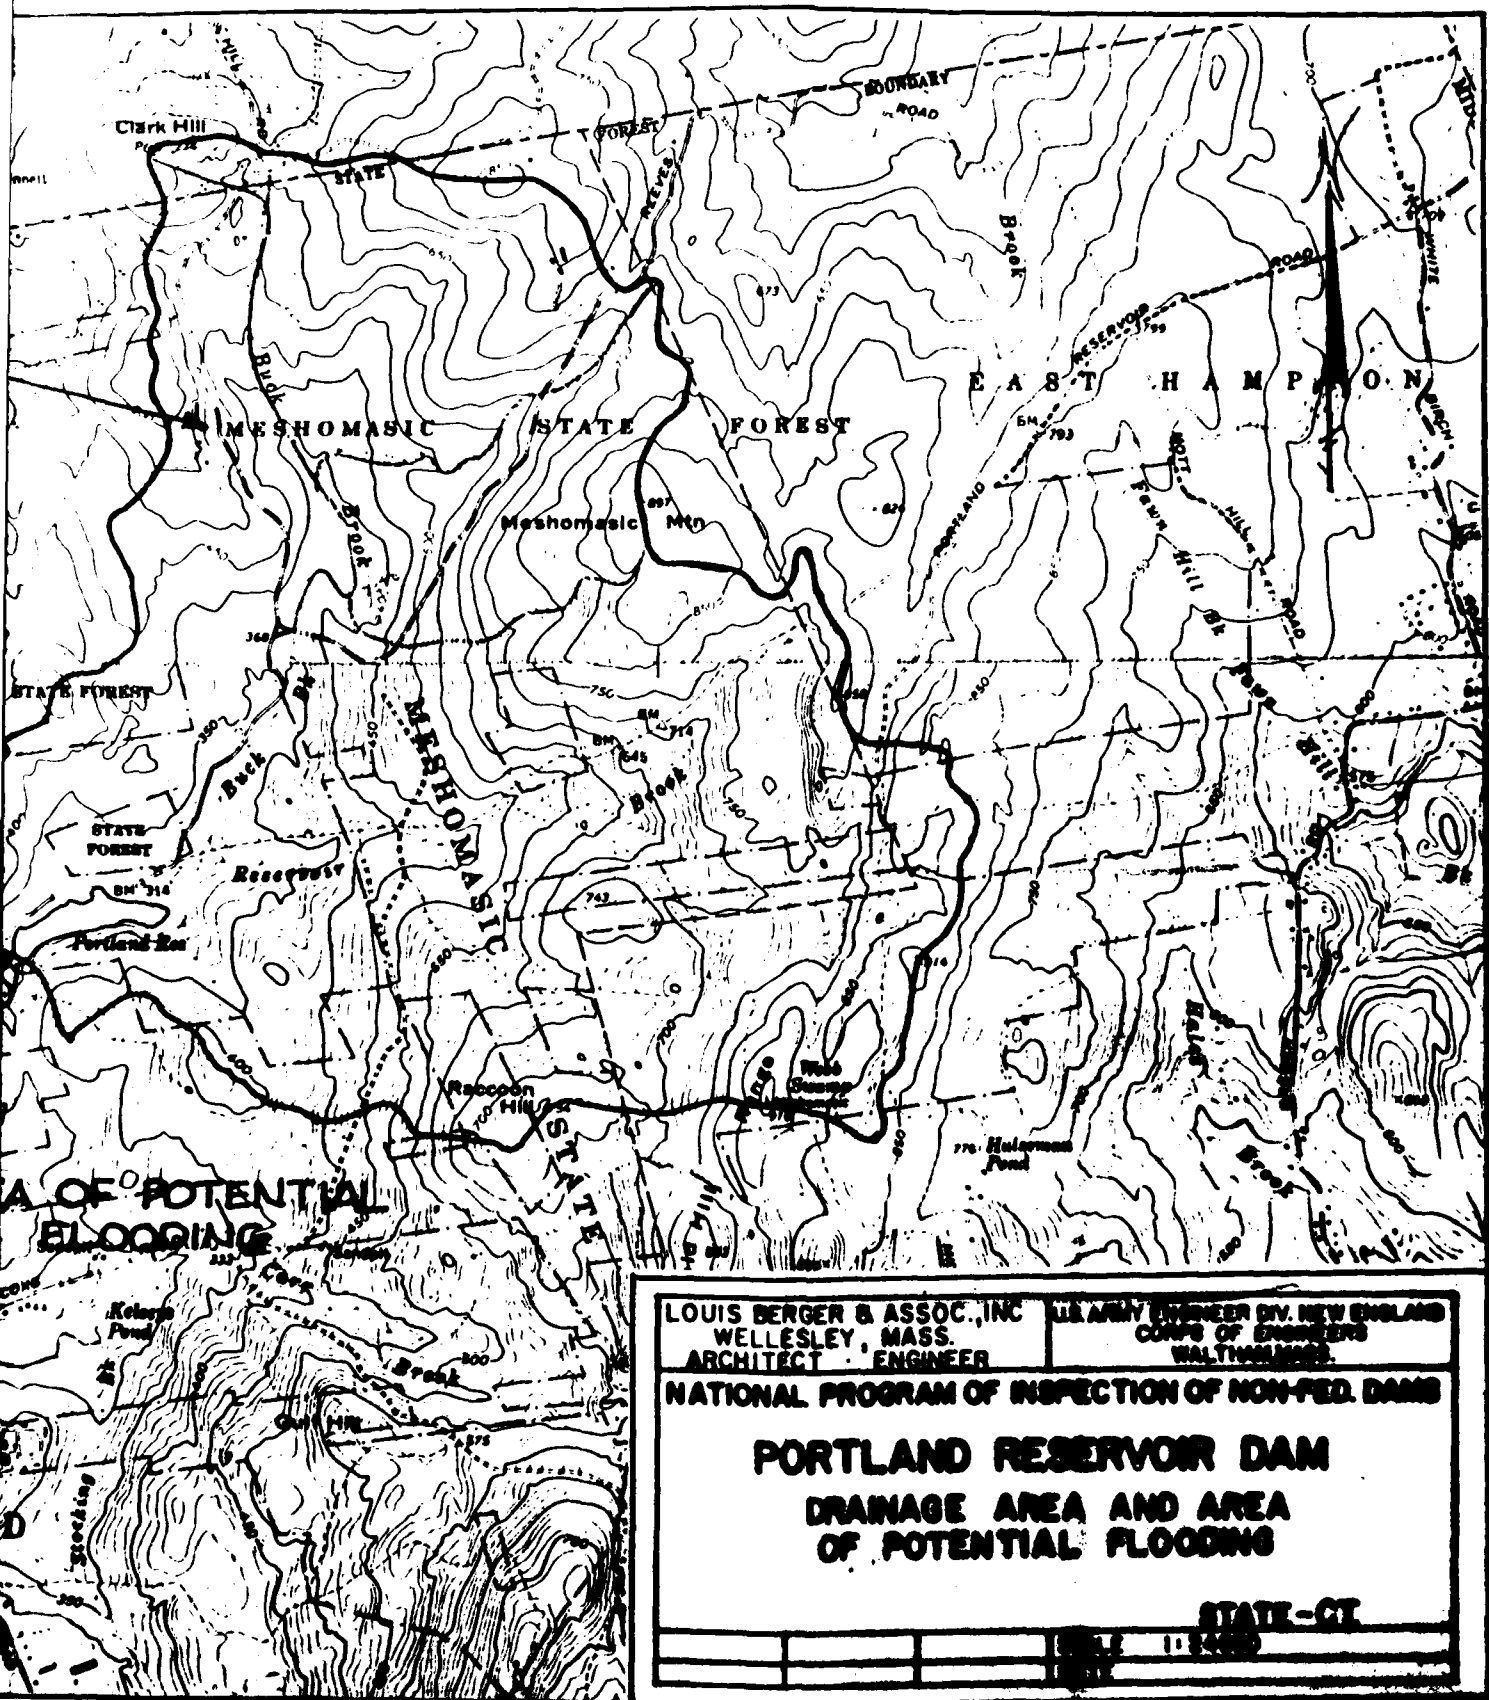
2 FIGURE 5-SHEET D-22

In summary, a total of 16 dwellings and three roadway crossings would suffer significant damage, should a breach of this type occur (see Figure 5, Sheet D-22, Appendix D).
