SECTION 32 PROGRAM
STREAMBANK EROSION CONTROL
EVALUATION AND DEMONSTRATION
WORK UNIT 2-EVALUATION OF EXISTING
BANK PROTECTION

FIELD INSPECTION OF SITES IN THE
MISSOURI RIVER DIVISION

Malcolm P. Keown, Elba A. Dardeau, Jr., Etta M. Causey

October 1980
Inspection Report 10

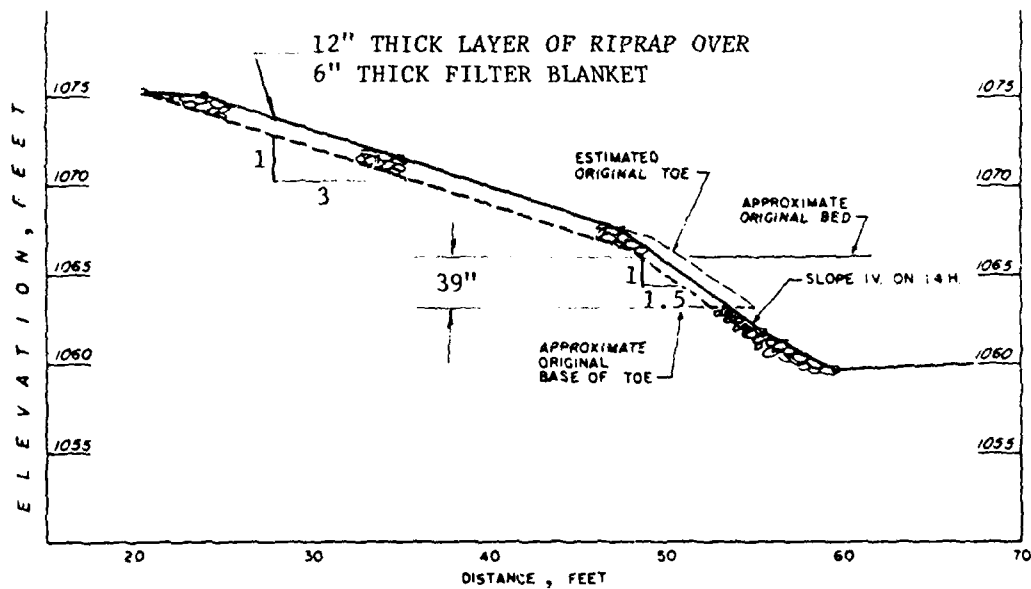
31. Three to 3-1/2 ft of degradation had occurred below the original base of the toe of Test Section 1. The surveyed cross section indicated that the entire riverward face of the toe had receded as the riprap moved downward and adjusted to the degradation (Figure 20). The toe rock had covered the lower slope quite well; however, there was some evidence of separation in the vicinity of the original base of the toe. Since there was little or no stone reserve remaining in this toe, the team concluded that progressive failure of the lower slope protection could occur if there were additional significant degradation.

Figure 20. Republican River at Milford Dam Outlet Channel, Kans. Cross-sectional view of Test Section 1 shown as constructed in 1969 and as surveyed in 1974. (Adapted from Reference 9)

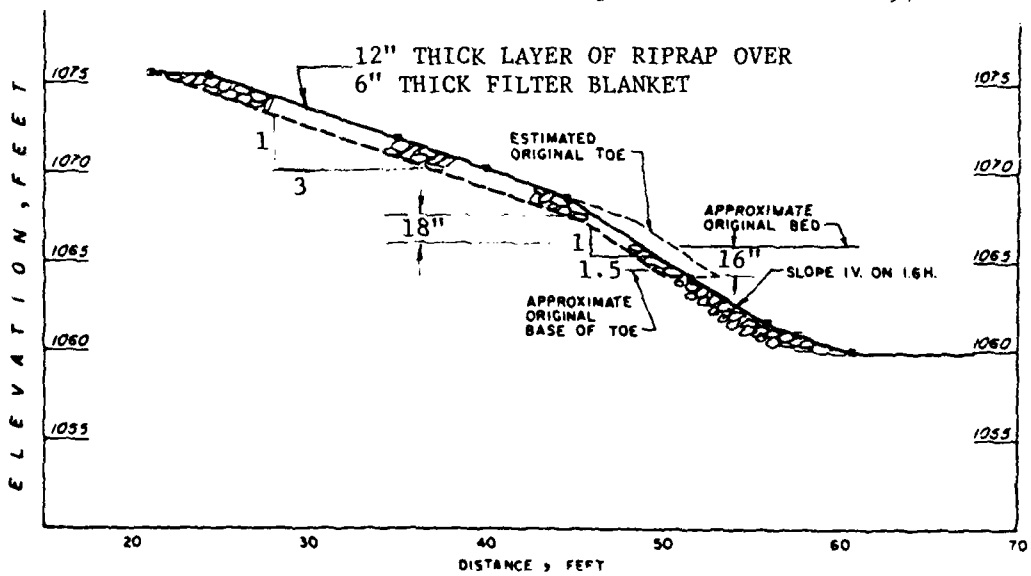
32. Approximately 4-1/2 ft of degradation below the original base of the toe had occurred in Test Section 2 (Figure 21). Riprap had covered the lower slope to a thickness of approximately two rock diameters. There appeared to be some evidence of separation along the original base elevation of the toe as a line of exposed bedding could be seen along the entire length of the test section.

Figure 21. Republican River at Milford Dam Outlet Channel, Kans. Cross-sectional view of Test Section 2 shown as constructed in 1969 and as surveyed in 1974. (Adapted from Reference 9)

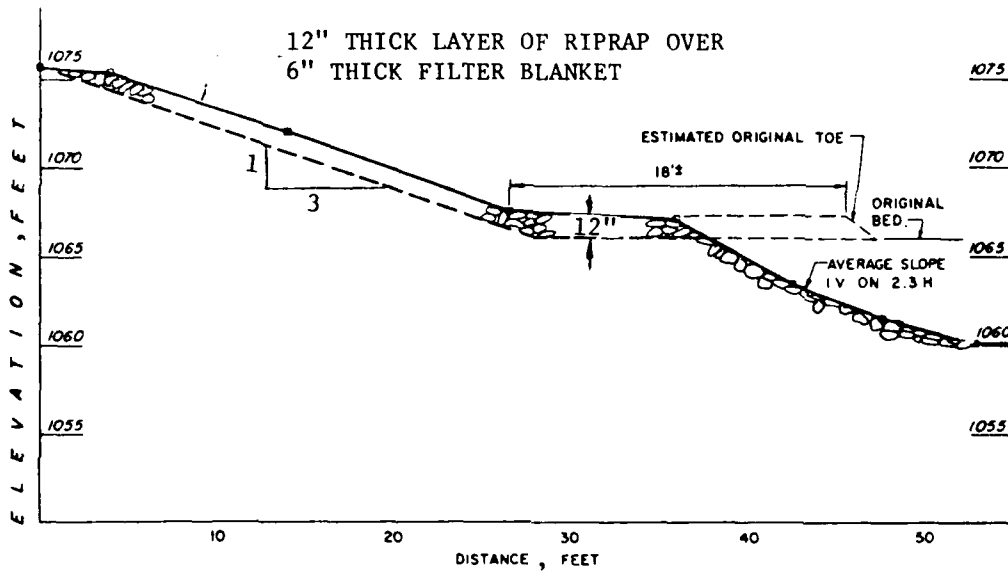
33. The streambed in the vicinity of the toe of Test Section 3 had degraded approximately 6 ft (Figure 22). The riprap had moved downward to cover the lower slope; however, the thickness averaged somewhat less than one rock diameter, i.e., small areas of exposed sand could be seen over the entire face of the toe. There was a substantial reserve of stone remaining in the toe; however, the MRK inspection team noted that if additional degradation occurred too rapidly, partial revetment failure could occur due to separation of the thin blanket. Alternatively, recession of the bank by leaching could cause additional riprap to move downward from the reserve and form a thicker bank covering.

Figure 22. Republican River at Milford Dam Outlet Channel, Kans. Cross-sectional view of Test Section 3 shown as constructed in 1969 and as surveyed in 1974. (Adapted from Reference 9)

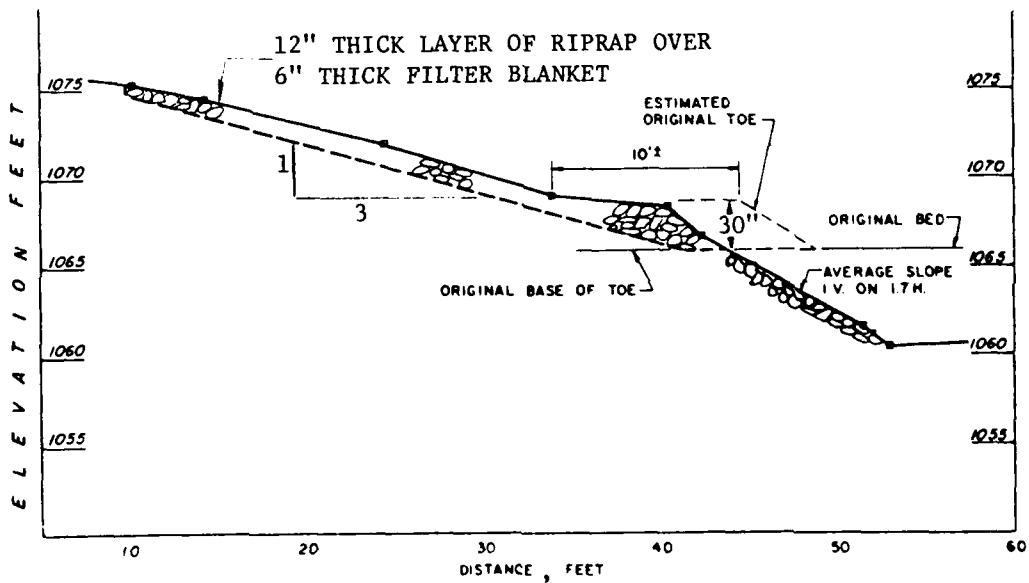
34. Approximately 5 ft of degradation had occurred along the toe of Test Section 4 (Figure 23). There was a uniform blanket of riprap on the lower slope averaging at least two rock diameters thick. No evidence of blanket separation or areas of exposed bed material were noted. The riverward edge of the stone was essentially at the base of the slope

with very little migration of riprap out into the channel. A substantial reserve of rock that could provide material to accommodate additional degradation still remained.

Figure 23. Republican River at Milford Dam Outlet Channel, Kans. Cross-sectional view of Test Section 4 shown as constructed in 1969 and as surveyed in 1974. (Adapted from Reference 9)

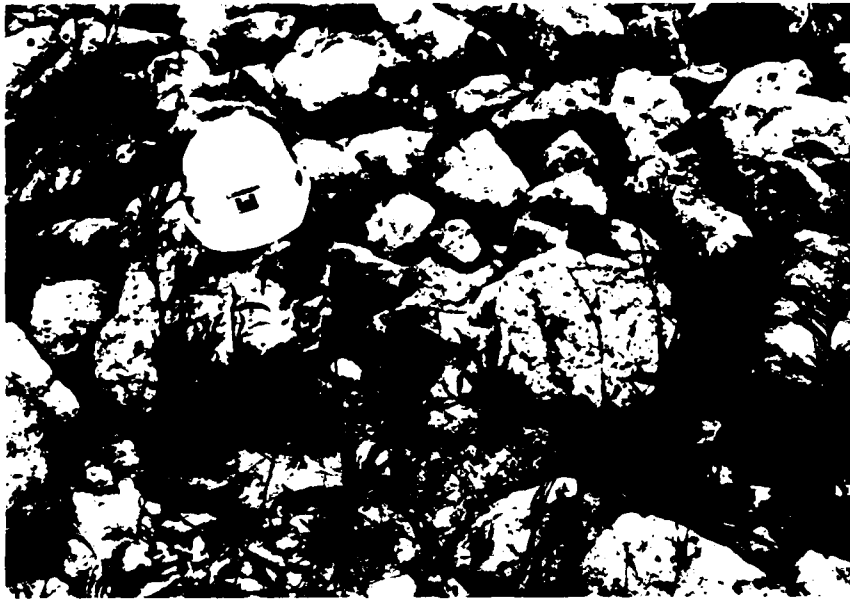
exposed areas between individual rocks. This was typical of the slope below the 12-in.-thick horizontal blanket in Test Section 3 (Figure 26) and isolated areas over Test Sections 1 and 2 (Figure 27). Good coverage of riprap on the slope below the 30-in.-thick horizontal blanket was noted in Test Section 4 (Figure 28). No areas of exposed sand could be found in this test section. A substantial growth of willows, cottonwoods, and other woody vegetation had developed over Test Section 3 (Figure 29). The team concluded that this growth could retard the downward movement of rock from this test section and that in order to retain a valid test, the vegetation should be removed. Breakdown of stone on the left bank near the waterline was noted. This was due to exposure to the sun during the winter and the resulting range of temperature variation that the riprap experienced; however, the extent of deterioration was not considered sufficient to affect the integrity of the revetment.

Figure 26. Republican River at Milford Dam Outlet Channel, Kans. Areas of exposed sand visible between individual rocks below the 12-in.-thick horizontal blanket in Test Section 3 (May 1977). (Source: Reference 11)

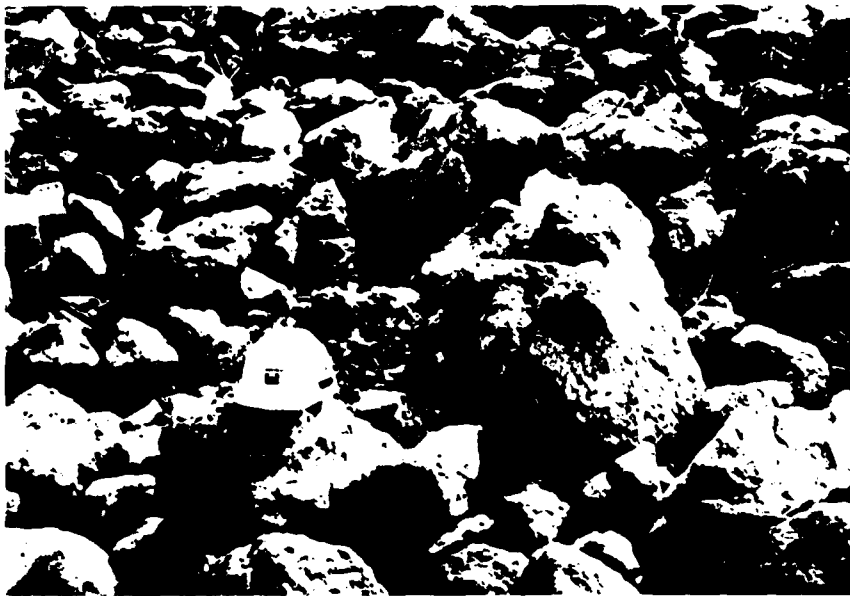
Figure 27. Republican River at Milford Dam Outlet Channel, Kans. The area behind the hard hat is typical of the isolated areas of exposed bedding material in Test Sections 1 and 2 (May 1977). (Source: Reference 11)

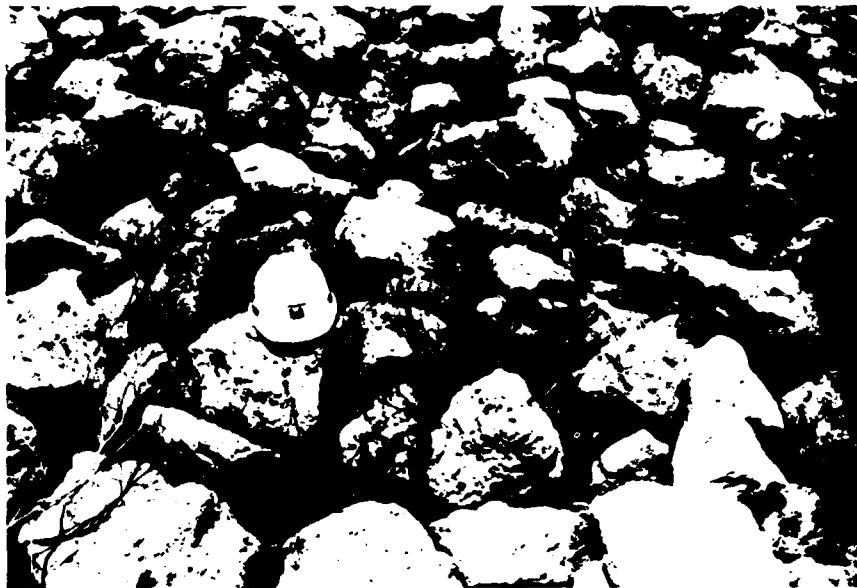
Figure 28. Republican River at Milford Dam Outlet Channel, Kans. There was good coverage of rock on the slope below the 30-in.-thick horizontal blanket at the time of the May 1977 inspection (Test Section 4). (Source: Reference 11)

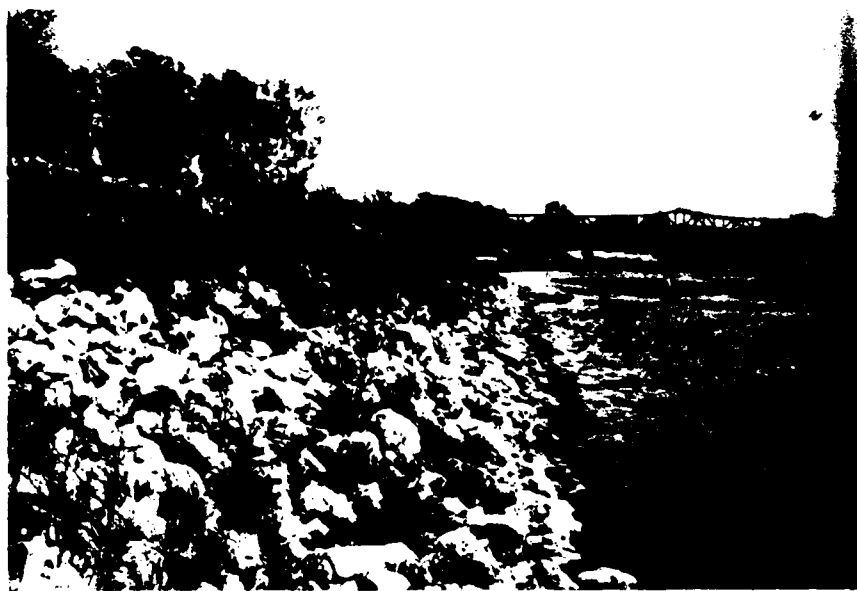
Figure 29. Republican River at Milford Dam Outlet Channel, Kans. There was a substantial growth of woody vegetation over Test Section 3 at the time of the May 1977 inspection. The view is downstream toward the U. S. Highway 77 Bridge. (Source: Reference 11)

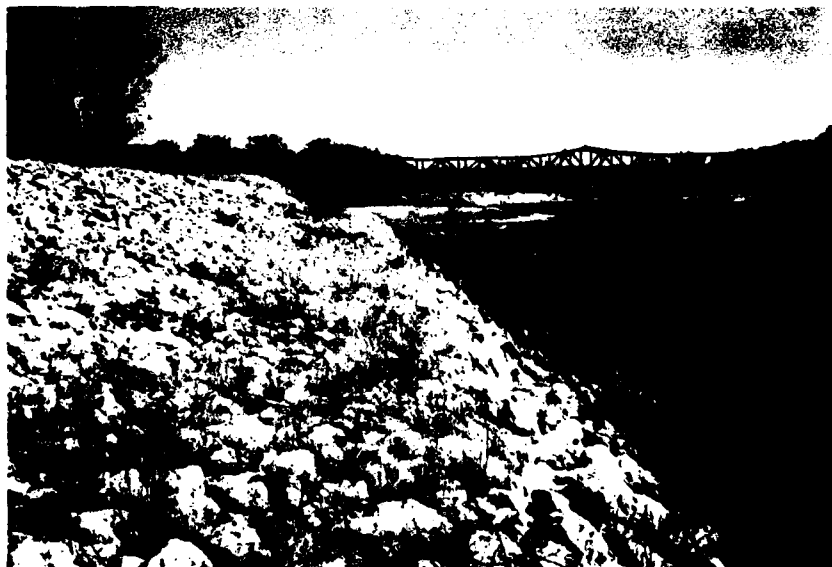
39. The WES Section 32 team visited the site on 18 September 1978. Figure 30 shows upstream and downstream views of the revetment in the outlet channel. The team found the side-slope revetment to be performing as designed; no apparent failures were noted. Later visits to the site by MRK through January 1980 indicate that the revetment continues to perform well.

Figure 30. Republican River at Milford Dam Outlet Channel, Kans.
Upstream and downstream views of the outlet channel revetment at
the time of the WEC inspection visit. Note that the vegetation
has been removed in the lower view; compare with Figure 29.
(18 September 1978)

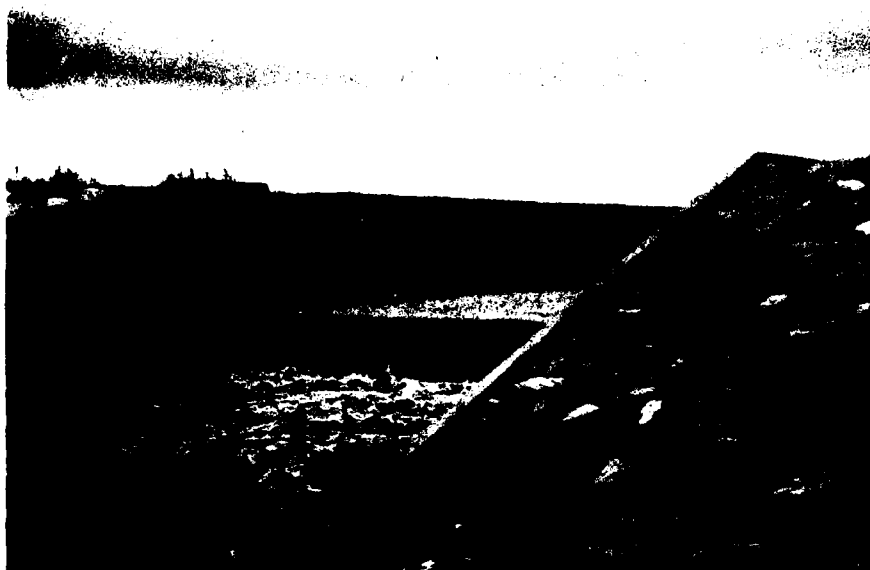
Figure 61. Little Sioux River at Onawa, Iowa. Damage to the stilling basin riprap as a result of high flows in April 1965 required the placement of grouted derrick stone to repair the basin

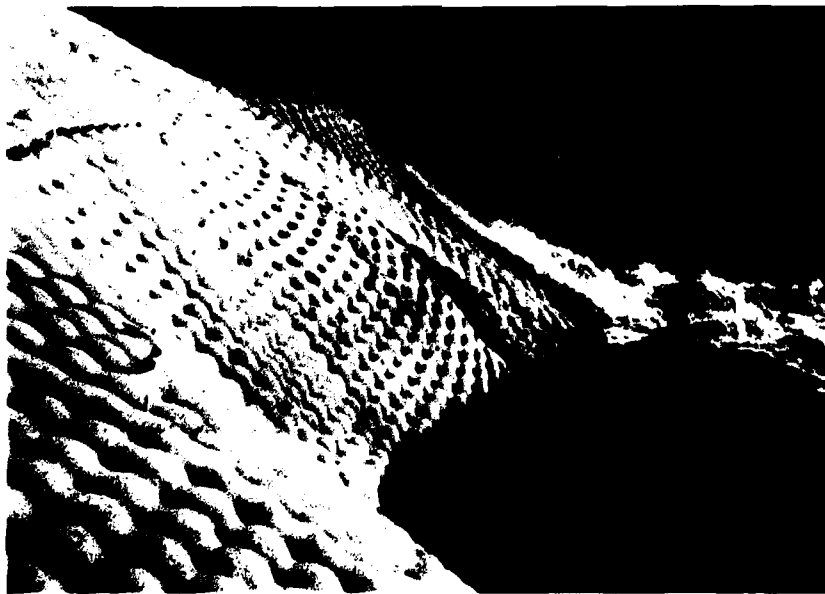
Figure 77. 10L river (East Fork) at Bedford, Iowa. High flows undercut the gabriiform mattress at the Bedford Water Treatment Plant resulting in subsidence of a section of the revetment. (21 September 1973)

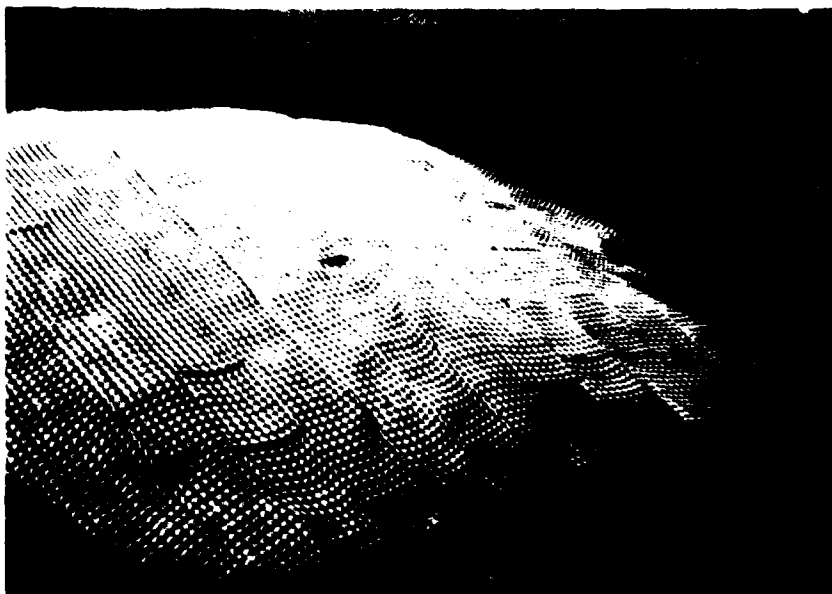
Figure 78. 102 River (East Fork) at Bedford, Iowa. At the time of the WES inspection visit, most of the Fabriform re-
vetment was intact. This view shows the mattress downstream
from the State Street Bridge (21 September 1978)

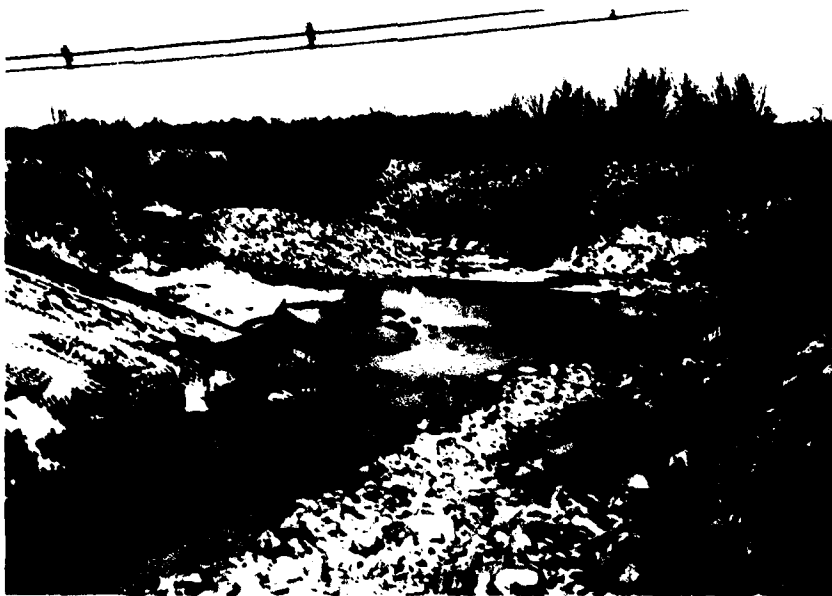
Figure 79. 102 River (East Fork) at Bedford, Iowa. Failure
of drop structure at sta 61+60 (March 1979). Note damaged
Fabriform mattress in left portion of view. (Photograph
taken 22 January 1980)
