MOUNT HIGBY RESERVOIR DAM  
CT. 00140

PHASE I INSPECTION REPORT  
NATIONAL DAM INSPECTION PROGRAM

FEBRUARY, 1979

Identification No: CT 00140  
Name of Dam: Mount Higby Reservoir Dam  
Town: Middletown  
County and State: Middlesex County, Connecticut  
Stream: Fall Brook  
Date of Inspection: 8 November 1978

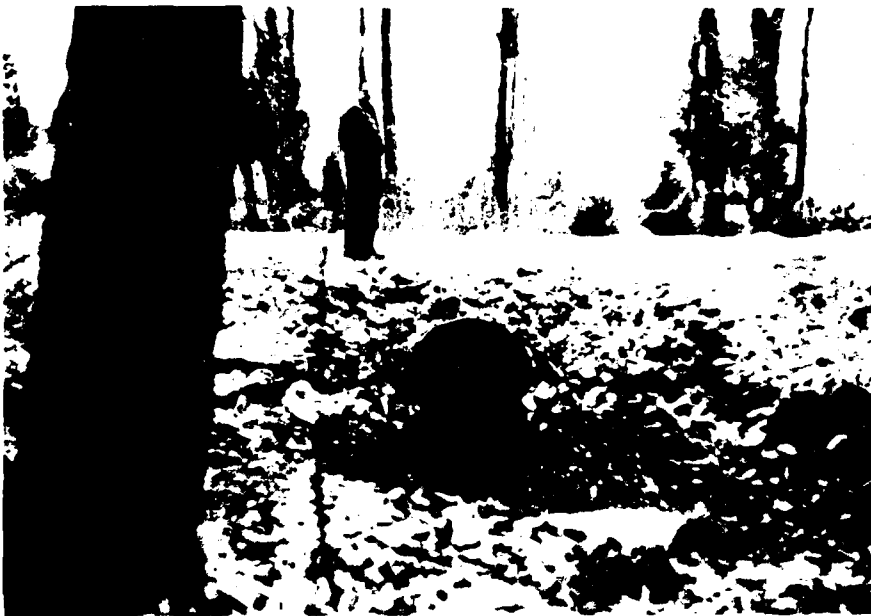
2. Outlet channel culvert under trail below dam.

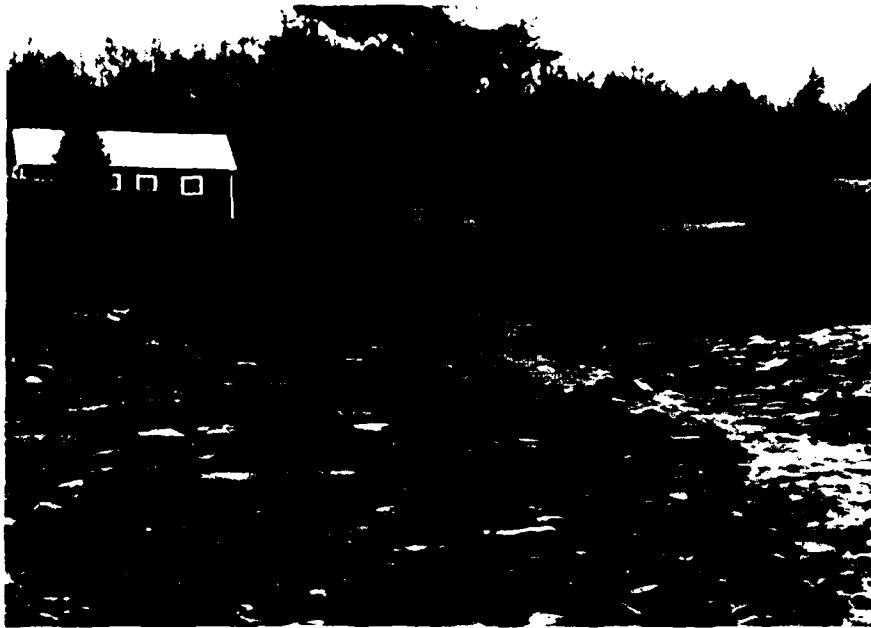
The spillway channel is unlined. The first 150 ft. is riprapped and the remainder is in rock cut, which appears to be stable. Some brush growth has established itself in the channel, which might best be grubbed out (Appendix C, Photo Nos. 5 & 6). The riprap at the beginning of the spillway channel appears to be in good condition. The twin masonry arch bridge across the channel requires some grouting but otherwise is in good condition (Appendix C, Photo No. 7). The concrete spillway sill is 2 ft. high, in good condition, and the discharge channel is paved with asphalt for about 50 ft.

5. Spillway approach channel

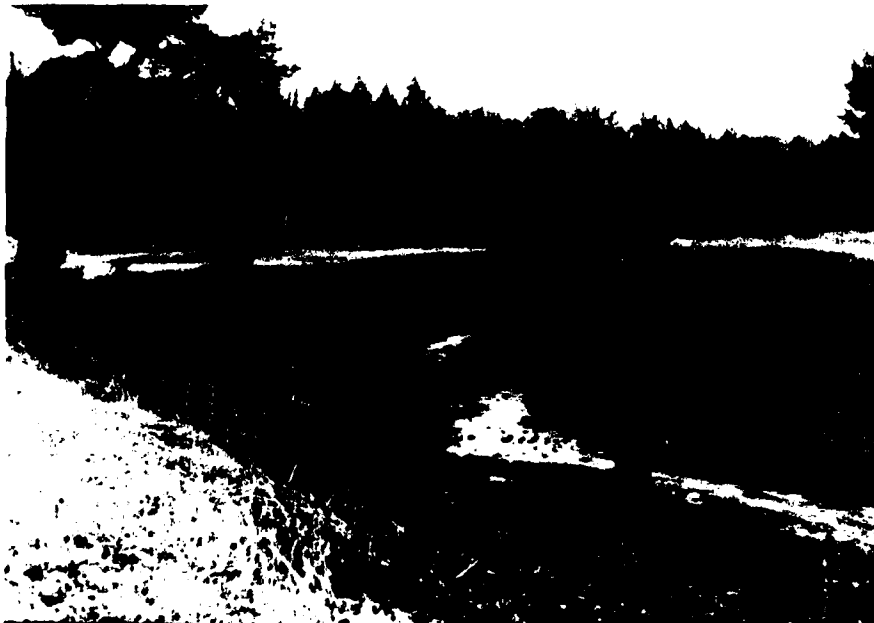
6. Spillway approach channel

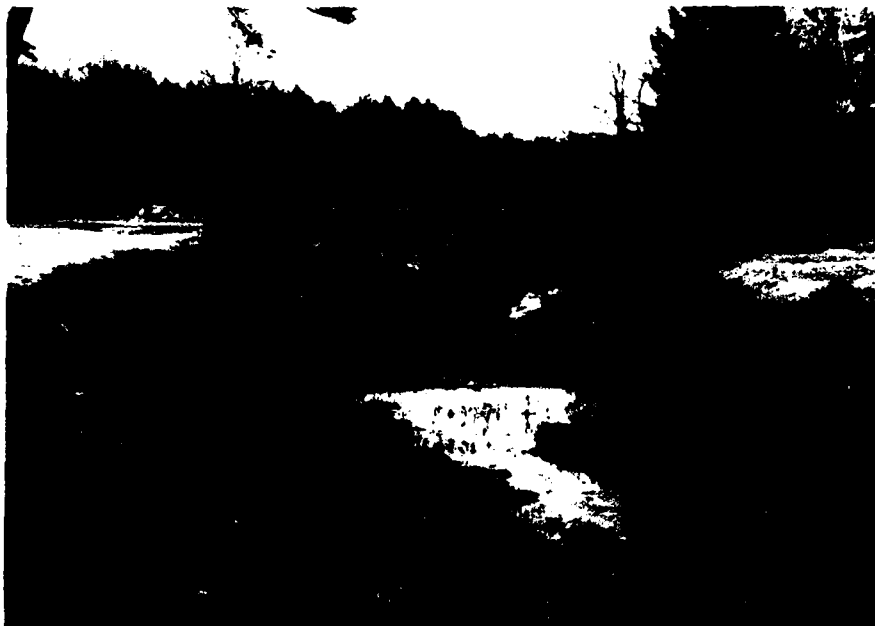
7. Twin arch culvert carrying access road across spillway approach channel
