NATIONAL PROGRAM FOR INSPECTION OF NON-FEDERAL DAMS
MULBERRY RESERVOIR DA. (U) CORPS OF ENGINEERS WALTHAM
MA NEW ENGLAND DIV JAN 80

SERRY RESERVOIR DAM
CT 00130

PHASE I INSPECTION REPORT
DAM INSPECTION PROGRAM

JANUARY 1980

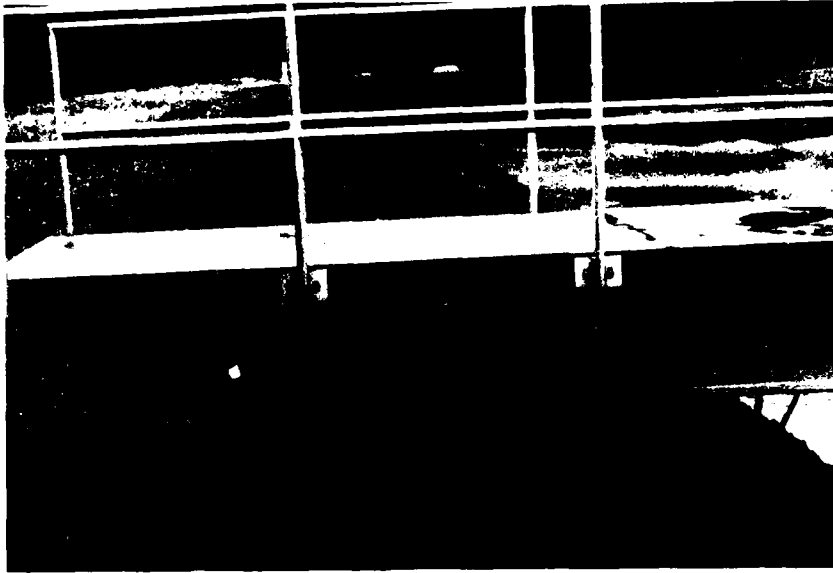
PHOTO NO. 5

The bridge to the gatehouse is generally in good condition, except for a transverse crack at the second pier from the dam, Photo 5. The visible part of the gatehouse structure is in good condition.

GATEHOUSE BRIDGE PIER
TRANSVERSE CRACK IN PIER SUPPORTING STEEL BEAM
