THAMES RIVER BASIN
NORWICH, CONNECTICUT

GREENVILLE DAM
CT. 00206

PHASE 1 INSPECTION REPORT
NATIONAL DAM INSPECTION PROGRAM

OCTOBER, 1980

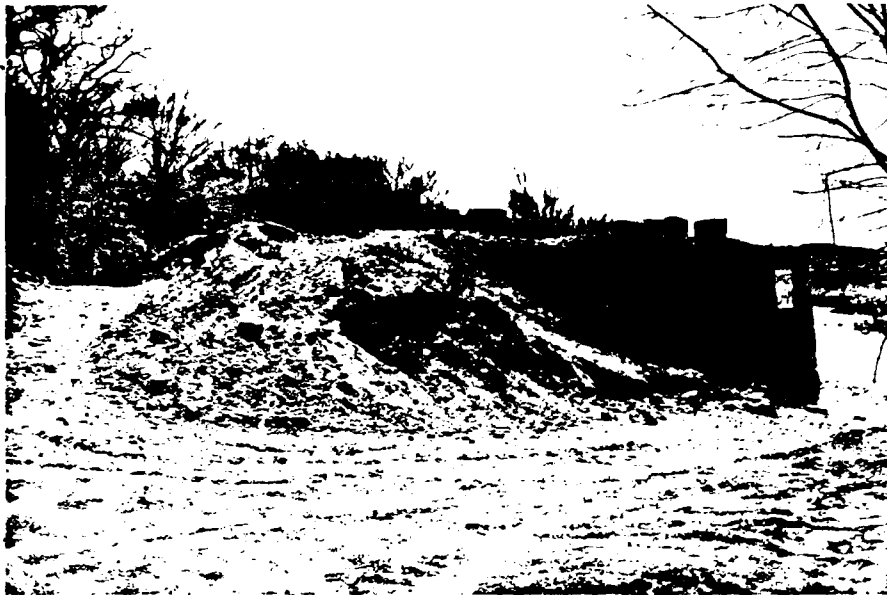
2. Left Embankment. The left masonry block wall of the dam is shown in Photos C-1 and C-5. A concrete training wall has been built downstream from the masonry wall to divert water away from the toe of the downstream masonry wall and adjacent earth embankment (Photos C-5 and C-7). A roadway has been excavated adjacent to the left abutment as indicated in Photos C-1 and C-4. This roadway construction has created a minor depression in the crest profile of the dam. The length and depth of this depression could not be measured and inspected due to overflow conditions. A small seep was noted near the downstream toe of the embankment approximately 30 ft. to the left of the end of the masonry training wall. This seepage zone can be observed in Photo C-13. The Owner reports that repair work is presently taking place at the toe of the left embankment where a small tributary flows into the

PHOTO C-1 Upstream face of dam , left embankment.

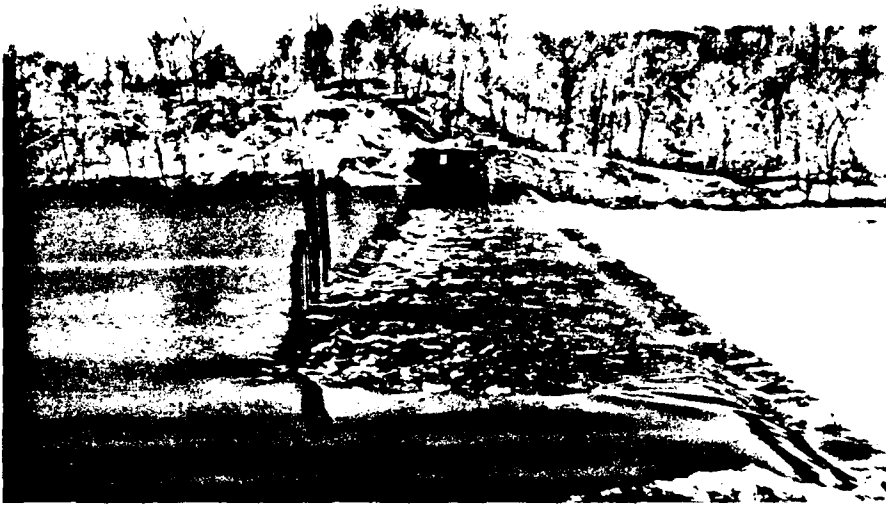
PHOTO C-3 Crest of spillway from right dam embankment.

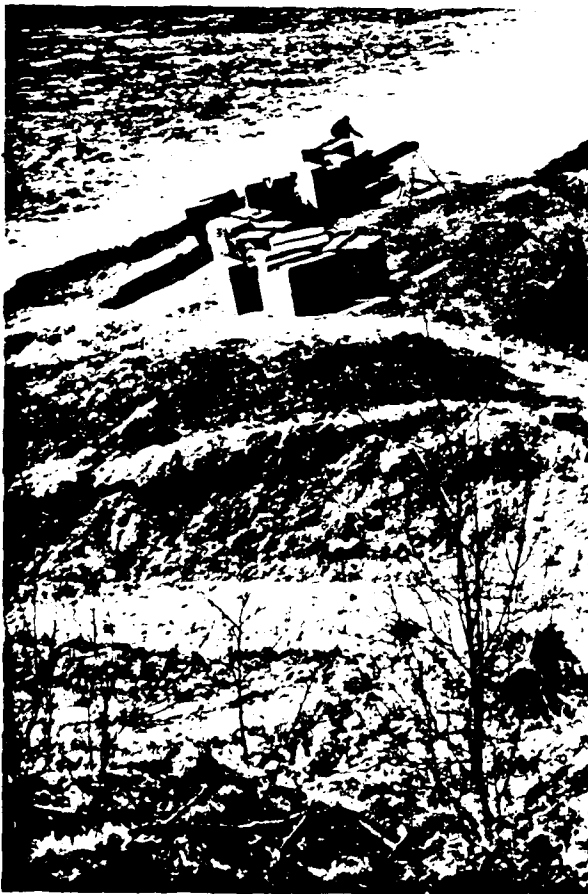
PHOTO C-4 Crest of dam embankment, left side.

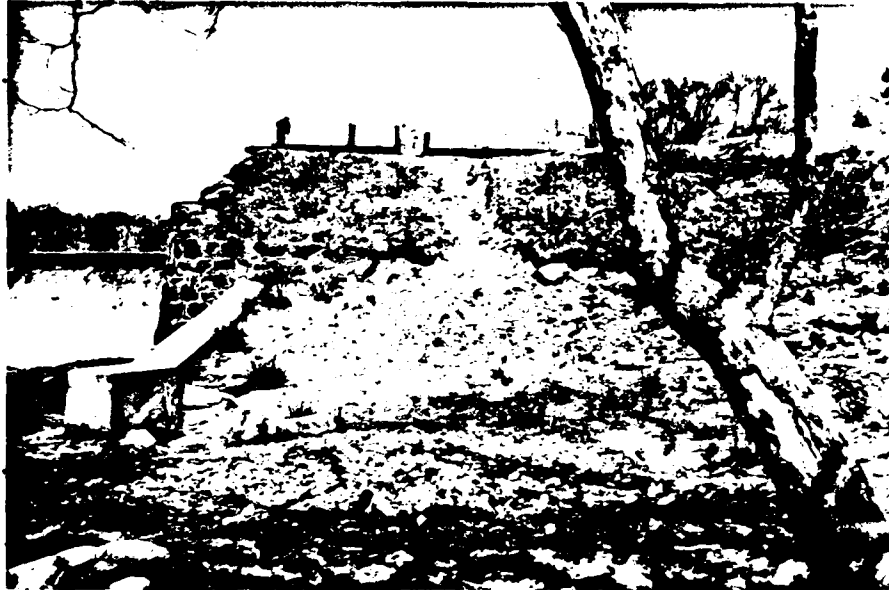
PHOTO C-5 Downstream face of embankment left side.

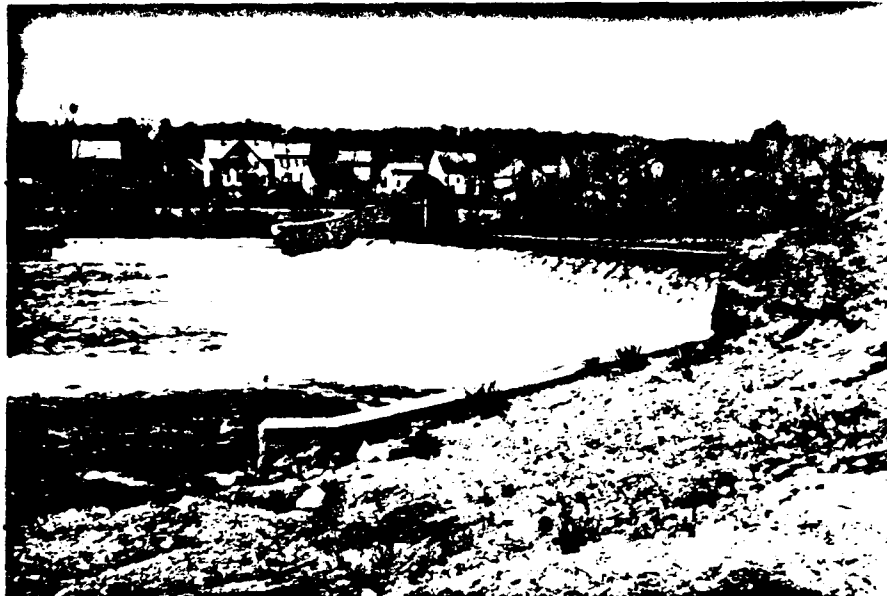
PHOTO C-7 Spillway from left side.

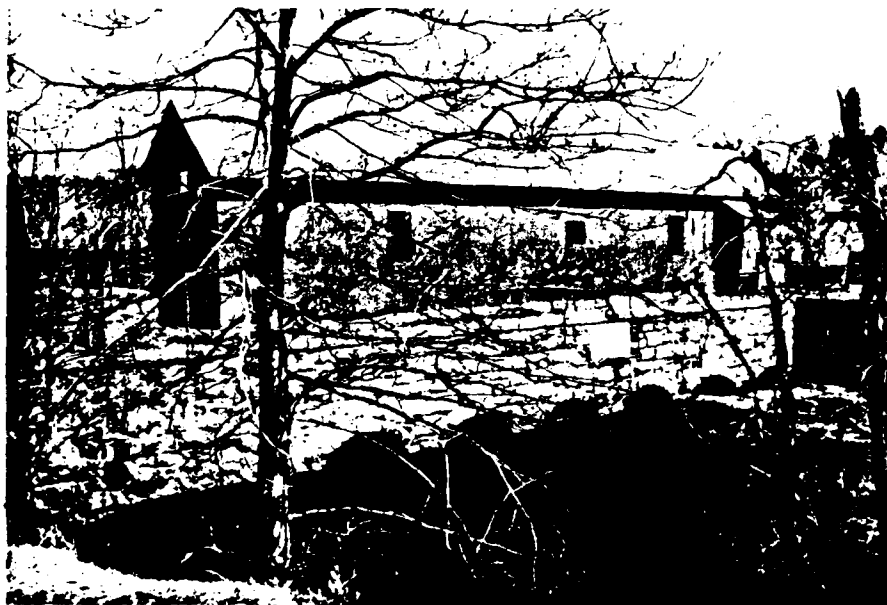
2. Gatehouse and Gate Controls. The gatehouse is a timber superstructure on the stone masonry portion of the embankment. This structure is shown in Photos C-2, C-10, and C-12. The general condition of the superstructure was to be judged fair. The gates appeared to be well maintained and in operating condition although an operational check was not conducted. Three of the six gates can be electrically operated, the remaining gates are manually operated.

PHOTO C-10 Outlet works.

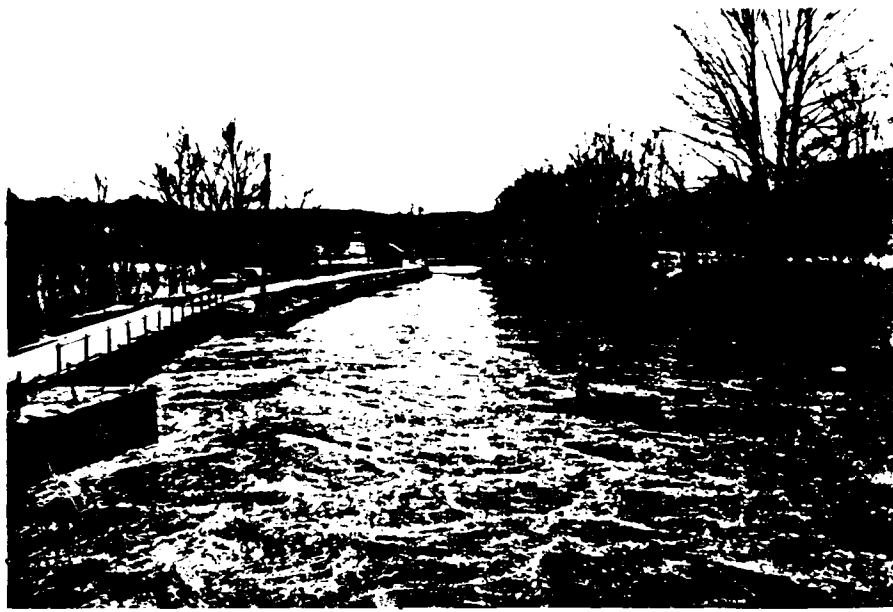
PHOTO C-11 Outlet channel.

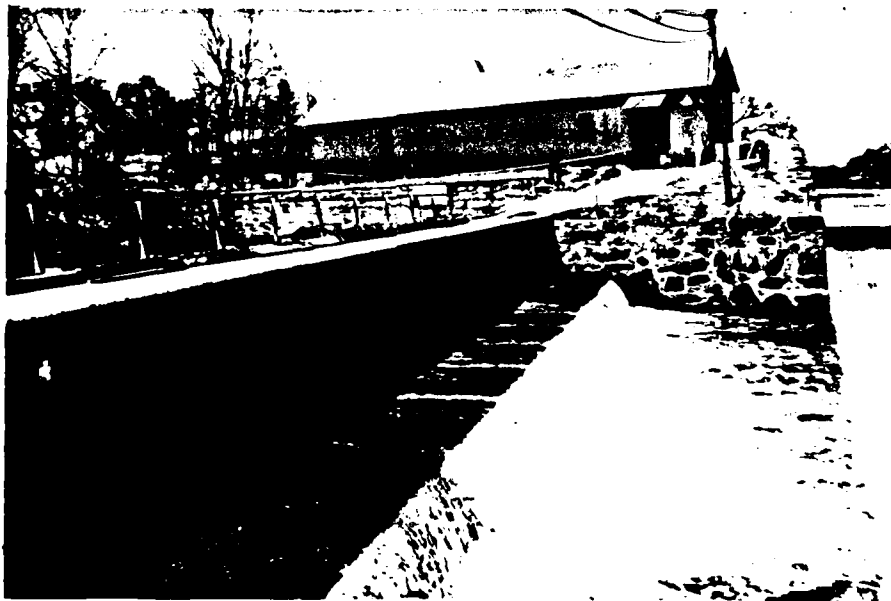
3. Canal Outlet Channel Spillway. This structure is shown in Photo C-12. The structure is of concrete and judged to be good condition.
4. Canal Intake Channel. The intake channel is shown in Photo C-9. The channel runs parallel to the Shetucket River and is connected with the river immediately upstream from the gatehouse (Photo C-2). The location of the intake channel is visible in the overview photo as a break in the trees upstream from the gatehouse. There are many overhanging trees and branches.

PHOTO C-12 Outlet channel spillway discharging to Shetucket River.
