**LOWER CONN RIVER BASIN
CLINTON, CONNECTICUT**

**INDIAN LAKE DAM
CT 00189**

**PHASE 1 INSPECTION REPORT
NATIONAL DAM INSPECTION PROGRAM**

MARCH 1981

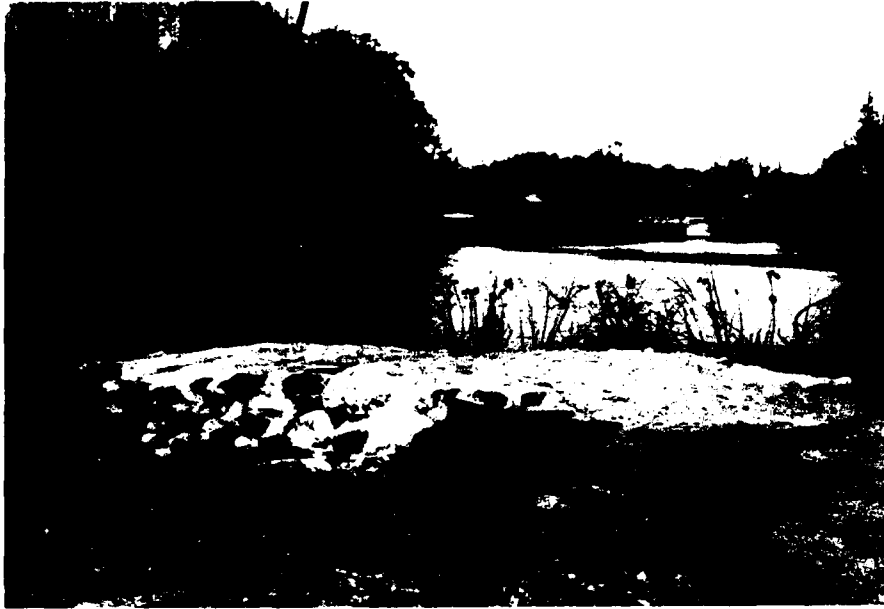
Photo 1 - Overview of left abutment showing repairs made in 1979 after the dam was overtopped. View of pond and I-95 culvert at inlet to the pond.

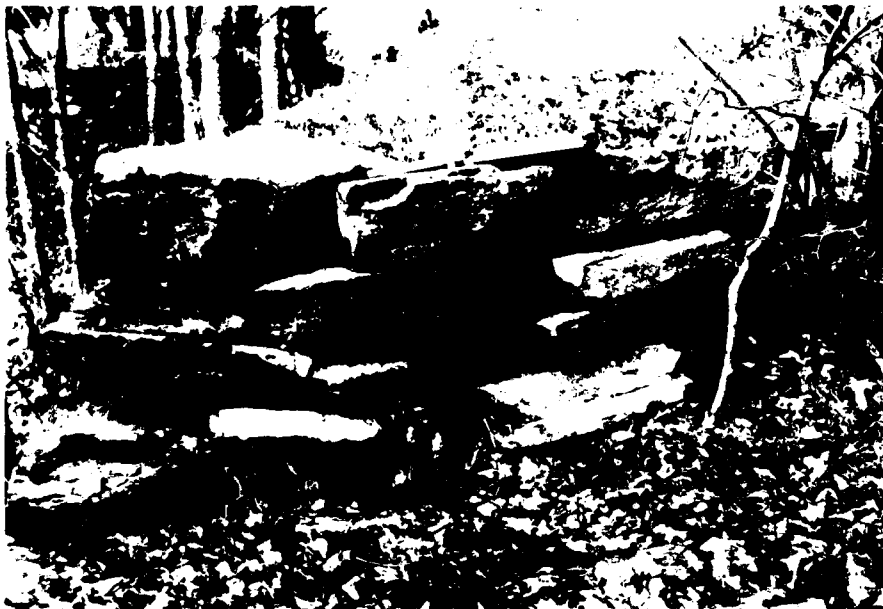
Photo 4 - Right training wall of spillway. Note large voids and tree growing at upstream end. (Extreme right of photo.)
