ELMVILLE DAM
CT 00165

PHASE I INSPECTION REPORT
NATIONAL DAM INSPECTION PROGRAM

OCTOBER, 1979

Identification No.: CT 00165
Name of Dam: Elmville Dam
Town: Killingly
County and State: Windham County, Connecticut
Stream: Whetstone Brook
Date of Inspection: 21 August 1979

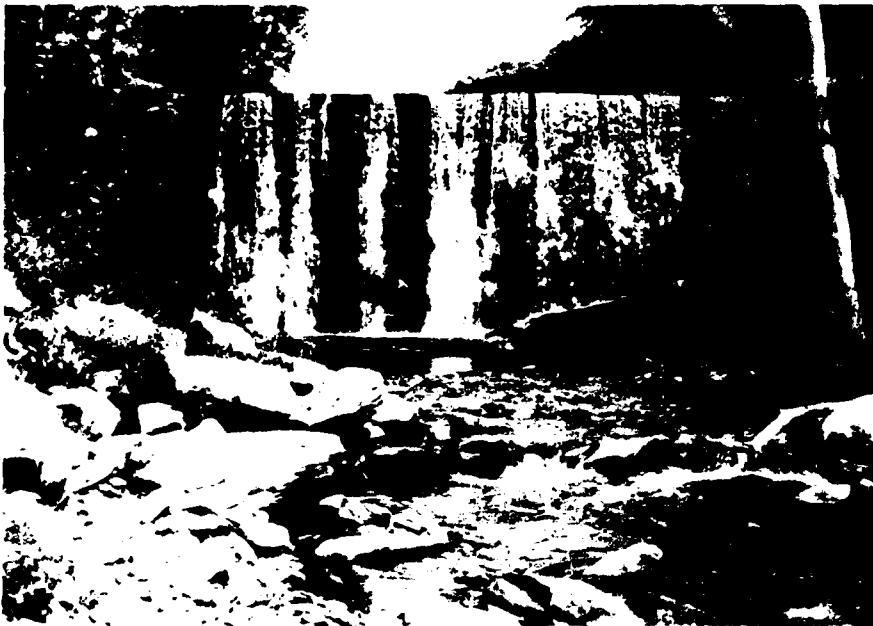
Overview of overflow section from downstream.
