MECHANICSVILLE DAM

CT 00182

PHASE I INSPECTION REPORT
NATIONAL DAM INSPECTION PROGRAM

SEPTEMBER, 1979

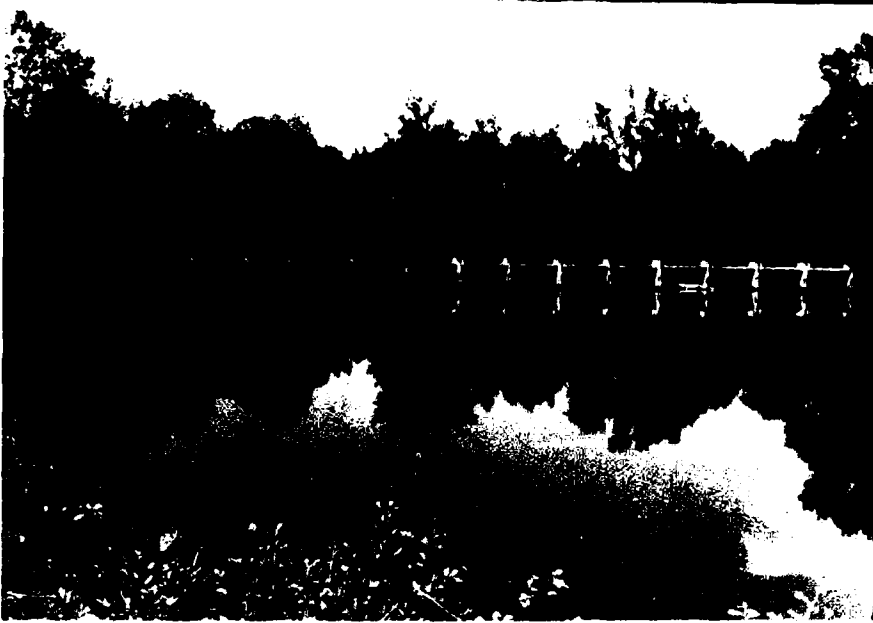
1. Overflow section and bridge from upstream.

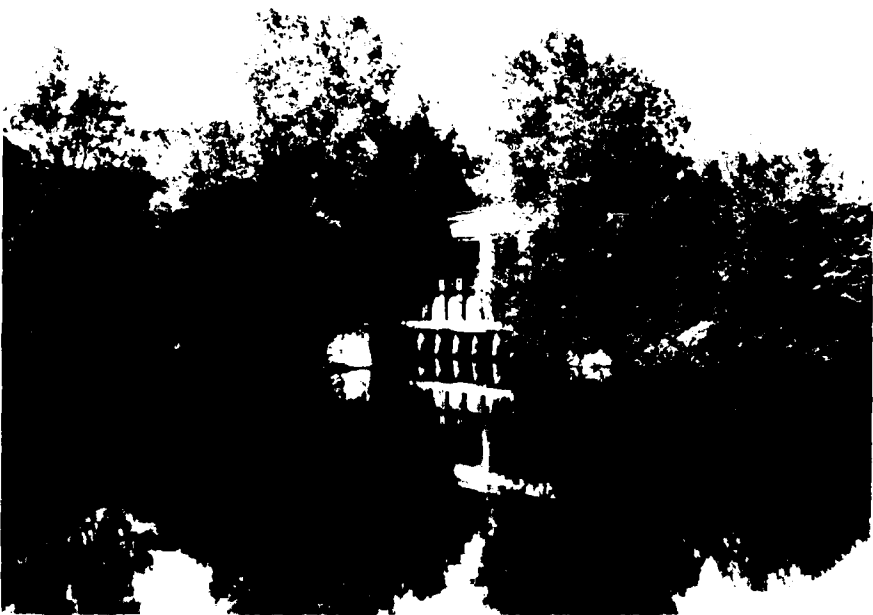
2. Abandoned power house and forebay from upstream.

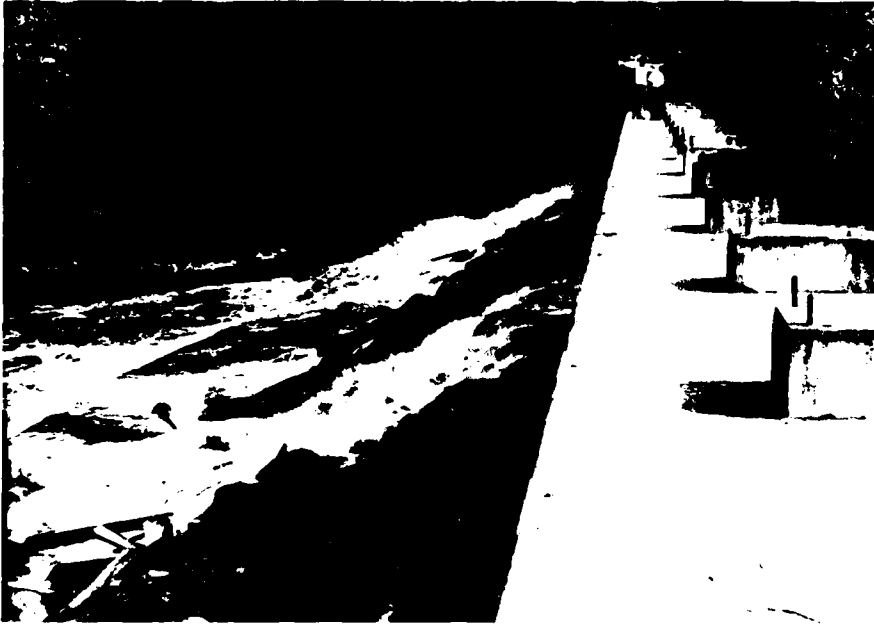
(1) Spillway. The overflow section is comprised of a laid-up stone gravity structure capped with reinforced concrete at its crest and spanned by a reinforced concrete bridge (Appendix C, Photo Nos. 3 & 4). Concrete piers support the bridge and form 16 spillway bays of 11 ft. 6 in., giving the dam an effective hydraulic width of 184 ft. While the massive stone stepped structure and concrete cap were sound and stable, the concrete piers supporting the bridge were in poor condition; spalling has taken place and much of the reinforcing steel is visible. The crest of the spillway and the downstream stone stepped section were covered by debris and remnants of the old spillway bay gates and their control mechanisms. Examination of both banks of the river downstream of the spillway for some distance revealed no evidence of seepage. The masonry at both abutments has become invaded by mature trees which are visibly disrupting the integrity of the walls. On the downstream side of the overflow section at both abutments, shaped concrete and masonry flumes guide the flows to mid channel. At the left abutment the flume's concrete veneer over rubble core has been stripped away. At mid-dam the configuration of the stone is stepped, assisting energy dissipation.

The concrete wall piers are deteriorating. If it is your intention to preserve the concrete bridge over the dam, these piers should be repaired in the not too distant future.

3. Spillway bridge with remains of gate controls.

- (1) Make a thorough study of the hydrology of the drainage basin, including an assessment of the attenuating effects of Lake Webster. Review the spillway adequacy in relation to the potential overtopping of the abutment walls and the dike.
- (2) Determine whether the spillway bridge should be repaired or removed.

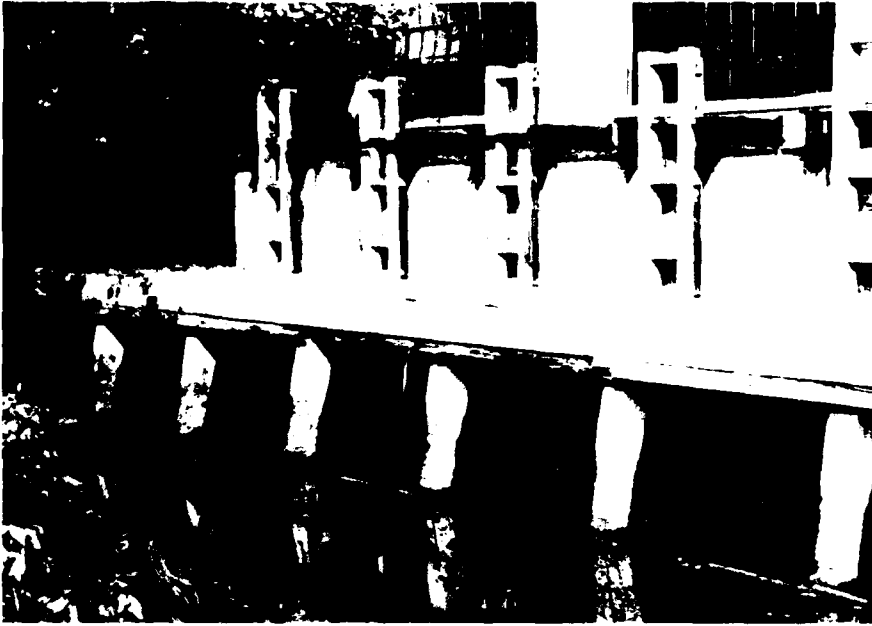
To the left of the stone wall is the abandoned power house and forebay with 6 intake gates into the old turbine room of the structure (Appendix C, Photo No. 5). The gates were in a closed or nearly closed position, but water was leaking through the structure (Appendix C, Photo No. 6). From the floor of the power house, inspection of the turbine areas was attempted through an uncovered access hole, but the water surface was within 6 ft. of the floor obscuring all detail. There is a bypass flume to the left of the intake gates in the forebay. Water appeared to be leaking between the forebay and the flume as the aperture through the wall was at least 1 ft. above the level of the water (Appendix C, Photo Nos. 7 & 8). The power house structure was in a dilapidated condition.

5. Five of 6 intake gates to power house.
