THAMES RIVER BASIN
KILLINGLY, CONNECTICUT

OLD DANIELS DAM
CT. 00168

PHASE 1 INSPECTION REPORT
NATIONAL DAM INSPECTION PROGRAM

AUGUST, 1980

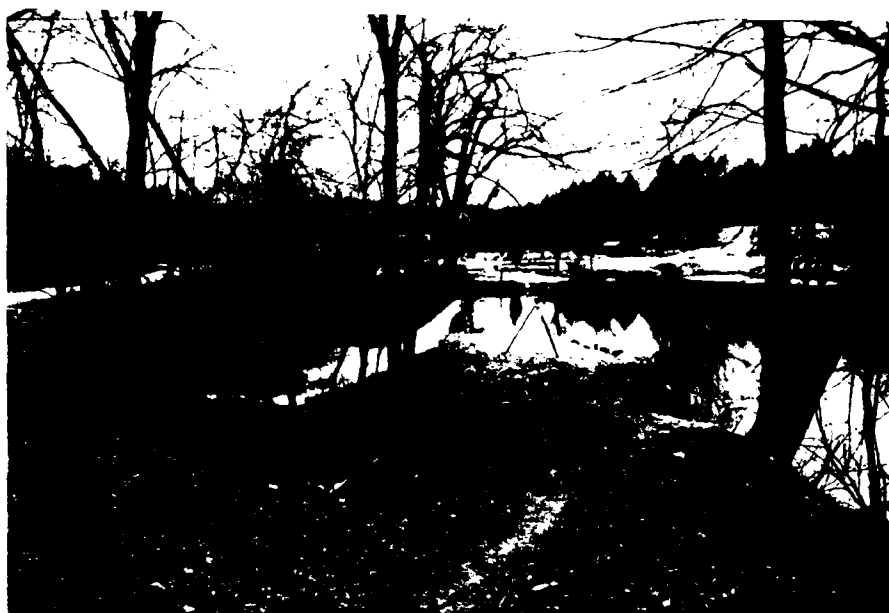
The embankment crest to the left of the spillway is grass covered with a typical crest width of 14 feet. Trespassing has removed the grass cover in some areas (see Photo C-1). Runoff from the crest has caused some soil to wash out from behind the stone masonry wall on the upstream slope (see Photo C-3).

PHOTO C-1 Crest of dam and downstream slope looking from the left dam abutment. Note large trees growing on the slope.

- a. Design and place riprap on upstream slopes of the embankment.
- b. Remove trees growing on the embankment slopes and backfill root depressions with appropriate compacted soils.
- c. Cut all trees growing within 20 feet of the stone walls forming the sidewalls of the spillway discharge channel from the spillway to the Putnam Road Bridge.
- d. Repair all sections of the stone sidewalls forming the banks of the spillway discharge channel where large voids or irregularities exist and where the walls are partly collapsed.

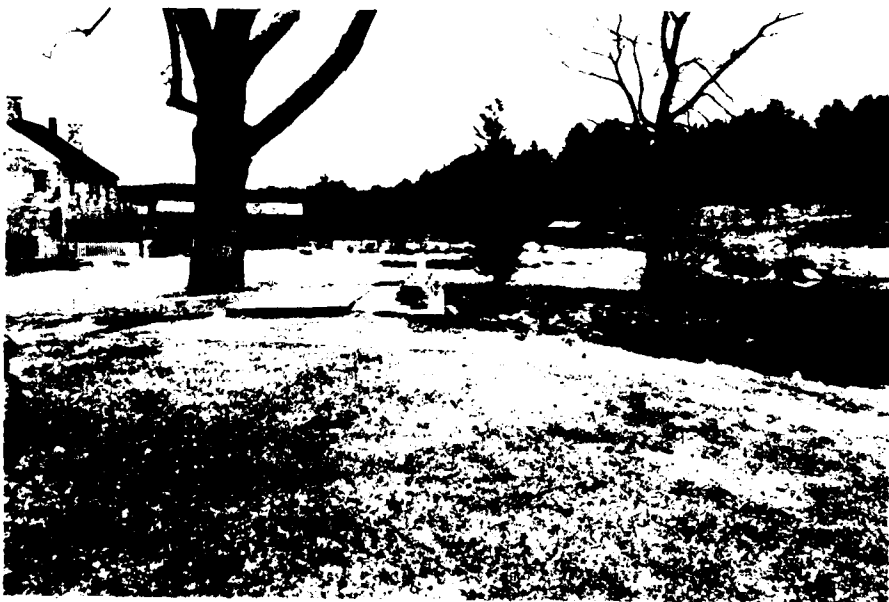
PHOTO C-2 Crest of dam looking from the right spillway abutment.

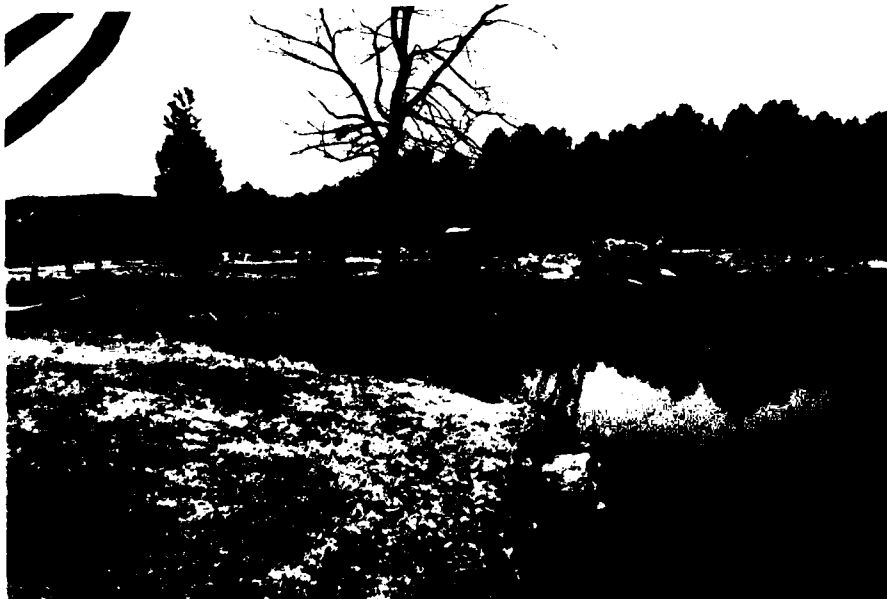
PHOTO C-4 Upstream slope of dam and headrace looking toward the right dam abutment from the right spillway abutment.

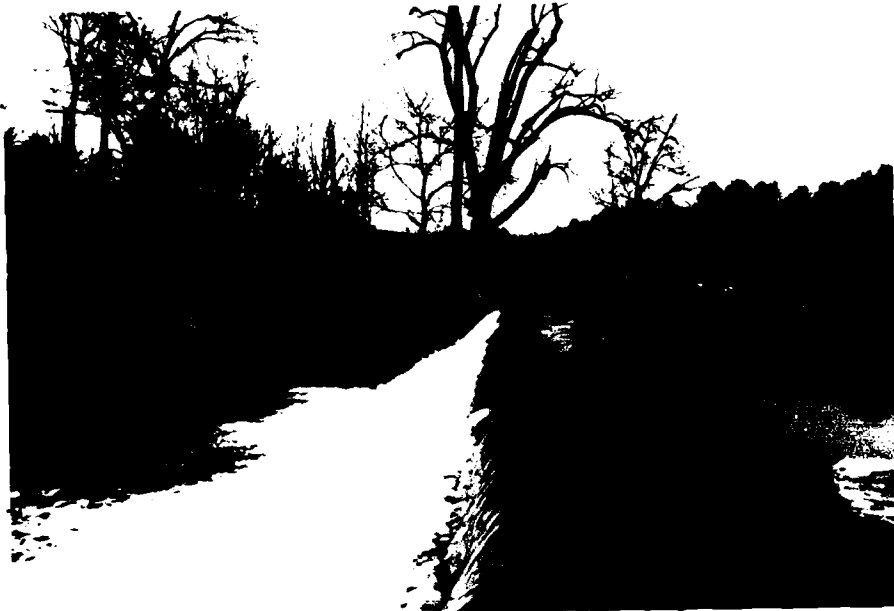
PHOTO C-5 Spillway crest looking from the left spillway abutment.

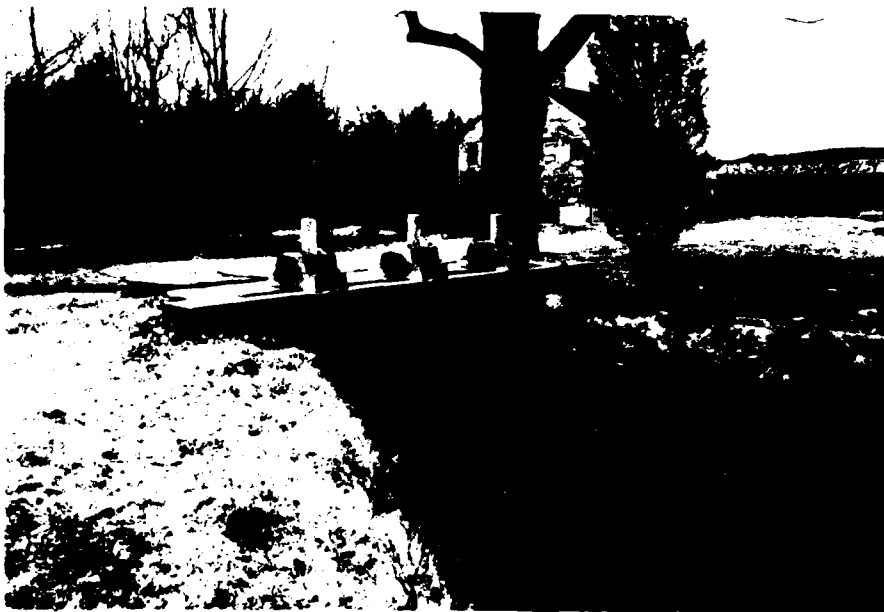
PHOTO C-8 Triple gated headrace.

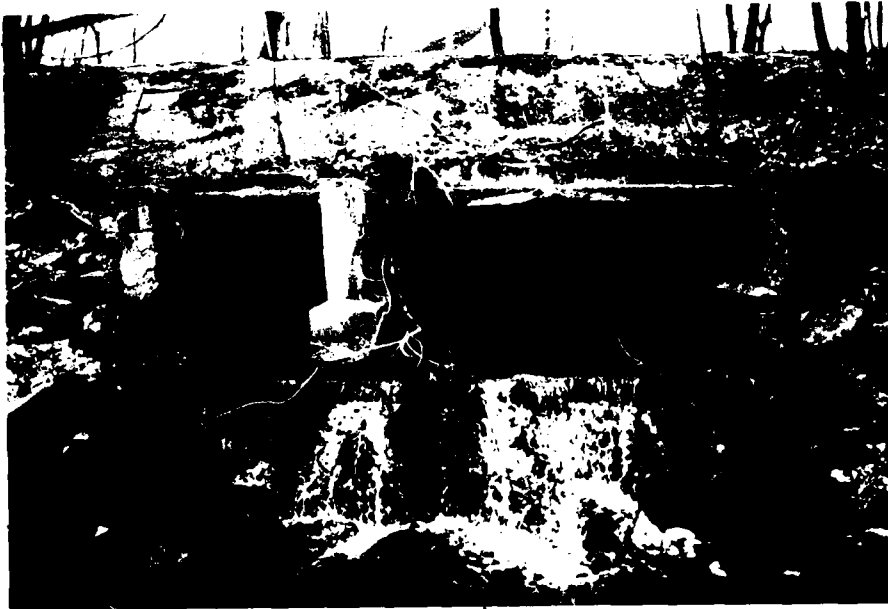
The overall appearance of the conduit (see Photo C-9) is fair. Several areas along the joint between the sidewalks and floor slab of the conduit have been eroded from scour and water was observed to flow or seep out before reaching the outlet. Spalling and cracking of the concrete in the conduit and exposed reinforcement were observed. The left and right sidewalls of the intake structure also showed general deterioration (see Photo C-8). The exposed concrete on the gate structure appeared to be in good condition.

PHOTO C-9 Tailrace outlet chamber.
