**SOUTHWESTERN COASTAL BASIN  
WILTON, CONNECTICUT**

**POPE'S POND DAM  
CT 00214**

**PHASE 1 INSPECTION REPORT  
NATIONAL DAM INSPECTION PROGRAM**

APRIL, 1980

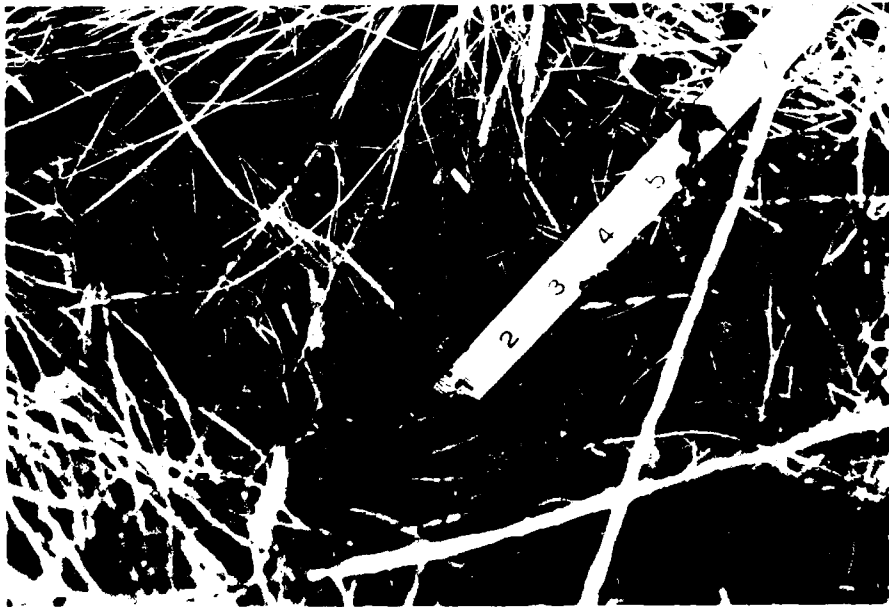
3. **Downstream Face:** The downstream face is an earth embankment and exhibited some signs of moisture fairly high on the embankment. It appears possible that some seepage is coming over the top of the steel sheet piling. Two specific areas of moisture were noted and are graphically shown on the Photo Index (Appendix C). The seepage spots noted are not serious; however, because this is a relatively young dam, these areas should be monitored closely. The face of this dam is free from large trees but grass and wild shrubbery were waist high (Photo C-1). Toe drains were noted on the plans; however, were not visible. An animal hole was noted in the embankment below the dam's east crest (Photo C-10).

C-10 ANIMAL HOLE ON EASTERN  
DOWNSTREAM EMBANKMENT

2. The trees and brush on the upstream face should be removed and the animal hole filled.
3. Develop a downstream warning and surveillance plan, including round-the-clock monitoring during heavy precipitation.
4. Joint material should be replaced in open joints where it is missing.
5. Institute a program of annual periodic technical inspection.
