THAMES RIVER BASIN
MONTVILLE , CONNECTICUT

CONGDON DAM
CT. 00234

PHASE 1 INSPECTION REPORT
NATIONAL DAM INSPECTION PROGRAM

OCTOBER, 1980

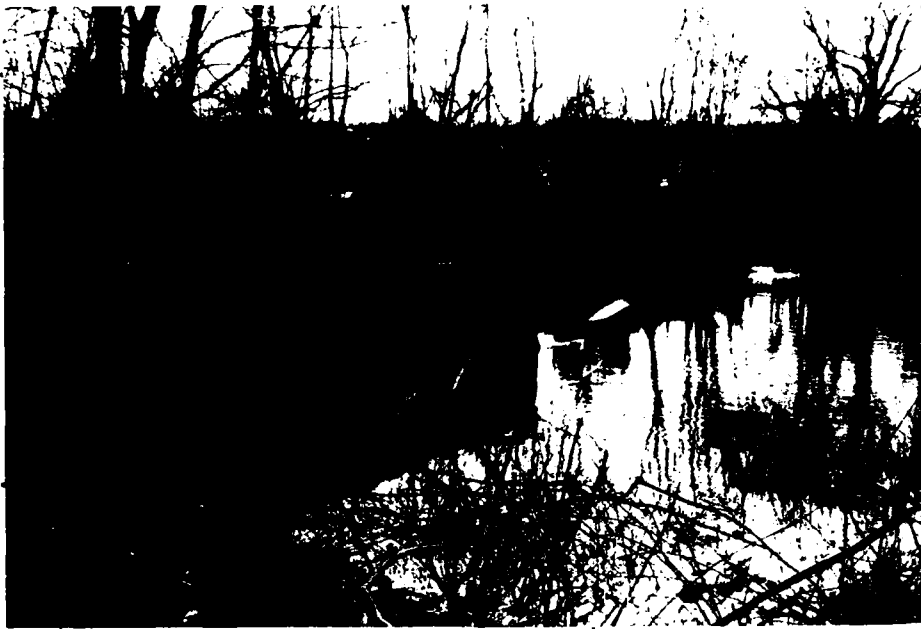
PHOTO C-1 Upstream face of dam from left side.

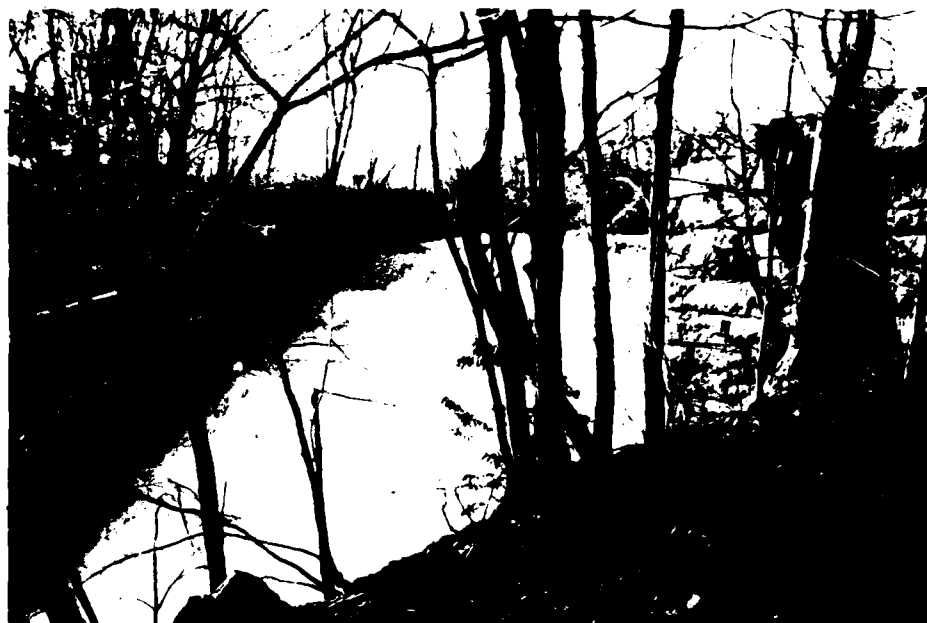
- a. Left of Spillway. The downstream face of the dam at the left of the spillway is shown in Photos C-3 & C-5. An abandoned outlet is located at the toe of the wall where the ground surface is locally depressed. There is a missing stone block at the toe of the wall; the cavity is about 32 in. by 15 in. in size and about 15 in. deep. No seepage was observed at that location.

PHOTO C-5 Spillway and abutments from left side.

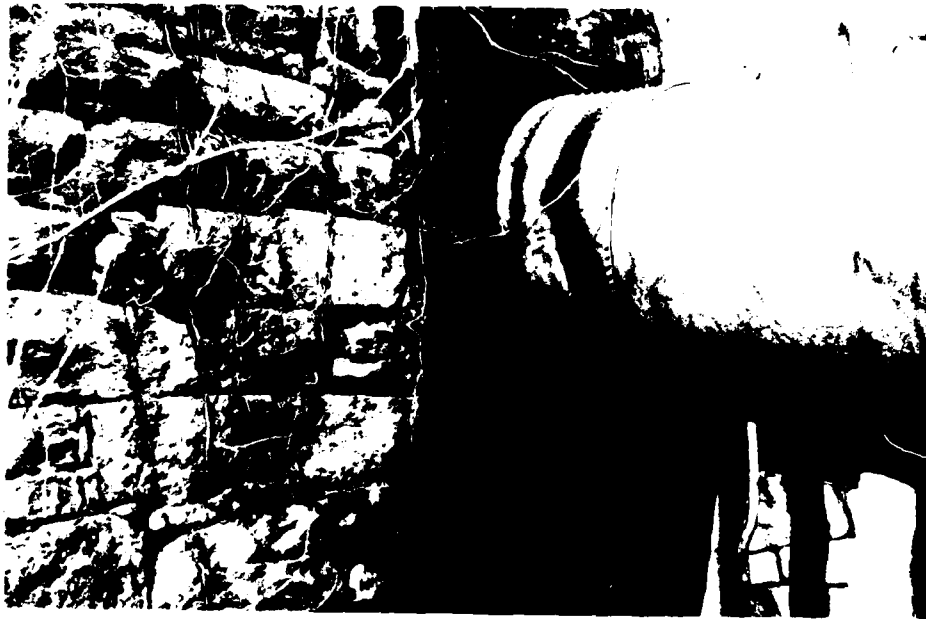
- b. Right of Spillway. The downstream face of the dam at the right of the spillway is shown in Photo C-4. A steel penstock forming part of the outlet works is located on the left side of the wall (Photo C-8). The stone blocks below the penstock have been displaced. The bottom two rows of stonework in this area have moved down about 6 to 12 in. and have also moved out, toward the downstream direction. Seepage was observed at the intersection of the downstream face and the right spillway training wall. Seepage was also observed on the right side of the penstock attachment plate. Seepage from both locations appeared to be clear (Photo C-8). A missing stone has created a gap in the downstream face about 12 in. by 12 in. in size and about 14 in. deep. The gap is located about 3.5 ft above the downstream toe. A rod could be placed 2.5 ft into a nearby joint between stone blocks. Several large trees are growing at the downstream toe of the dam. The largest has a diameter of 21 in. and is located at the right side of the downstream face. Several trees are growing between the penstock and right spillway training wall which could lead to instability of the training wall (Photo C-9). Rock outcrops were observed downstream of the dam at the right of the spillway (Photo C-6, right side).

The steel plate penstock is shown in Photos C-6, C-8 and C-9. The timber portions of the connection between the steel plate pipe and the face of the dam are decayed and rotted away leaving a large void at the top of the pipe (See Photo C-9).

PHOTO C-8 Penstock at downstream face of dam.
