CONNECTICUT RIVER BASIN
GLASTONBURY, CONNECTICUT

ADDISON POND DAM CT 00245

PHASE I INSPECTION REPORT NATIONAL DAM INSPECTION PROGRAM

APRIL 1981

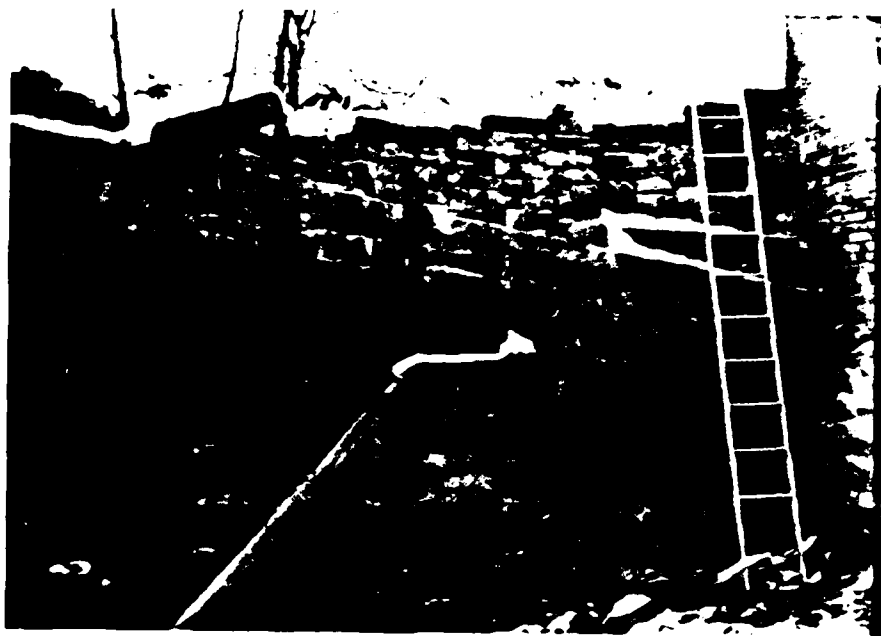
Founded on rock base, the 23' stone masonry east dam embankment was generally in fair condition with an appreciable amount of mortar missing between the stones of the lower two feet.

As shown in Photo 6, minor seepage was observed at these mortarless joints and at the contact zone with the rock base. The upper dam section appeared to be in better condition with the exception of the irregular horizontal alignment as a result of several missing stones (See Photos 5 & 6).

Mortar was missing and seepage was observed between the stones at certain areas of the east dam embankment. The continued deterioration of mortar resulting from the seepage will weaken the stone masonry embankment, increasing the possibility of dam failure. At the first five foot length of dam adjacent to the 50 ft. spillway towards the east, water was leaking between the concrete coping and stone masonry which tends to accelerate deterioration of the mortar by flowing down the face of the dam embankment.

Photo 6 - Seepage zone at contact of bedrock and masonry (Left of ladder). Note lack of mortar in joints.

1. A formal program of operation and maintenance procedures should be instituted and fully documented to provide accurate records for future reference
2. Replace the missing stones and concrete coping on the east dam embankment and east training wall.
3. Replace the concrete coping on the west training wall.
4. Fill in and seal off the intake chamber situated upstream and west of the spillway.

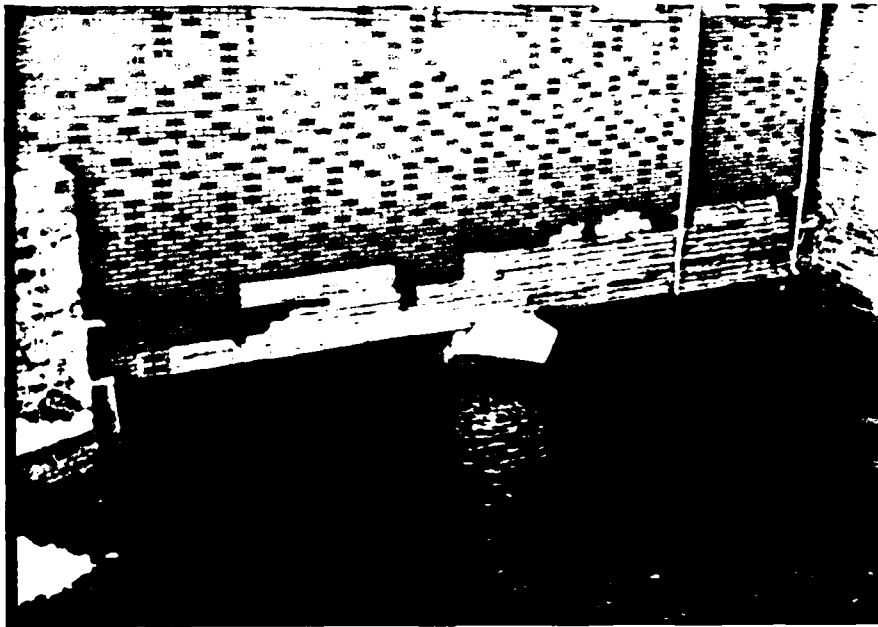
The downstream channel immediately south of the spillway flows under Porch and Patio warehouse, which is supported by timber girders on concrete pedestals. During the inspection of the downstream channel, one pedestal was observed to be displaced and not carrying the girder.

Photo 8 - Channel under warehouse downstream of spillway.
