SECTION 32 PROGRAM
STREAMBANK EROSION CONTROL
EVALUATION AND DEMONSTRATION
WORK UNIT 2 - EVALUATION OF EXISTING
BANK PROTECTION
INSPECTION OF SITES IN ALBUQUERQUE DISTRICT

Malcolm P. Keown

November 1977
Inspection Report 3

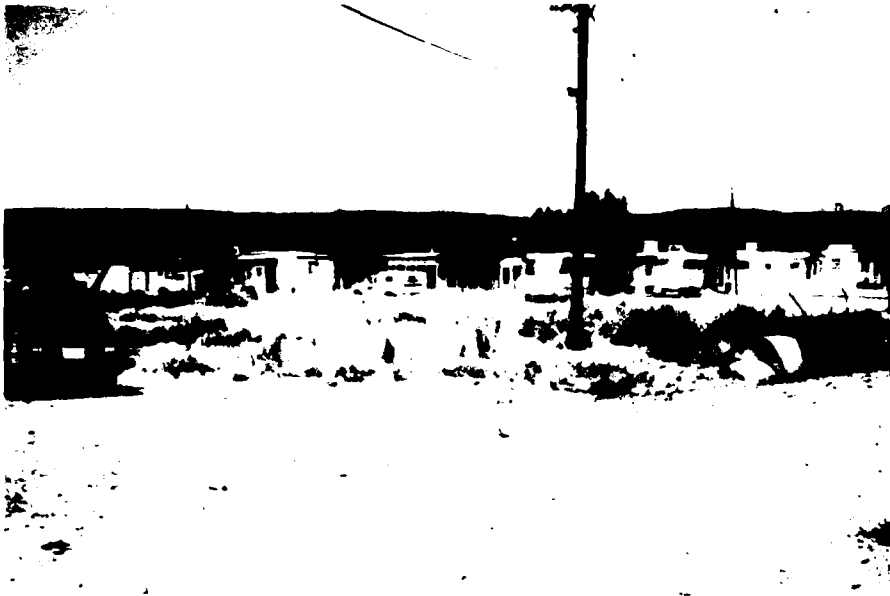
levees are constructed of native materials (sandy gravel) and are highly erosive even during low flows. Failure of the south bank levee would result in flash flooding to the low area which contains three permanent residences, 50 to 60 mobile homes, a ready-mix concrete plant, a boat storage facility, and a marine service (Figure 2).

Figure 2. Mobile home community behind south levee; access road to levee is in the right-hand portion of the photograph

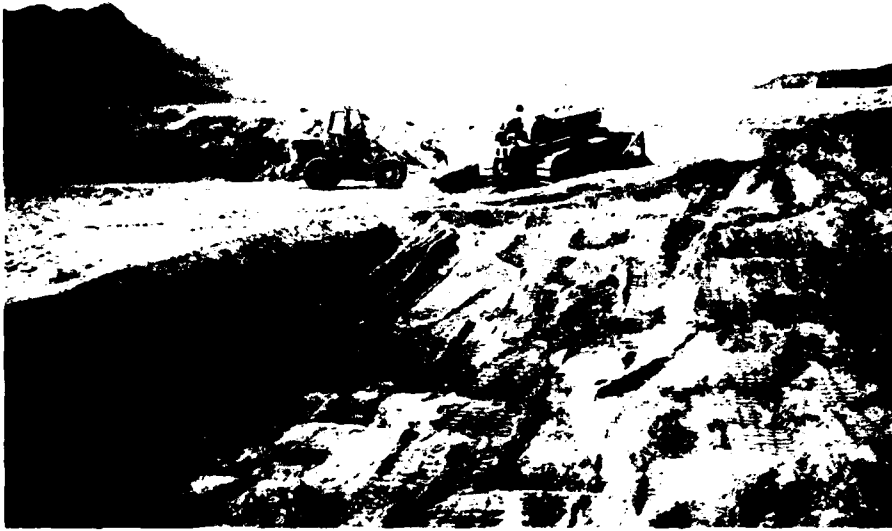
Figure 6. Fill material for eroded levee areas was secured from the channel bed

9. Before repairs of the 1975 flood damage, another 15,000-25,000 cu yd of levee erosion occurred in the September 1976 flood. In October 1976 and April 1977 the south levee was repaired. The now completed work includes: (a) placement of compacted fill secured from the channel bed in the eroded areas of the levee (Figure 6), (b) placement of rock-fill protection in selected portions of the restored levee, (c) completion of the gabion revetment installation on the west end of the levee (Figure 7), and (d) installation of eight training dikes between the existing training dikes and the gabion revetment installation. A project map for this work is shown in Figure 8. Federal and local participation costs were \$38,000 and \$22,000, respectively. Land use re-evaluation of the area behind the north levee indicated that there was nothing of value to protect; therefore no efforts were made to protect this levee, thus allowing the creek width to expand and reduce flow concentrations along the south levee.

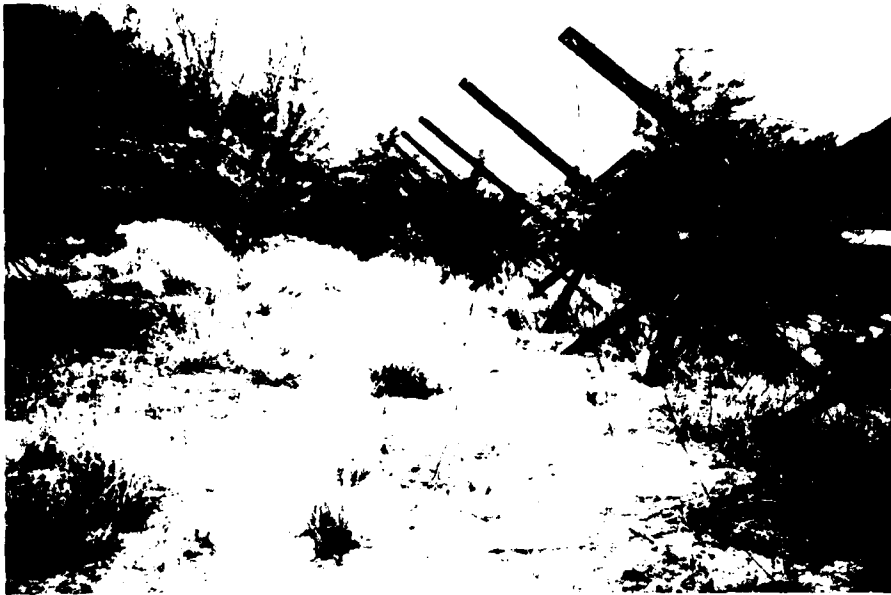
Figure 12. Section of main-line jetty

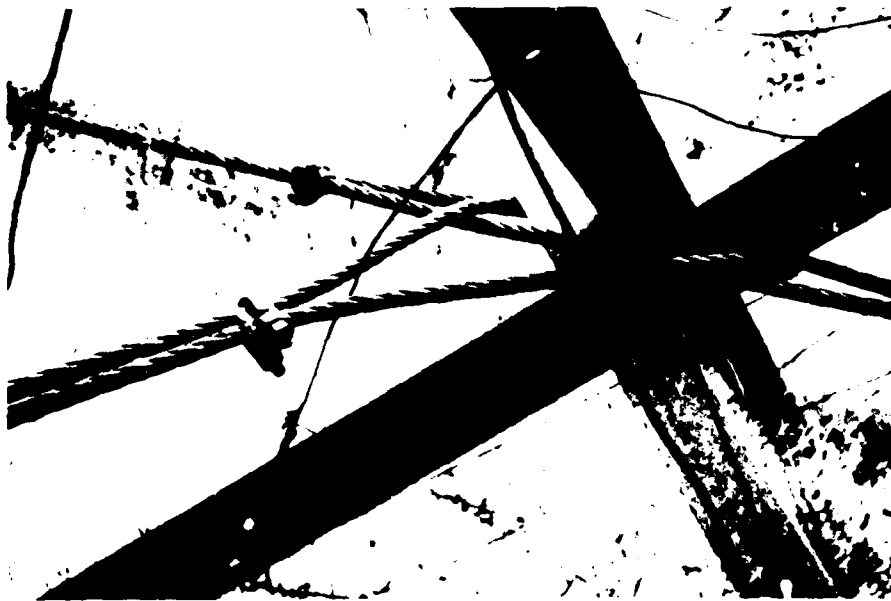
Figure 13. Jacks units are connected with steel cable; this figure shows the cable configuration at the junction of a main-line jetty and retard line

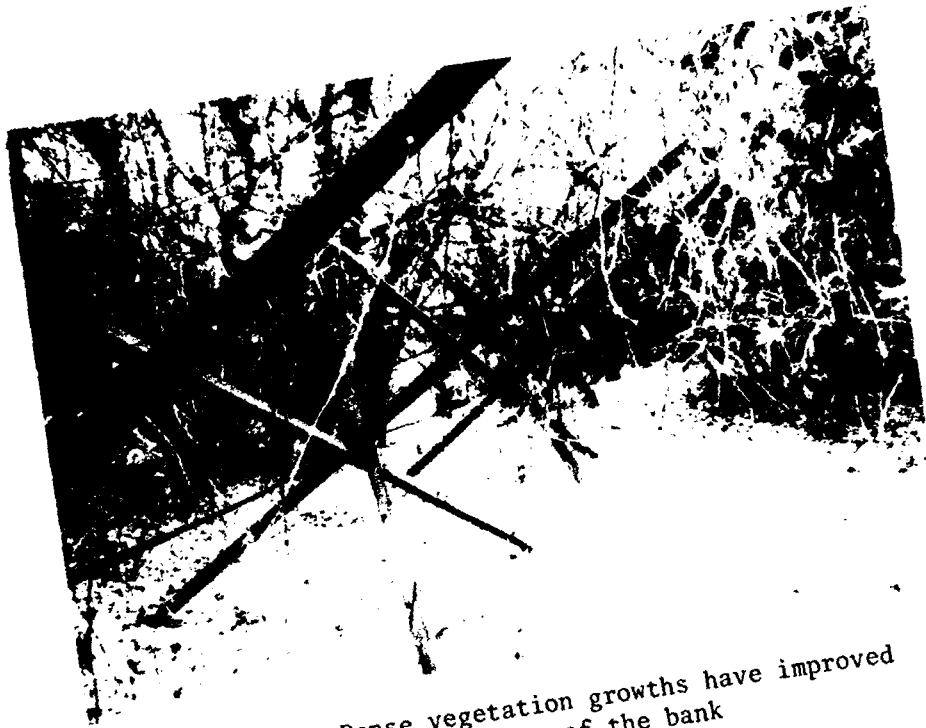
12. Inspections performed by SWA in 1955, 1956, 1958, 1960, 1963, and 1968 indicated that the project was performing its function; some of the jacks were in poor condition at the time of the 1968 inspection. Considerable sediment deposition had occurred, providing a substrate for dense growths of willow, Russian olive, and underbrush that have measurably improved the stability of the bank (Figure 14).

Figure 14. Dense vegetation growths have improved the stability of the bank

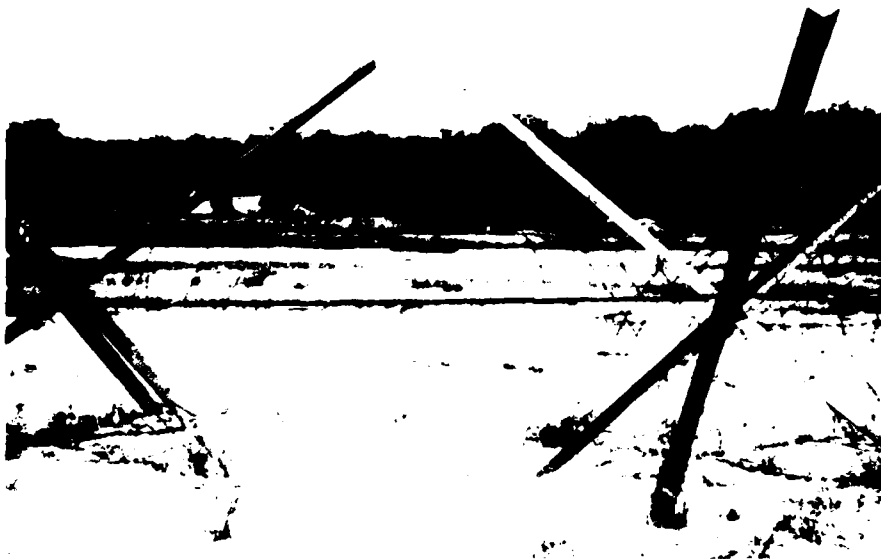
13. Six new jacks were required in 1969 as a repair measure. Beginning in 1972, a gravel bar began to build up in front of the project which has served to direct the flow away from the Kellner Jack Field (Figures 15 and 16). The last inspection, conducted in November 1976, indicated that the project has been effective in preventing further bank erosion and has encouraged sediment deposition and general restoration of the eroded bank. A project file including the inspection reports is available at the SWA office.

Figure 16. During low flows, the major portion of the discharge passes between the gravel bar and the left bank
