SECTION 32 PROGRAM
STREAMBANK EROSION CONTROL
EVALUATION AND DEMONSTRATION
WORK UNIT 2 - EVALUATION OF EXISTING
BANK PROTECTION

FIELD INSPECTION OF BANK PROTECTION MEASURES
ON THE UPPER YAZOO RIVER

Stephen T. Maynard

February 1978
Inspection Report 4

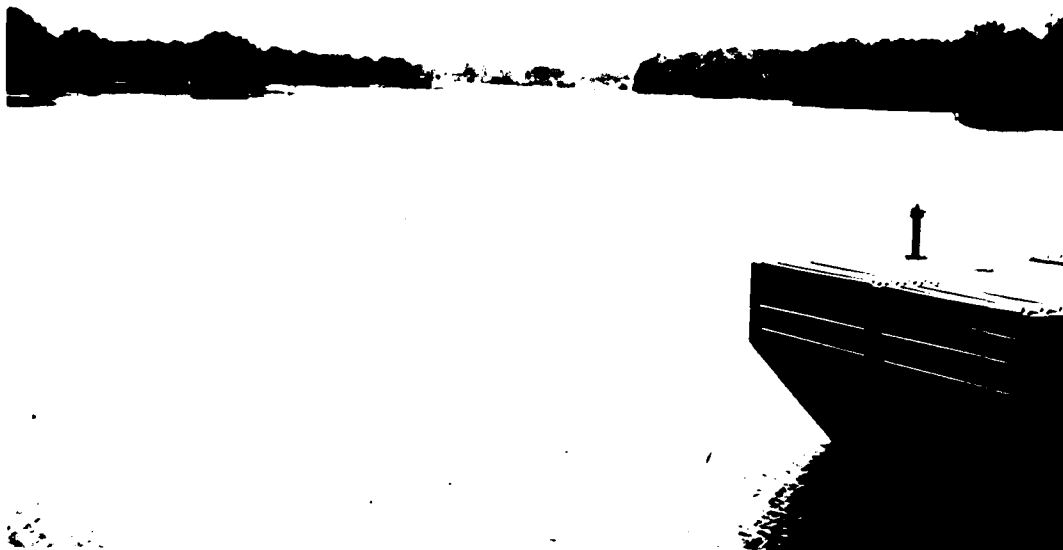
3. The first site observed was the Big Sand Creek near Greenwood, Mississippi, where the Vicksburg District, Soil Conservation Service, and others have undertaken various bank protection projects. About 52 percent of the Big Sand drainage basin is controlled by 40 Soil Conservation Service detention basins that were built in the early 1960's. Drop inlet spillway structures (Photo 1) assist in regulating flow for flood control purposes.

Photo 1. Soil Conservation Service flood control structure

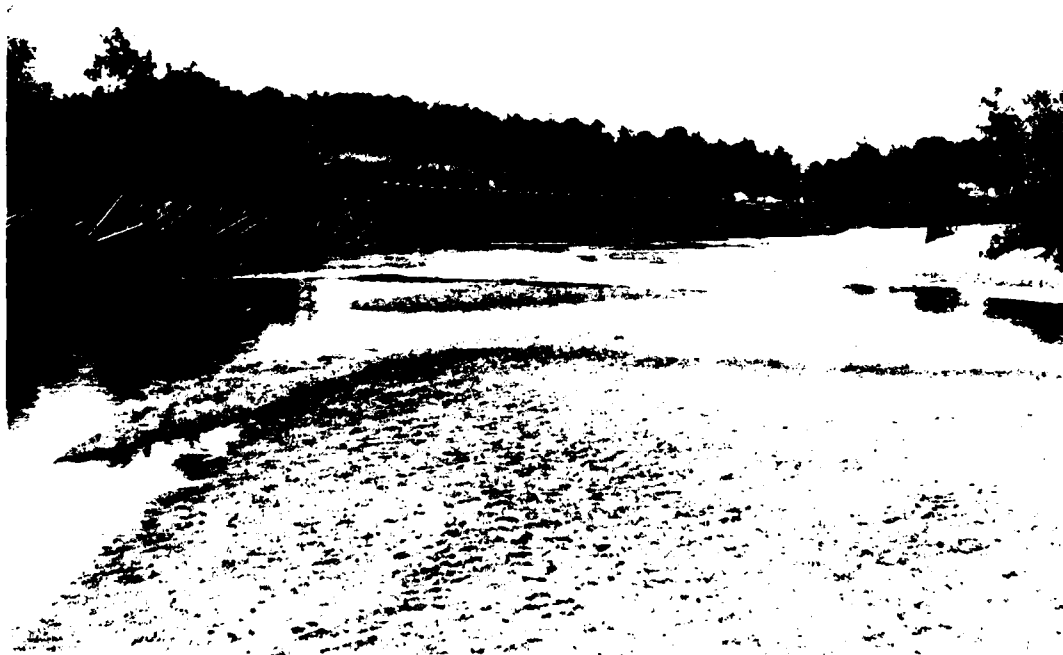
4. The first protection method observed on Big Sand Creek was a system of board fencing parallel to the streambank on the outside bank of a channel bend with concrete jacks upstream and downstream of the fencing (Photos 2 and 3). Fencing and jacks have been used in several locations on the Big Sand Creek and have worked well for the 10 years they have been in place. The next area observed on the Big Sand was where kudzu had been planted to stabilize the bank (Photo 4). The kudzu was not doing an adequate job of stabilizing the bank and had taken over the overbank vegetation.

Photo 2. Board fencing with concrete jacks upstream and downstream

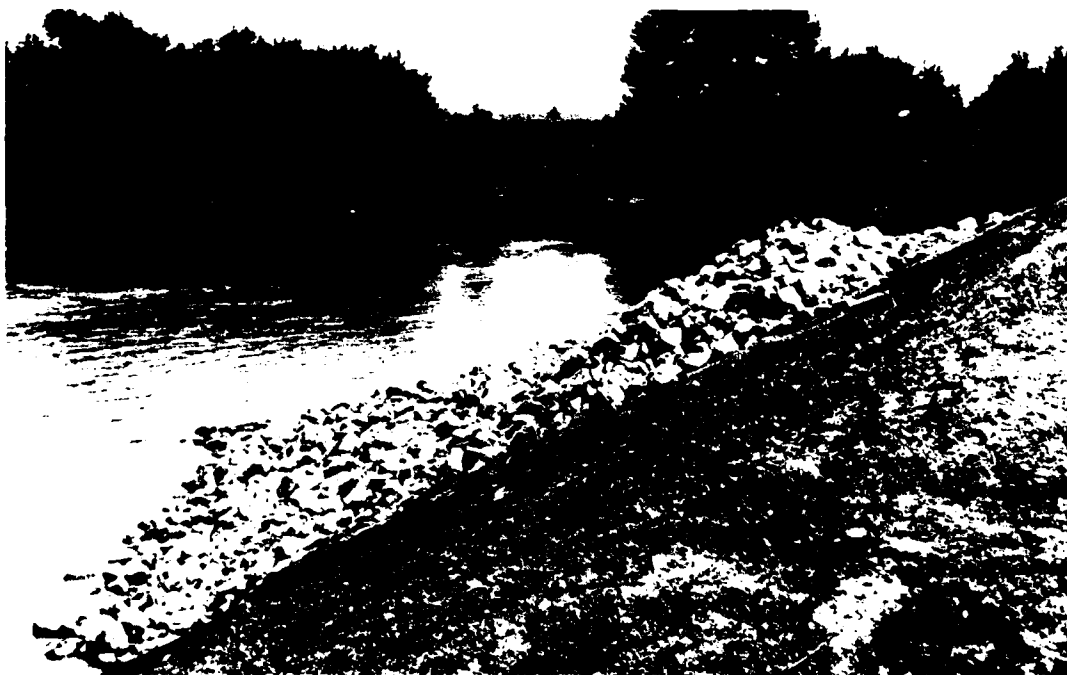
7. Next, riprap revetment was observed at the junction of the Greenwood diversion canal and the Tallahatchie River (Photo 8). The riprap was being placed on a 1V-on-2H slope on a black plastic filter cloth. Toe protection for the revetment was being extended well out into the river.

Photo 8. Riprap placement on black plastic filter material

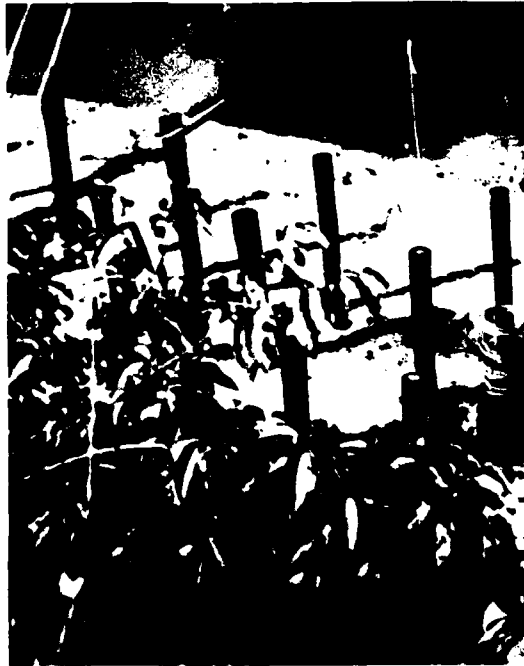
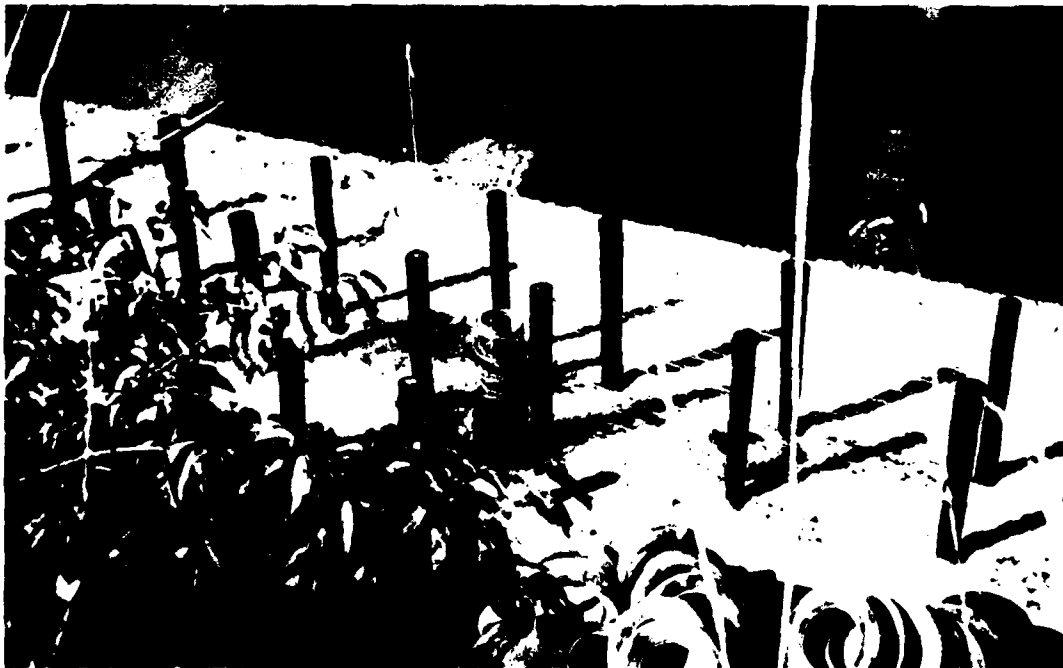
9. Another Section 32 demonstration site was observed consisting of sand-cement bag protection (Photo 11). These bags were placed on a steep slope (1V on 1.5H) and some evidence of toe launching was observed. The next protection method observed on Tillatoba Creek was a site under construction using a double row of wire fencing parallel to the stream (Photos 12 and 13). The space between the double fence will be filled with old tires. Farther upstream a double-row wire fence will be constructed and filled with hay bales.

Photo 12. Double-row wire fence (to be filled with tires)

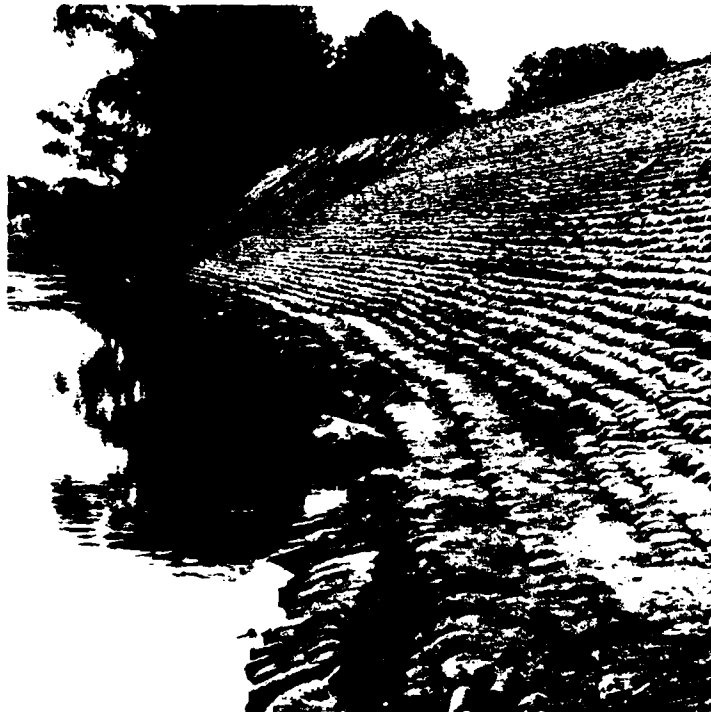
Photo 11. Sand-cement bags with toe launching

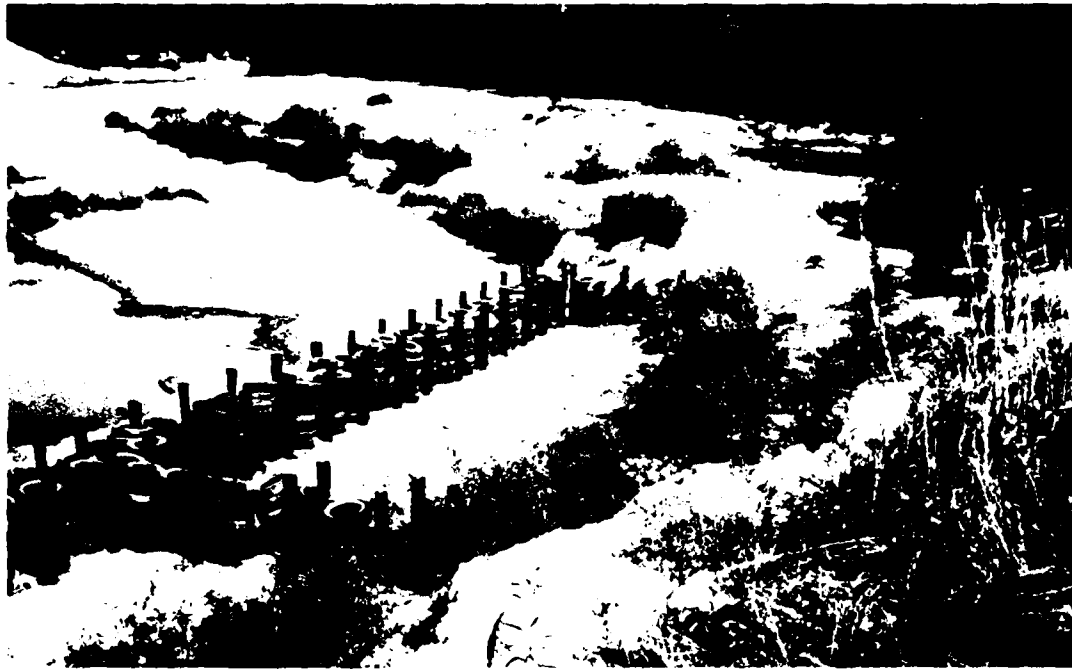
Photo 13. Double-row wire fence with tiebacks

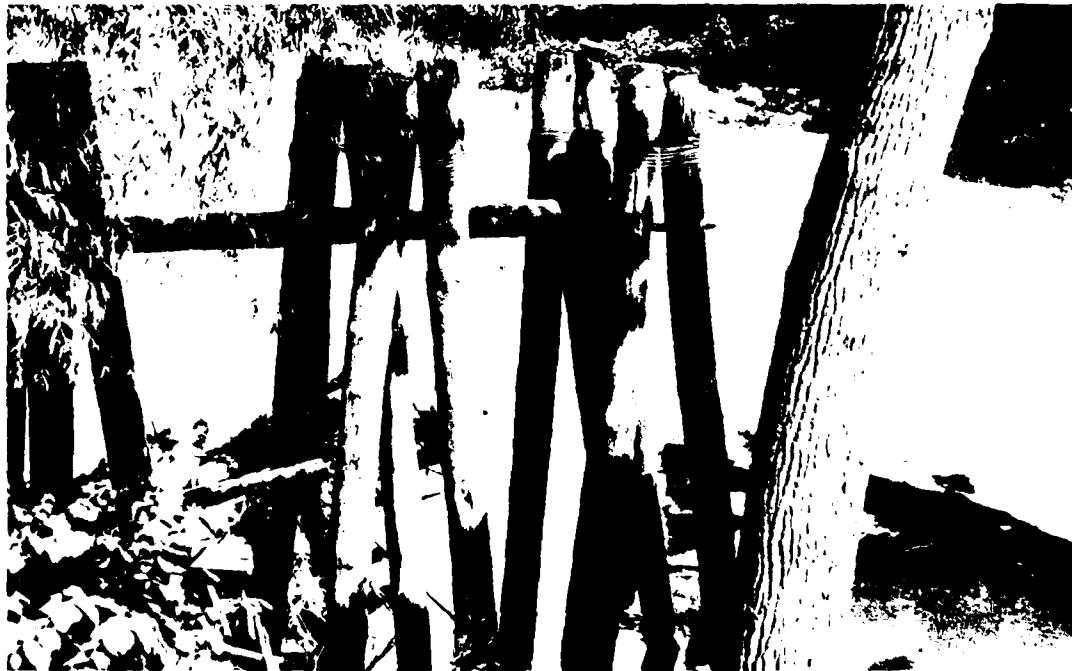
10. Timber pile groins that had been in place many years were observed in a bend upstream of the highway bridge (Photo 14). These groins had trapped debris and appeared effective in halting the erosion of the outside bank of the bend. Riprap hard points were observed at two locations on Tillatoba Creek (Photos 15 and 16). Kudzu was well established between the riprap hard points at one location.

Photo 14. Timber pile groins
