CONNECTICUT RIVER BASIN
GLASTONBURY , CONNECTICUT

BUCKINGHAM RESERVOIR DAM
CT 00244

PHASE I INSPECTION REPORT
NATIONAL DAM INSPECTION PROGRAM

APRIL 1980

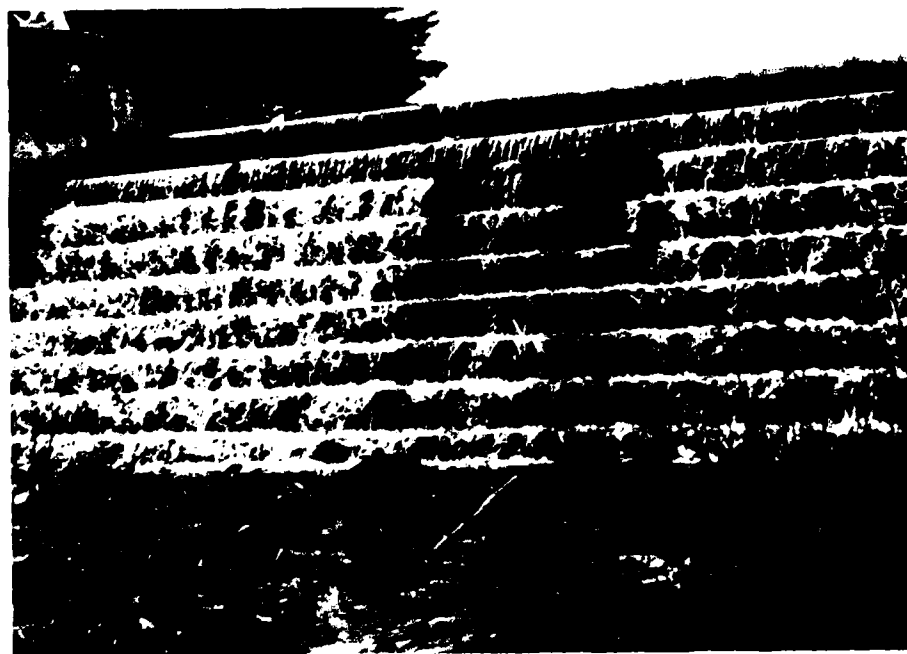
2) Spillway - The spillway weir and training walls are concrete (see Photo No. 16). The spillway training wall is in fair condition, with some spalling noted (Photo No. 17). There are short sections of stone masonry wall at the downstream ends of the spillway training walls, as shown in Photo No. 18. The downstream end of the stone masonry wall on the left side of the spillway has been displaced about 4-5 inches downslope. 12" high, wooden flashboards were in place on the spillway crest and are in good condition.

PHOTO #16: Spillway.
