**LOWER THAMES RIVER BASIN  
NORWICH, CONNECTICUT**

**TRADING COVE POND DAM  
CT 00237**

**PHASE 1 INSPECTION REPORT  
NATIONAL DAM INSPECTION PROGRAM**

**JUNE 1981**

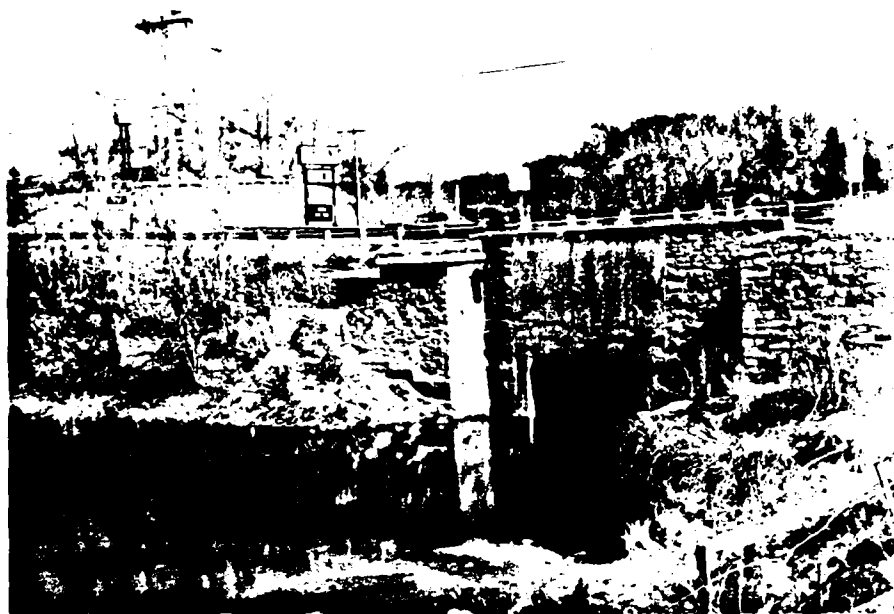
2. Upstream Slope: The upstream slope of the dam consists of an ashlar masonry wall near the crest and an earth embankment on the lower part of the slope (see Photo 1). Part of the wall on the left side of the spillway has been gunited. Some of the gunited areas near the spillway have begun to show signs of spalling, as seen in Photo 1. To the right of the spillway there are areas which have mortar missing from between the stone blocks. Earth fill has been placed against the lower part of this wall, but the fill has a very irregular surface and an extensive growth of small trees. The retaining wall just to the left of the spillway has also been gunited and has had PVC drain pipes installed about 2 to 3 feet into it.

Photo 1. Upstream view of the dam from parking lot at edge of pond. Note cement bag retaining wall at left end of culvert embankment.

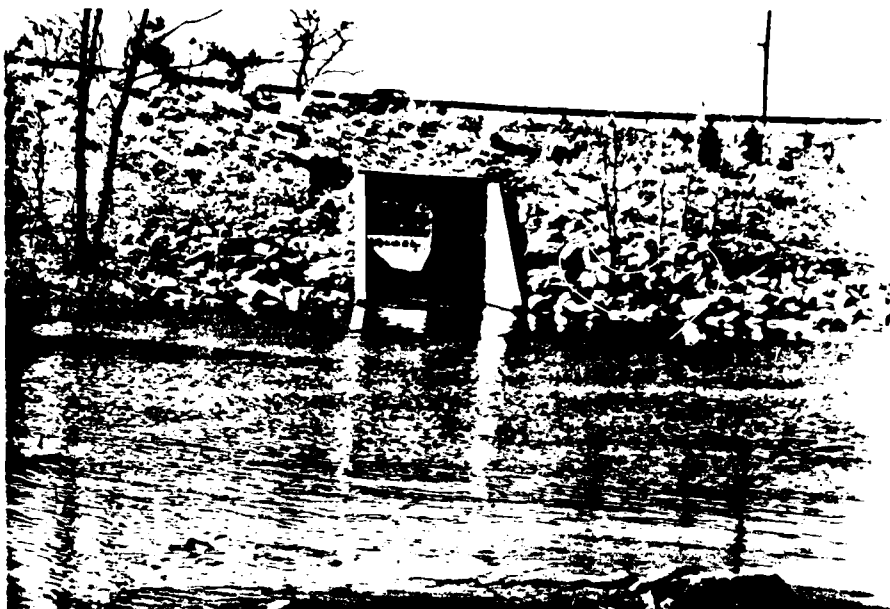
grass slope with some brush and small trees (up to a trunk diameter of 3 inches) growing on it (Photo 3). There are some footpaths along the slope which have resulted in erosion, particularly near the wing walls of the outlet channel to the spillway, as seen in Photos 3 and 4. The erosion here is as deep as 2 feet along the right side of the structure. No seepage or sloughing of the embankment was observed along any of the downstream areas. The lower part of the slope is protected against tail water erosion by riprap which extends about 10 feet up the slope in the vicinity of the wing walls of the outlet structure.

Photo 3. View of downstream slope of dam and spillway weir on upstream side (as viewed through the culvert). Note erosion along both wing walls of culvert outlet.

1. Repair the erosion adjacent to the wingwalls of the culvert on the downstream slope of the dam with crushed stone.
2. Remove small trees and brush growing on the slopes and within 20 feet of the toe, and develop protection against erosion with grass or riprap.
3. Regrout the upstream ashlar masonry wall and repair the gunited section.
4. Reinstall the trash rack removed from the outlet works and clean the general area around it.
5. Establish a program of annual technical inspections by a registered professional engineer.
6. Implement and intensify a program of diligent and periodic maintenance including, but not limited to, mowing brush on slopes, backfilling animal burrows with suitable well tamped material, and cleaning debris from spillway and slopes.

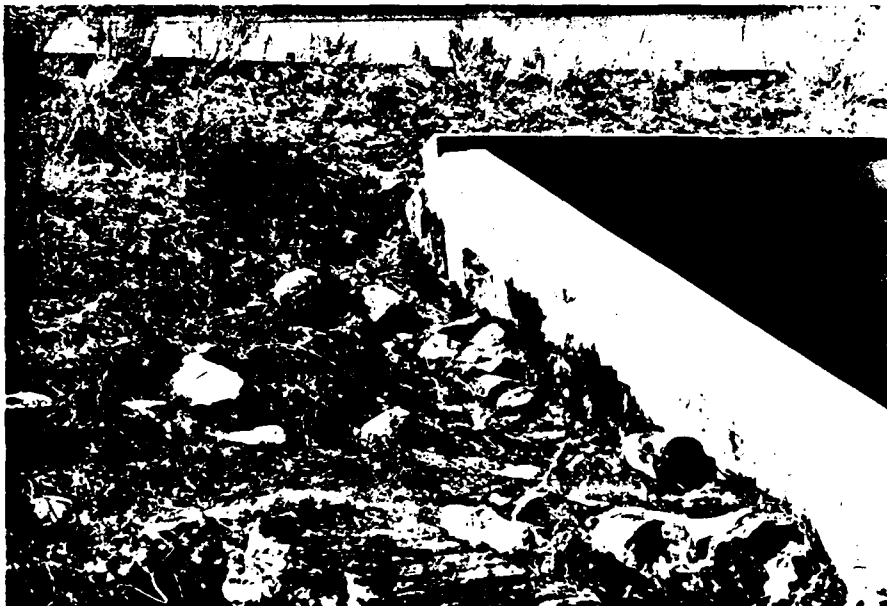
Photo 4. Closeup of erosion along the right wing wall of the culvert outlet.

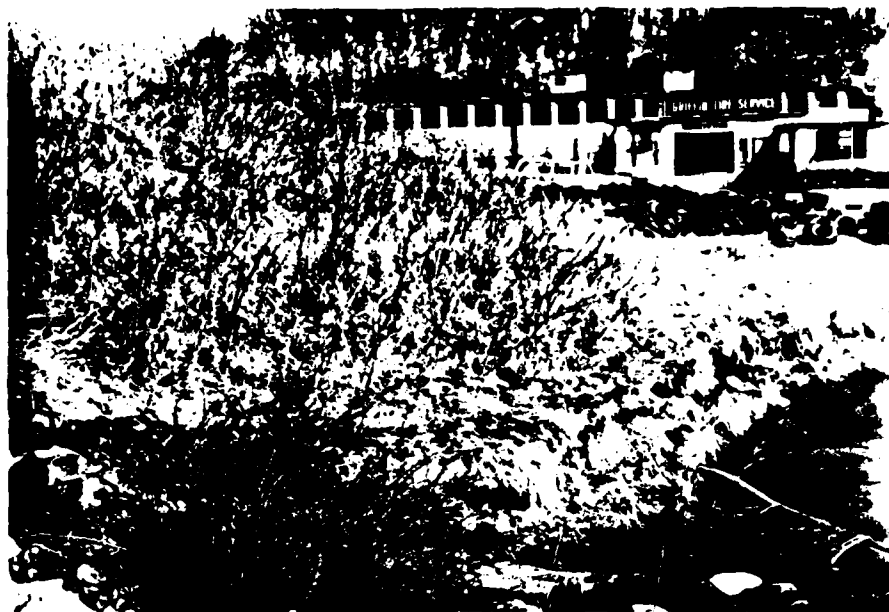
Photo 9. Downstream view of Griffin Tire Co.  
from toe of dam.
