## SECTION 32 PROGRAM STREAMBANK EROSION CONTROL EVALUATION AND DEMONSTRATION WORK UNIT 2-EVALUATION OF EXISTING BANK PROTECTION

# FIELD INSPECTION OF THE MILL CREEK MIDFLOODWAY GABION BARRIER IN THE LOS ANGELES DISTRICT

> April 1980 Inspection Report 9

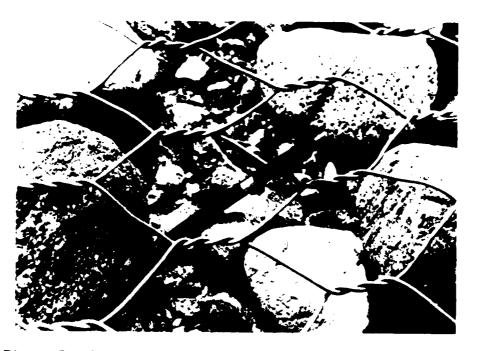
Figure 7. Detailed view showing the wire mesh structure and the variation in streambed stone sizes used to fill the gabions in Mill Creek (photograph taken 6 August 1979)

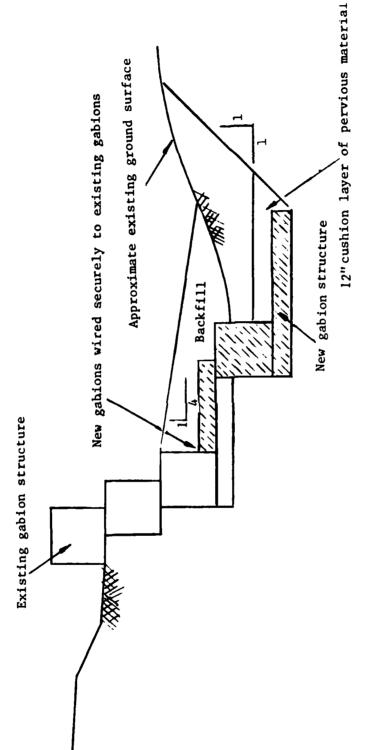
21. High flows resulting from the storms of 8-14 February and 3-6 March 1978\* caused some deflection of 200 ft of the farthest upstream section of the gabion barrier. Figure 13 shows the modification designed to maintain the integrity of this portion of the gabion barrier as constructed in September 1978. There was no deflection of the section of the gabion barrier downstream from Garnet Street Bridge.

Modification to farthest upstream section of the midfloodway gabion barrier as constructed in September 1978 (paragraph 21) Figure 13.
