TECHNICAL REPORT ARBRL-TR-02567

HANGFIRES, CAUSES, HAZARDS, AND  
REMEDIES (CASE STUDY OF XM242  
25-MM CHAIN GUN INCIDENT)

James O. Pilcher II

June 1984

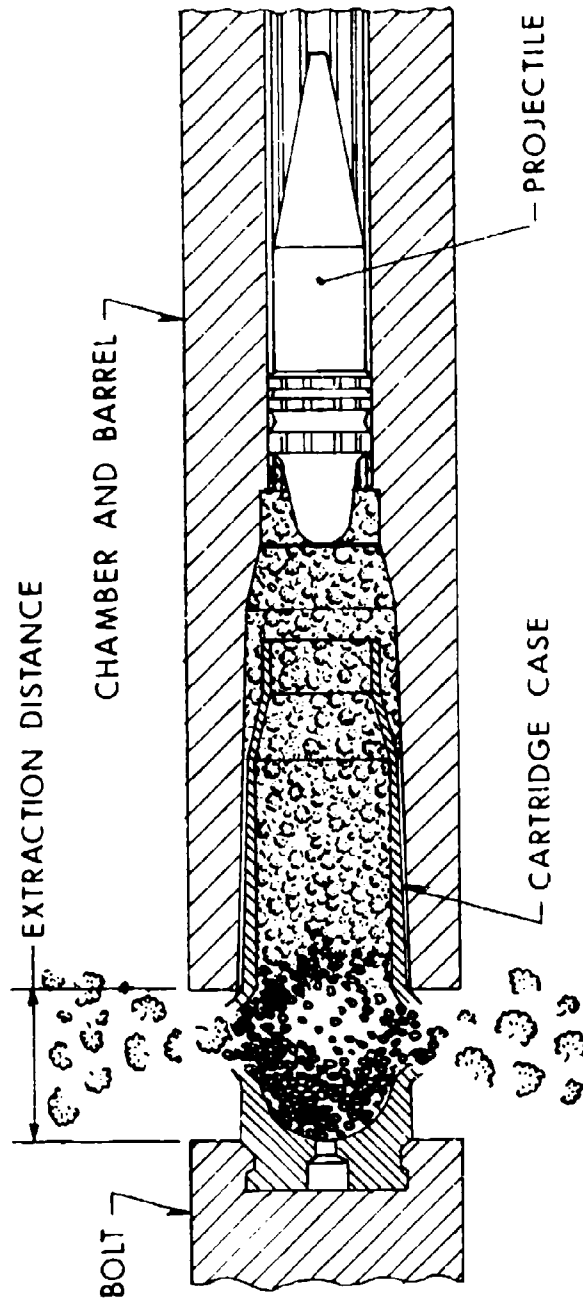
Figure 1. Cartridge Case Rupture During Extraction

The source of the hazards from a hangfire is the potential condition of igniting the propelling charge of the ammunition during the extraction phase of the operating cycle. As the cartridge is removed from the chamber, it loses its constraining support from the chamber walls. The ability of the cartridge case to sustain the propellant pressure is now dependent on the burst strength of the unsupported cartridge case wall. Figure 1 illustrates the condition of ignition during extraction. Figure 2 shows the calculated burst pressure versus extraction distance for the 25-mm TP-T projectile.

In the semiextracted condition, a cartridge case ruptures at pressures corresponding to the distance the cartridge has been extracted prior to ignition. This situation creates three separate conditions.

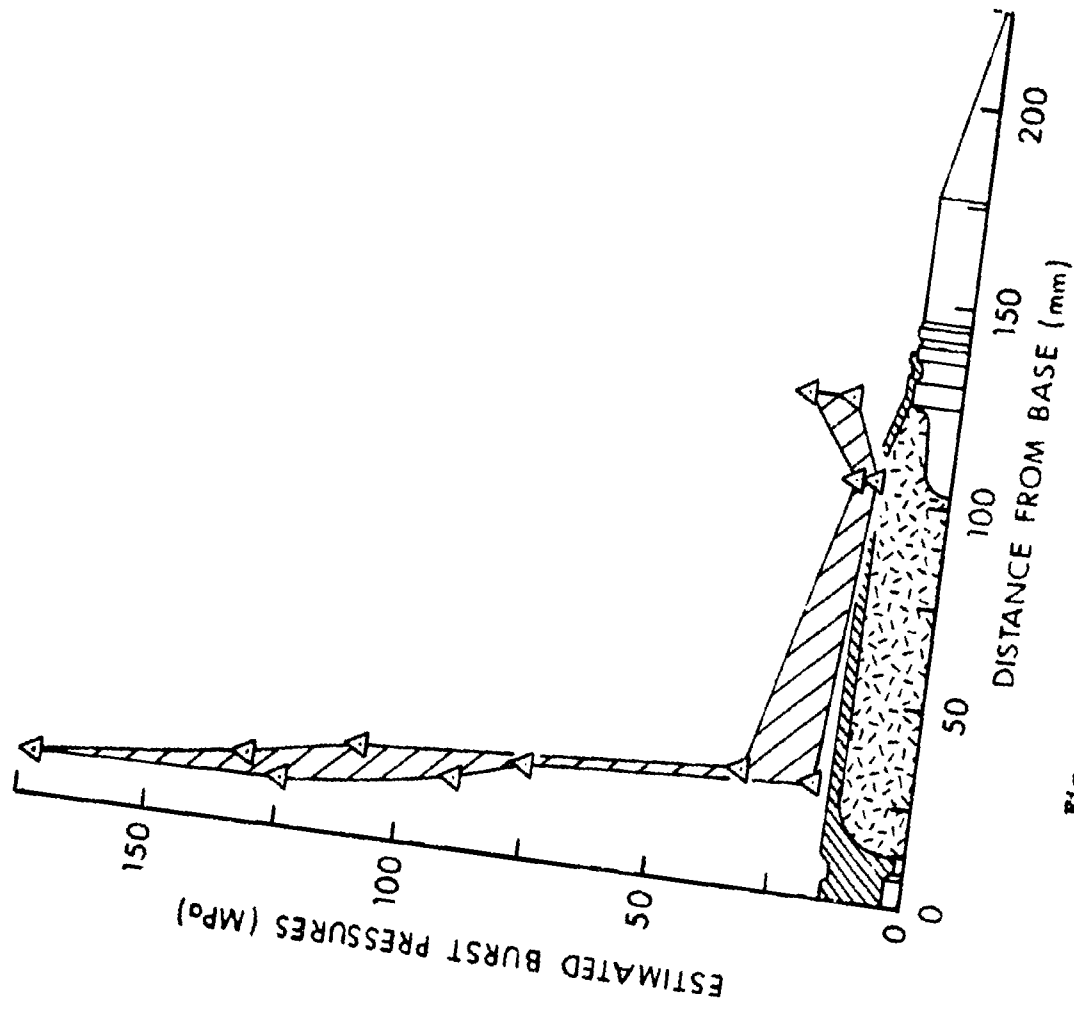
Figure 2. Cartridge Case Burst Pressure

Investigation of the damaged weapon showed that the 25-mm TP-T projectile was initiated during the extraction phase of the operating cycle and that the cartridge case burst when the round had been extracted approximately 19 mm. Calculated estimates of cartridge case burst pressure (shown in Figure 2) indicated that the burst pressure was between 87 and 132 MPa. The damage sustained by the weapon consisted of the bolt carriage assembly being driven into the rear bulkhead of the receiver; the receiver being cracked at the juncture of the rear and bottom walls; and the feed mechanism, feed cover and ejection chute being damaged by the blast and fragments. A pin from the bolt carrier assembly was found loose in the bottom of the receiver and was considered to be a possible cause of the hangfire. The gun was rendered unserviceable.

Based on burst pressure calculations for the cartridge (shown in Figure 2) a worst case condition could possibly cause the rear bulkhead of the receiver to be blown completely free of the weapon.

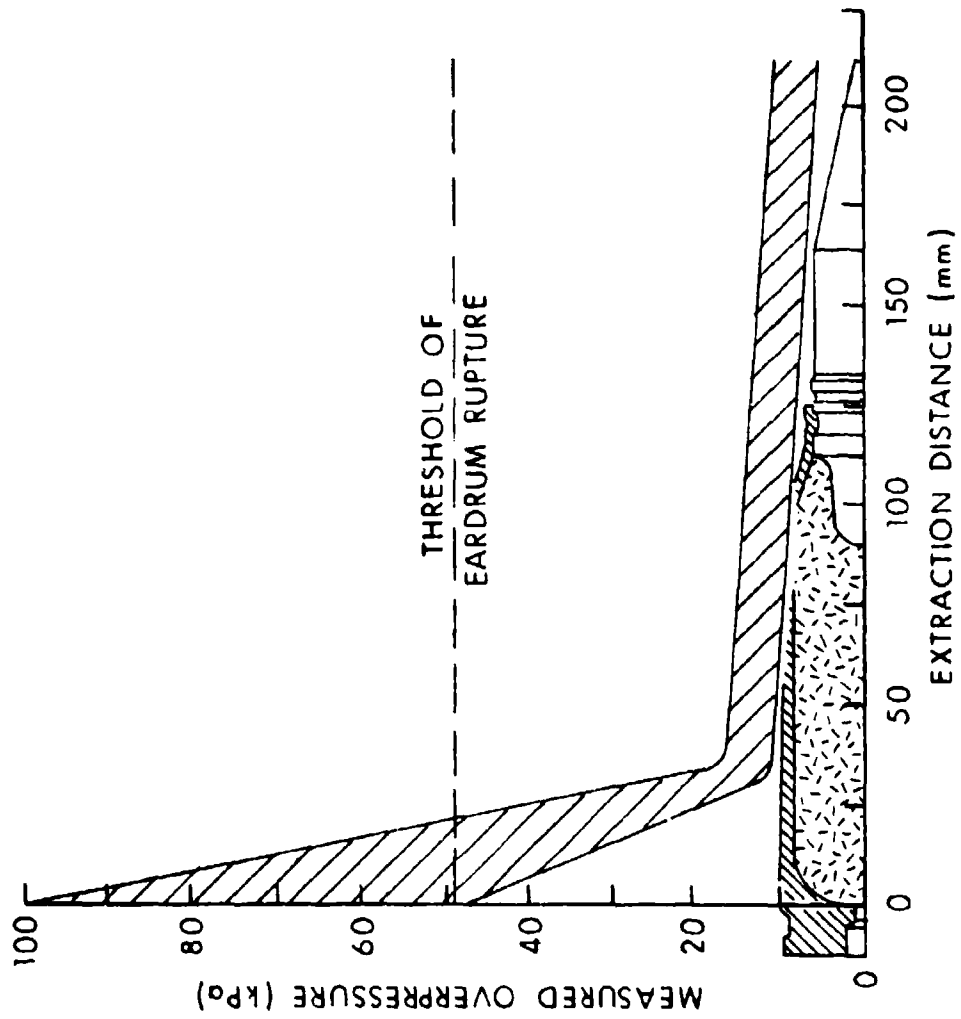
Figure 3. Blast Overpressure at Gunner's Position

The blast effects associated with the rupturing cartridge case present a hazard to both gun and gunner. Figure 3 shows the overpressure measured at the gunner position during a series of failure replication tests performed by Hughes Helicopter Inc.<sup>1</sup>

These overpressures are dependent on the amount of free volume around the weapon, the available energy in the propellant, and the burst pressure. In this case, damage to adjacent gun components due to blast ranged from insignificant at low pressures to catastrophic at higher pressures. The higher pressures were on the threshold of eardrum rupture based on the data reported by I.G. Bowen, E.R. Fletcher and D.R. Richmond.<sup>2</sup> Although incapacitation of the gunner appears to be minimal in this case, one can expect more severe effects from larger caliber weapons because of the increases in available energy.

A series of tests was performed to replicate the incident and establish the hazards generated. The results were that the weapon structure confined all of the fragmentation and potential flying parts; the blast pressure at the gunner's station was as shown in Figure 3. In the worst case the peak blast pressures were on the threshold of eardrum rupture conditions.

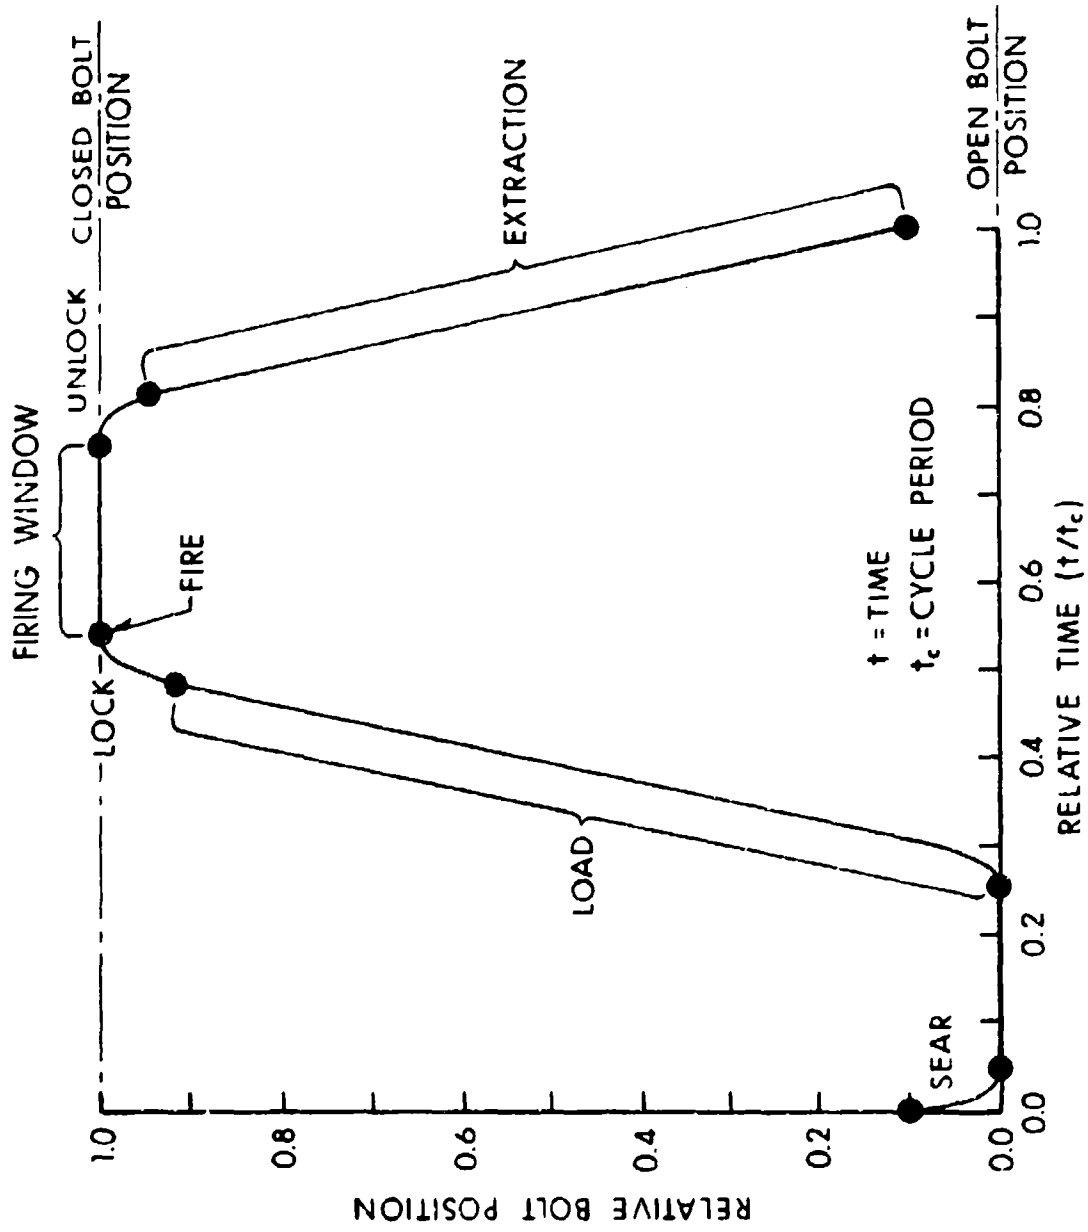
Figure 4. Operating Cycle of M242

Examination of the operating cycle for the gun, which is shown in Figure 4, showed that a 17 millisecond window was available for the ammunition to function. All rounds functioning outside this window represented a potential repeat of the experienced incident. Experimental data from Lake City Army Ammunition Plant showed that one out of ten hangfires would function outside the allowable window.\* For a nominally functioning weapon/ammunition system the overall probability of a reoccurrence of the incident is  $1 \times 10^{-6}$ . Data from experiments that examined the effect of flawed ammunition showed that the maximum delay was less than 300 milliseconds and that delays beyond that time were misfires. Figure 5 shows the relationship of hangfire delays with respect to the normal 600 rounds/min and 200 rounds/min firing window.
