SECTION 32 PROGRAM  
STREAMBANK EROSION CONTROL  
EVALUATION AND DEMONSTRATION  
WORK UNIT 2-EVALUATION OF EXISTING  
BANK PROTECTION

FIELD INSPECTION OF SITES IN THE VICKSBURG DISTRICT  
IN THE UPPER YAZOO BASIN

Malcolm P. Keown, E. A. Dardeau, Jr.

October 1978

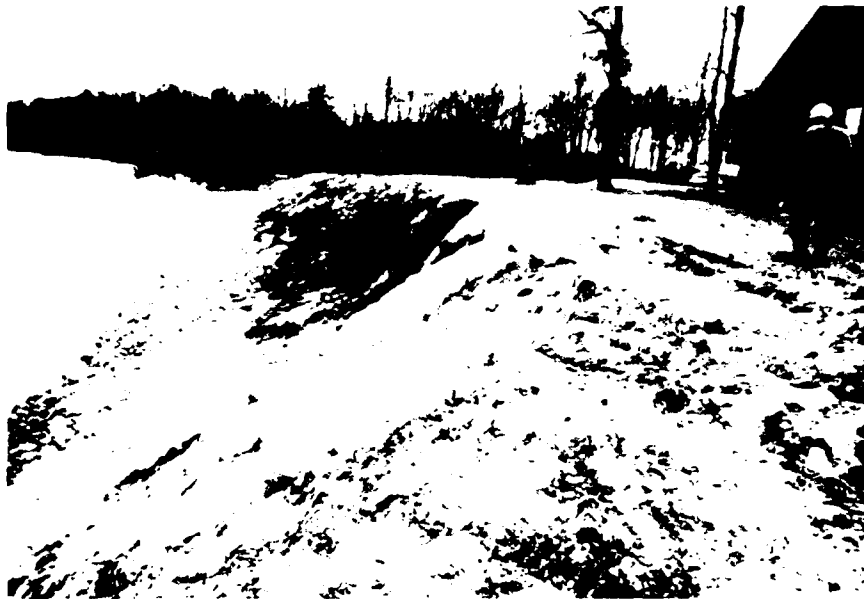
Figure 68. Serious scour occurred on the upper bank in Work Area 6 during the 21 November 1977 storm event, Batupan Bogue (25 January 1978)
