WEST HILL POND DAM

CT. 00377

PHASE I INSPECTION REPORT
NATIONAL DAM INSPECTION PROGRAM

Identification No. CT 00377
Name of Dam: West Hill Pond Dam
Town: Barkhamsted
County and State: Litchfield County, Connecticut
Stream: Morgan Brook
Date of Inspection: 9 November 1978

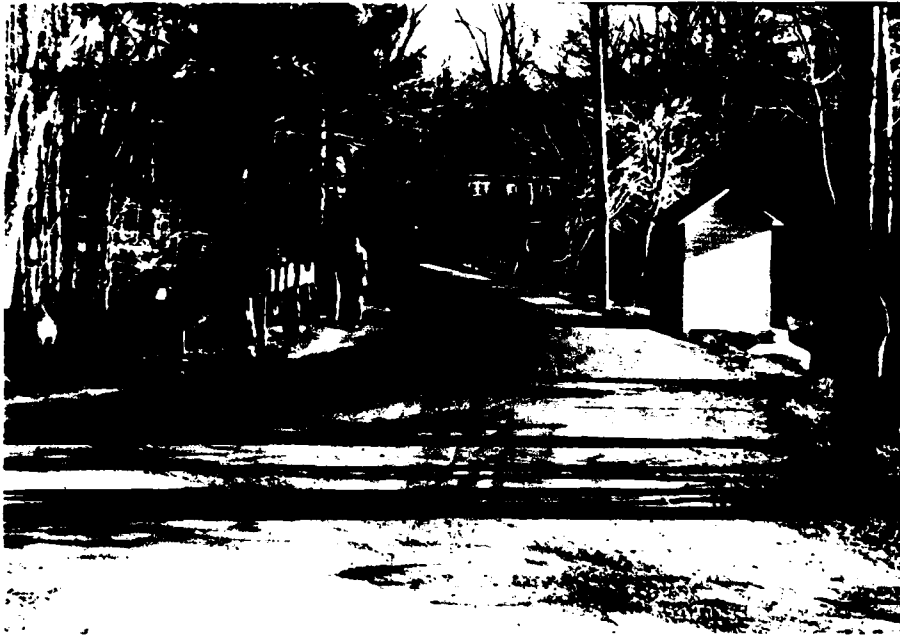
1. Road over dam and gatehouse from left abutment.
