NAUGATUCK RIVER BASIN
OXFORD, CONNECTICUT

SWAN LAKE DAM
CT 00328

PHASE I INSPECTION REPORT
NATIONAL DAM INSPECTION PROGRAM

SEPTEMBER 1980

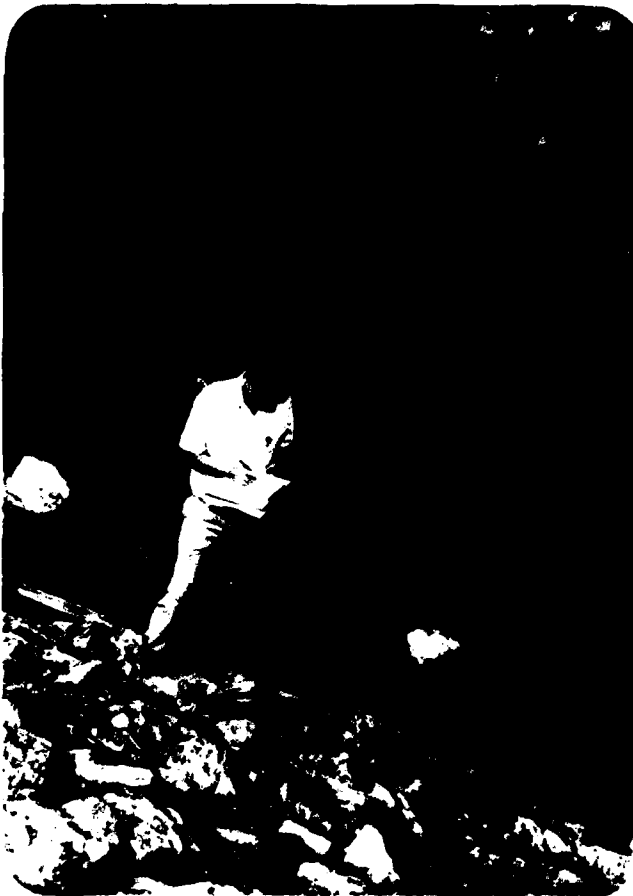
PHOTO NO. 10

DOWNSTREAM FACE OF
SPILLWAY AND DOWNSTREAM
CHANNEL VIEWED FROM
SPILLWAY CREST.

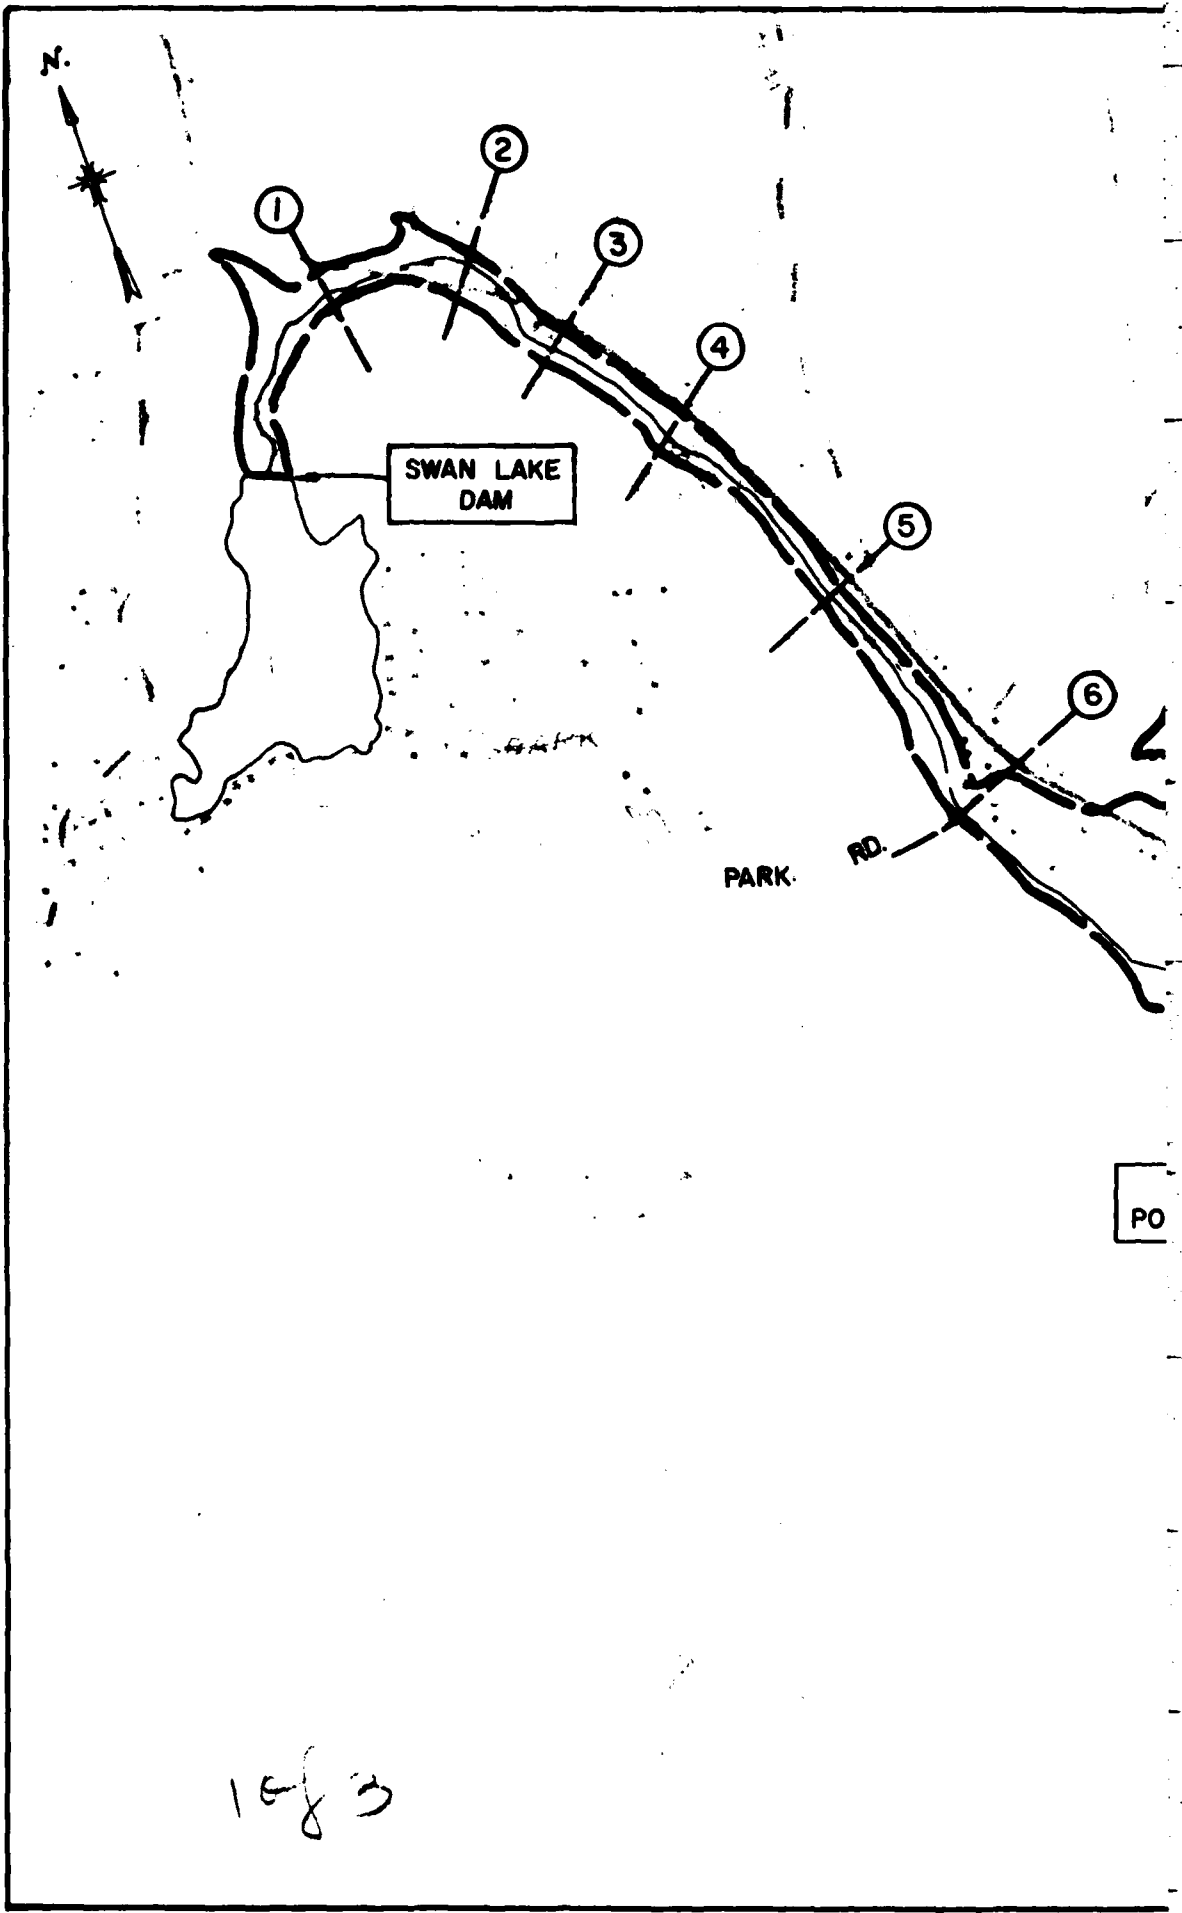
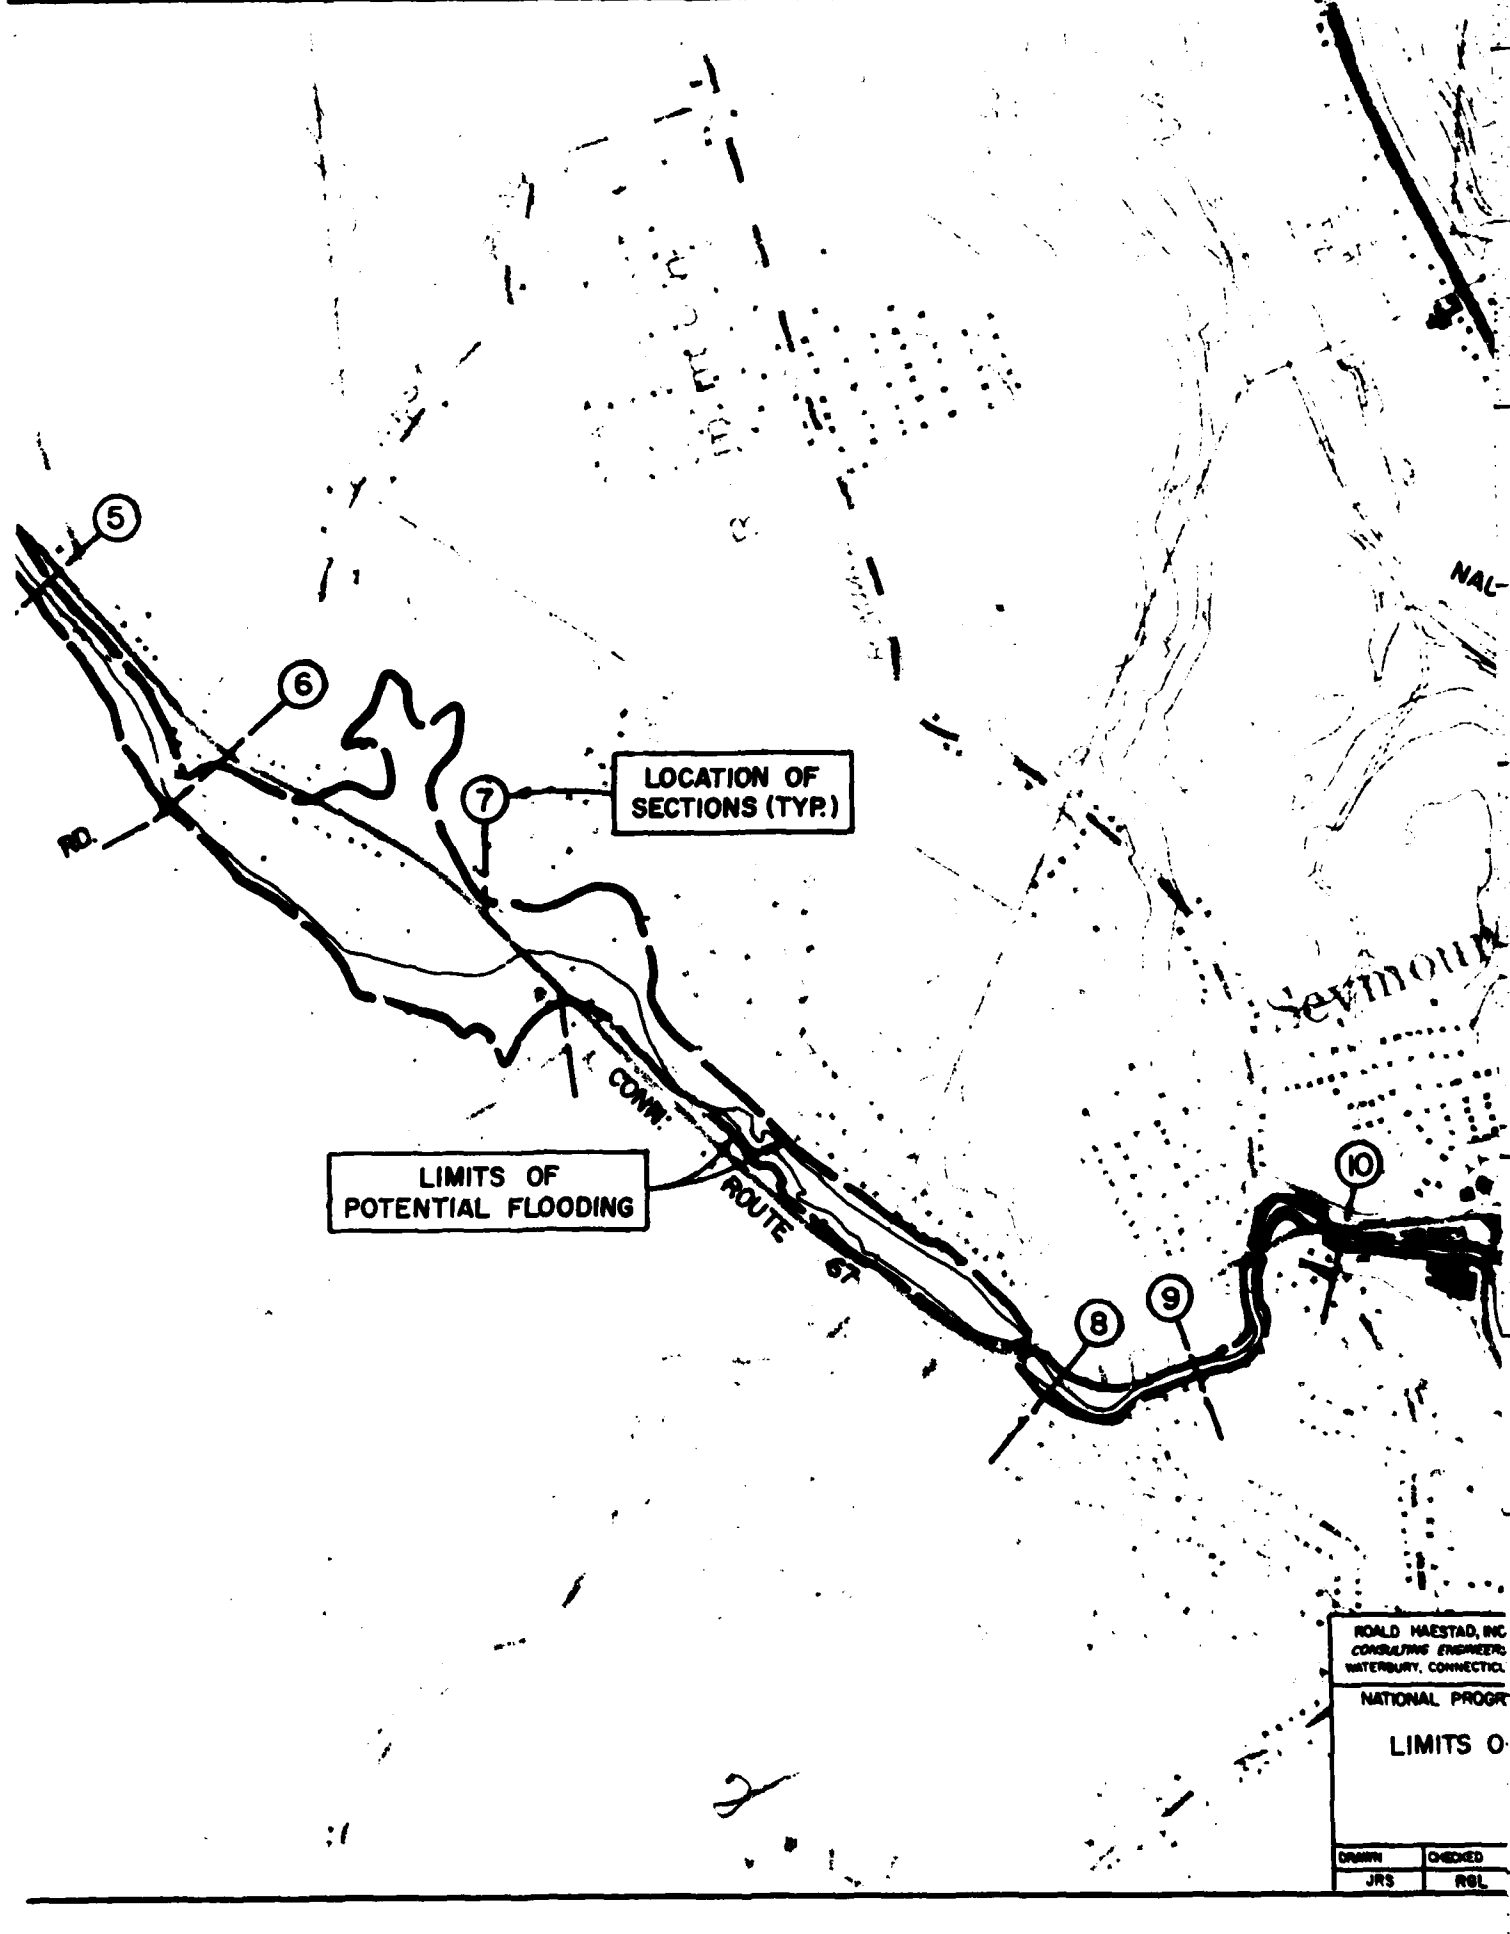
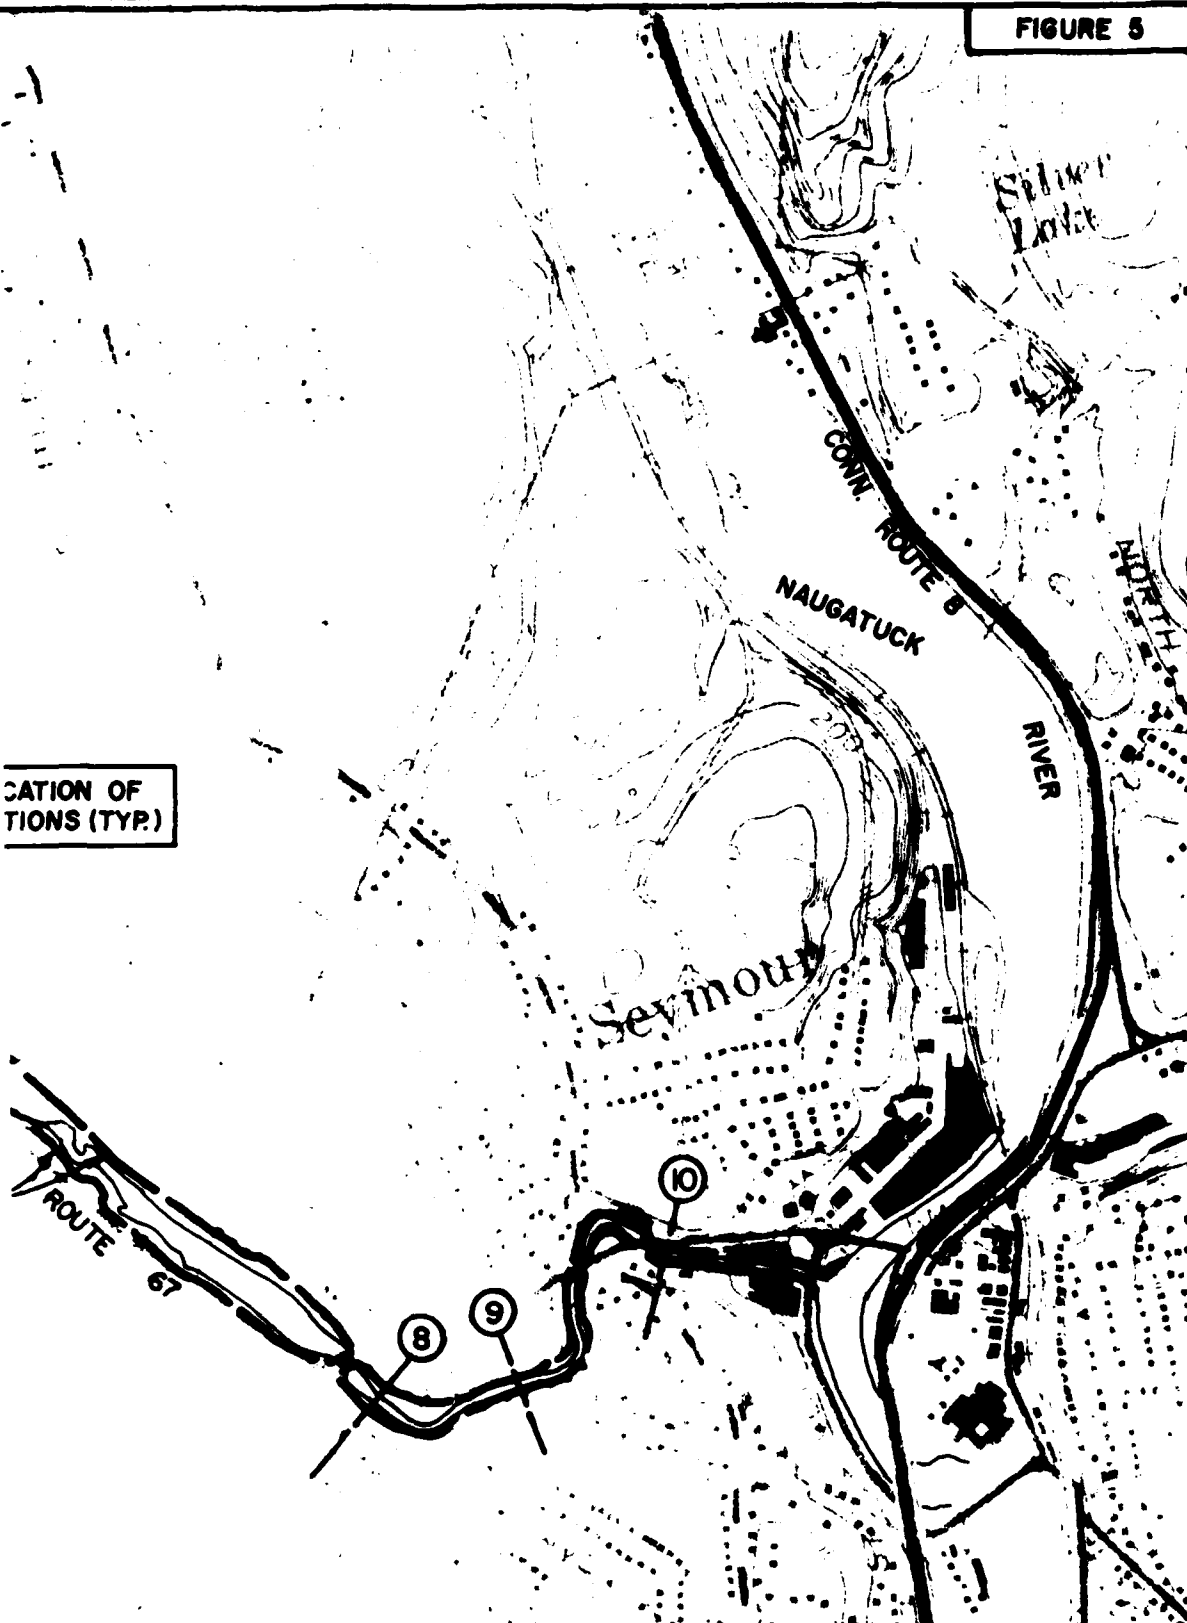
FIGURE 5

The maximum spillway flow of about 245 cfs prior to dam failure would be contained within the existing river channel. Increases in depth of flow due to the dam breach would range from 15 feet at section 3 to about 5 feet at section 10. (See Figure 5, page D-39.)
