QUINEBAUG RIVER BASIN
UNION, CONNECTICUT

MASHAPAUG POND
SPILLWAY (CT 00640)
DIKE (CT 01699)
DAM (CT 01700)

PHASE I INSPECTION REPORT
NATIONAL DAM INSPECTION PROGRAM

84 08 20 030
MARCH 1981

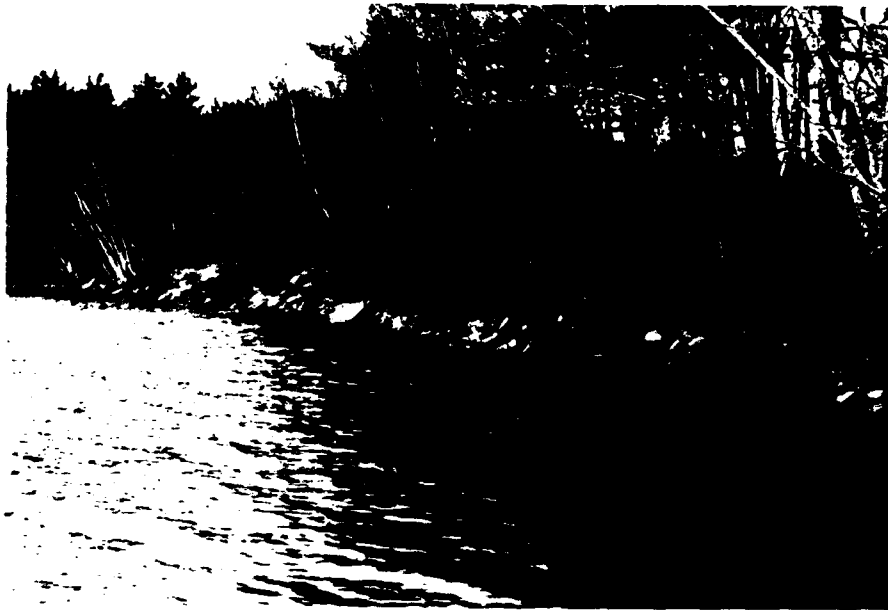
Photo 12. Overall view of dike from right abutment. Note heavy tree growth. Riprap protection is approximately 1.5H:1V.
