**THAMES RIVER BASIN
LEBANON, CONNECTICUT**

**WILLIAMS POND DAM
CT 00551**

**PHASE 1 INSPECTION REPORT
NATIONAL DAM INSPECTION PROGRAM**

OCTOBER 1978

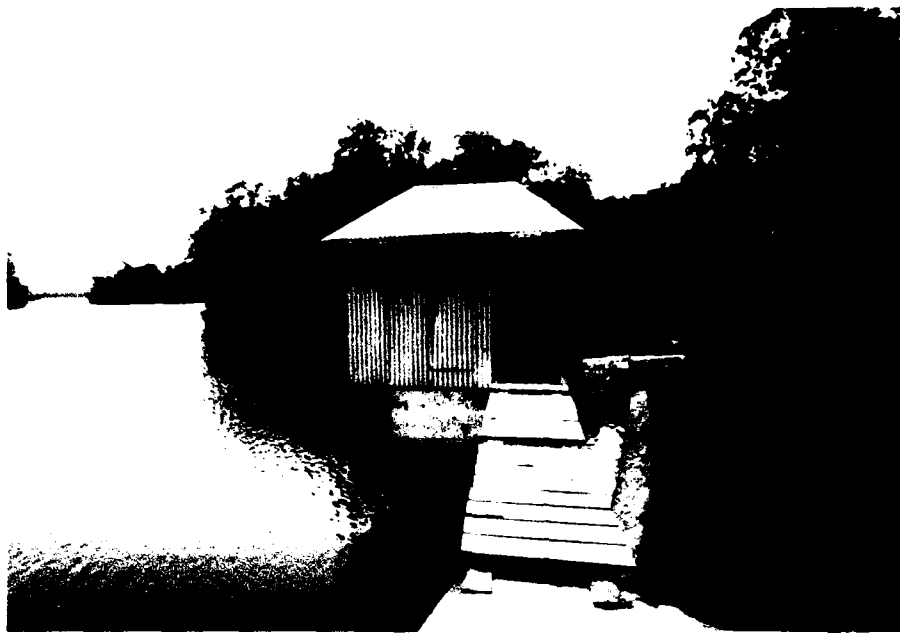
The access bridge to the gatehouse should be closely monitored during high flows to prevent floating debris from accumulating along its length. This accumulation has the potential to increase flooding or to damage the bridge and result in loss of gate control. See Photo C-2.

C-2 SPILLWAY AND GATEHOUSE (LOOKING FROM THE RIGHT
ABUTMENT TO THE LEFT.)

3. The access bridge to the outlet works gate should be monitored and kept in serviceable condition. It should be noted that the bridge will act as a debris collector and should be monitored particularly during high flow periods to ensure that floating debris will not overload it or that it will not be damaged, causing loss of control of the gate.

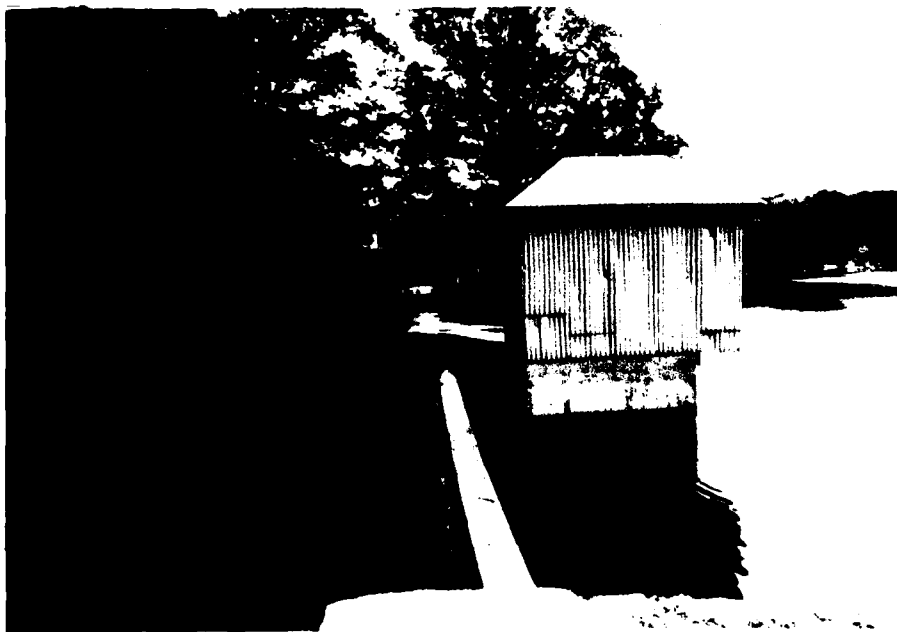
C-3 SPILLWAY AND GATEHOUSE (LOOKING FROM LEFT
ABUTMENT TO RIGHT ABUTMENT.)

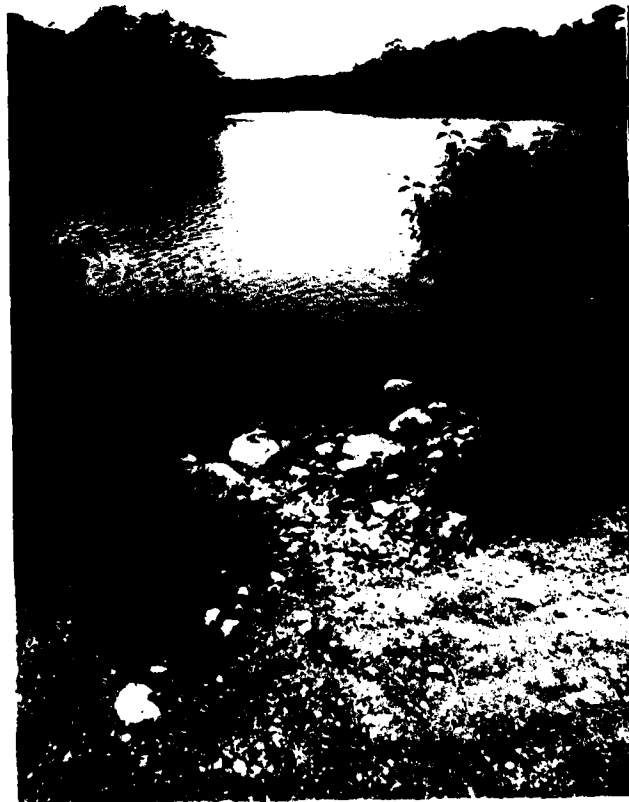
pond, exposing the dike soil directly to wave action. There is no filter material present between the rubble stone and the dike soil. Wave action, erosion and trespassing have combined to cause several zones at which a considerable portion of the crest of the dike has been eroded. In one location the erosion has proceeded to such an extent that the crest width is practically zero over a length of about 10 feet.

C-11 TYPICAL SURFACE
EROSION AT DIKE FROM
TRESSPASS.

- c. Design new riprap protection for the upstream face of the dike and restore the full cross section of the dike.
- d. Provide recommendations for removal of stumps and roots that presently exist on the embankments and for replacing the roots with properly selected and compacted soils.

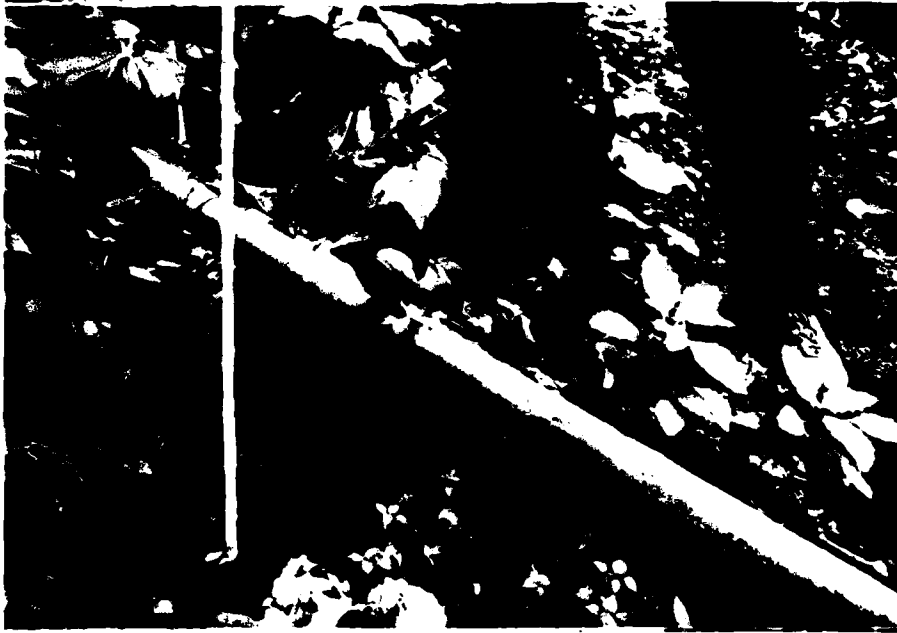
Seepage is occurring through and under the embankments on the left and right sides of the spillway, at the spillway-bedrock interface, and possibly through the left and right abutments or foundation soils. At the time of visual inspection, the seepage water was clear. The evidence for the seepage is the presence of mushy zones 10 to 20 ft. downstream from the dam just to the left and right of the spillway, as may be seen in Photograph C-6, 7, 12 and as shown in Appendix B-3.

C-12 SEEPAGE AT RIGHT ABUTMENT.
