TECHNICAL REPORT SL-84-9

# HOW TO AVOID DEFICIENCIES IN ARCHITECTURAL CONCRETE CONSTRUCTION

DEPARTMENT OF THE ARMY  
Waterways Experiment Station, Corps of Engineers  
PO Box 631  
Vicksburg, Mississippi 39180

June 1984  
Final Report

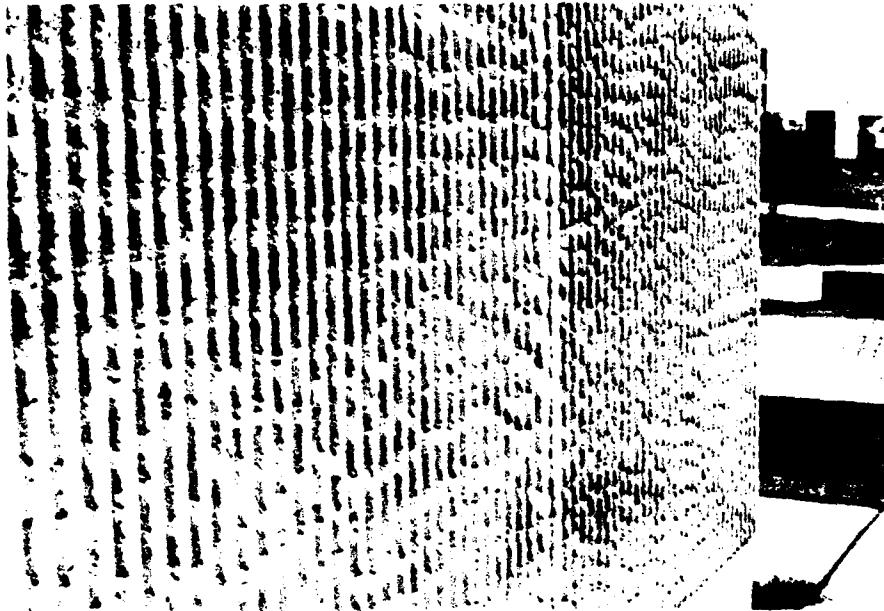
Problem: Precast ribbed architectural concrete with nonuniform sandblasting and substandard fractured ribs

Contrast in color of the two sections due to sandblasting at different angles. Near ribbed section sandblasted at three angles to texture rib sides. Far section sandblasted right angles only. Meandering lines of fractured ribs created by mechanical equipment rather than hammers used manually. Defects indicate inexperienced personnel used in construction and acceptance of panels. Field sample (3 ft by 3 ft) was too small to show possible problems.

Supervision and final acceptance by personnel experienced in architectural concrete texturing. Fractured rib texture is normally made by using hammer manually to fracture rib at uniform spacing in alternate directions. As straight line is difficult to hold with chipping or bush hammering equipment, this fractured texture needed a jig or template. Construction of full-size field sample before production phase is good insurance.

Additional sandblasting required on far section to abrade sides of ribs and uniform the texture and color of both sections. There is no method of altering the present appearance of the fractured ribs.

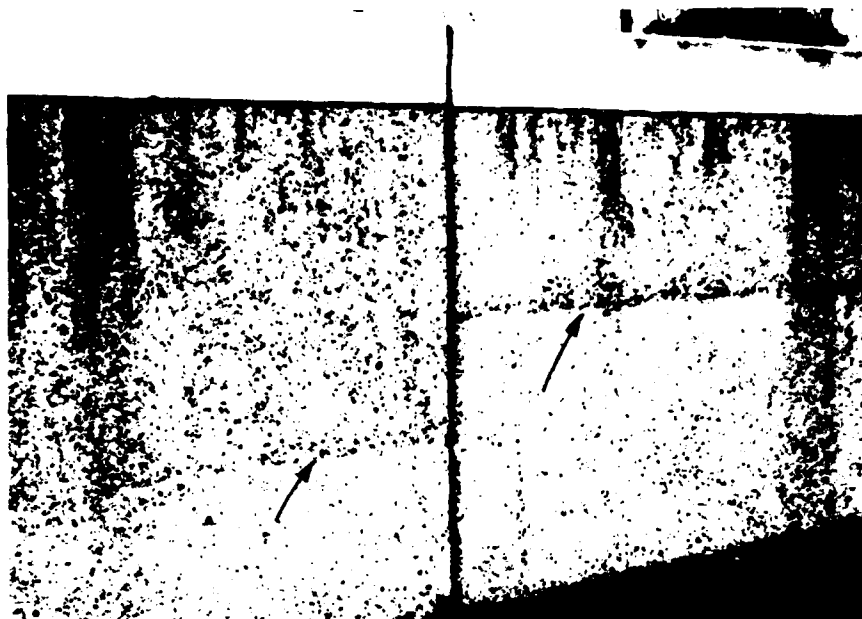
Problem: Offset lift lines in bush-hammered concrete

Project specifications required a change in location of lift line due to shortening of the exposed section of the wall. Form leakage concentrated aggregate at the two lift lines. Subsequent bush hammering exposed the aggregate concentration and accentuated the difference in elevation.

The elimination of the unnecessary construction joint from the plans would have solved the major problem. The leakage could have been prevented by the use of the recommended ACI Committee 303 procedures for such construction joints. Compressible plastic foam gaskets at the bottom of the form have also been used to prevent leakage.

There are two possible methods of repairing the present problem. One is to diminish the effect of the aggregate concentration by applying a cementitious mixture containing matching pigments to the area. After sufficient hardening, a needle gun is used to produce uniform appearance and texture. The second method would be to chip out the concentration and replace with a color matching mixture. Upon sufficient hardening, a light bush hammering along this line would provide the required texturing.

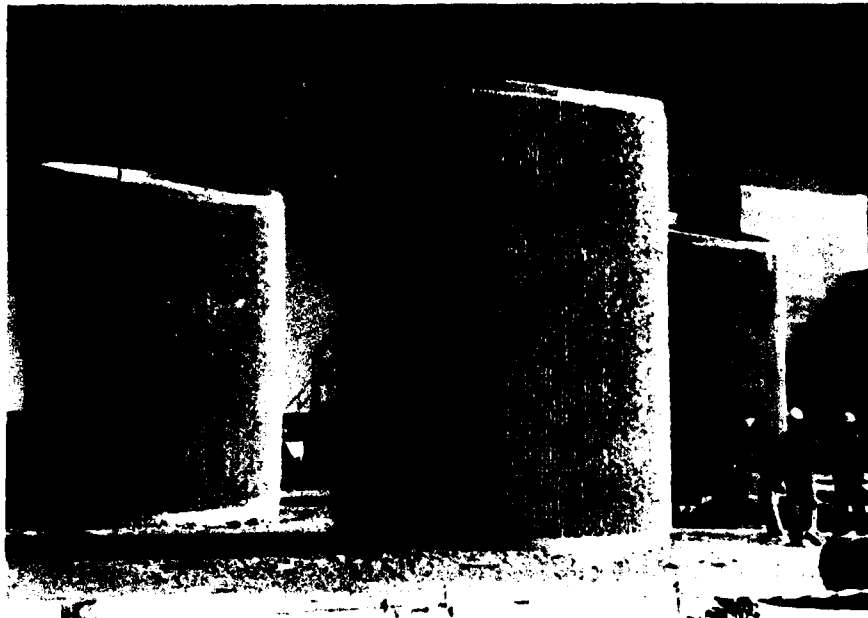
Problem: Poor quality construction joint in hammered rib chimney

The 20-ft- (6-m) high chimney was cast in two placements of approximately 13 ft (4 m) and 7 ft (2 m). The construction joint between the castings was not very well done. The upper form was not sealed tightly against the lower placement and there was considerable leakage.

After hammering the ribs, clean off the laitance which has leaked down and if necessary cement rub the smooth portion of the casting.
