HOUSATONIC RIVER BASIN
LENOX, MASSACHUSETTS

UPPER ROOT RESERVOIR DAM
MA 00019

PHASE I INSPECTION REPORT
NATIONAL DAM INSPECTION PROGRAM

MARCH, 1981

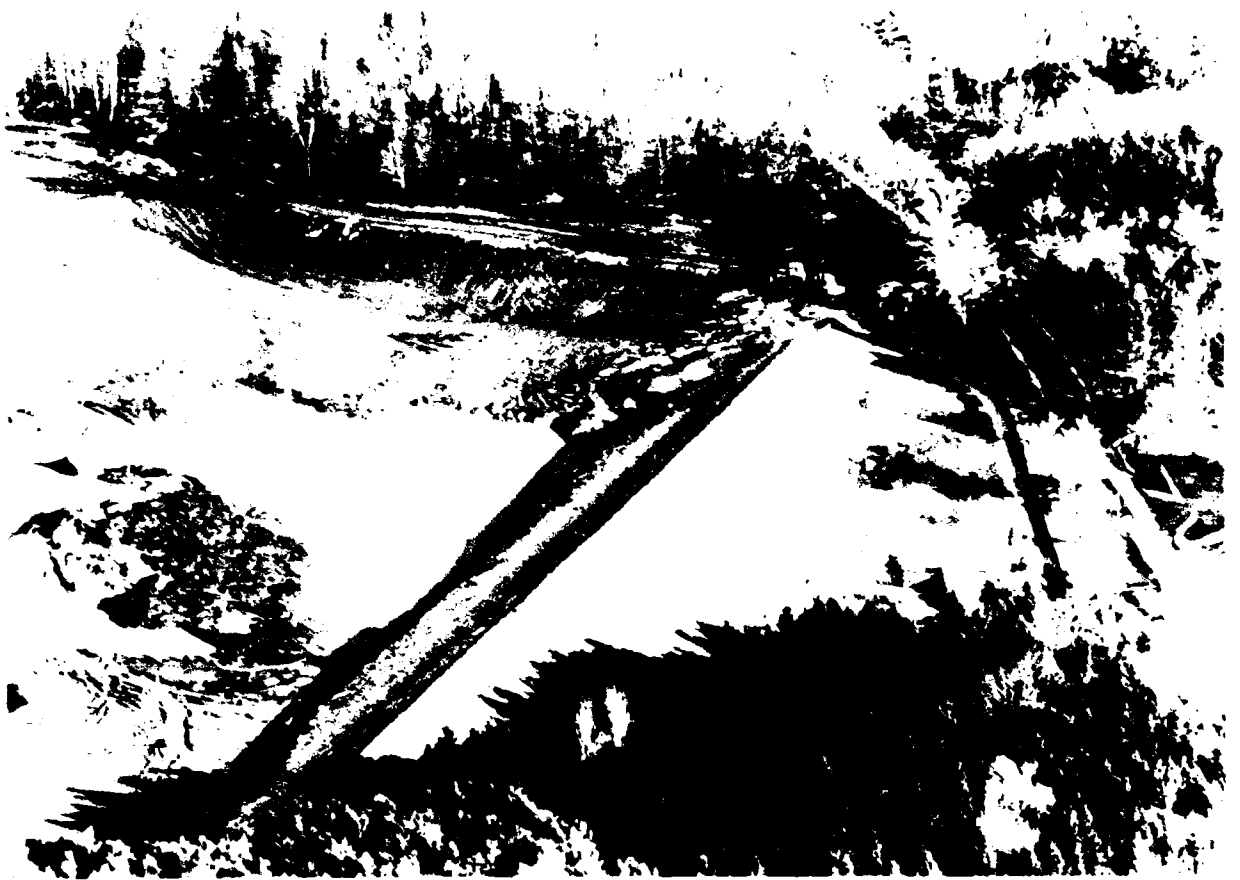
OVERVIEW OF UPPER ROOT RESERVOIR DAM

There are areas of anomalous vegetation (see Overview Photograph) on the downstream slope which should be monitored for wetness after the reservoir is filled. A couple of small (4 to 6-inch) active animal burrows were noted on the downstream slope.

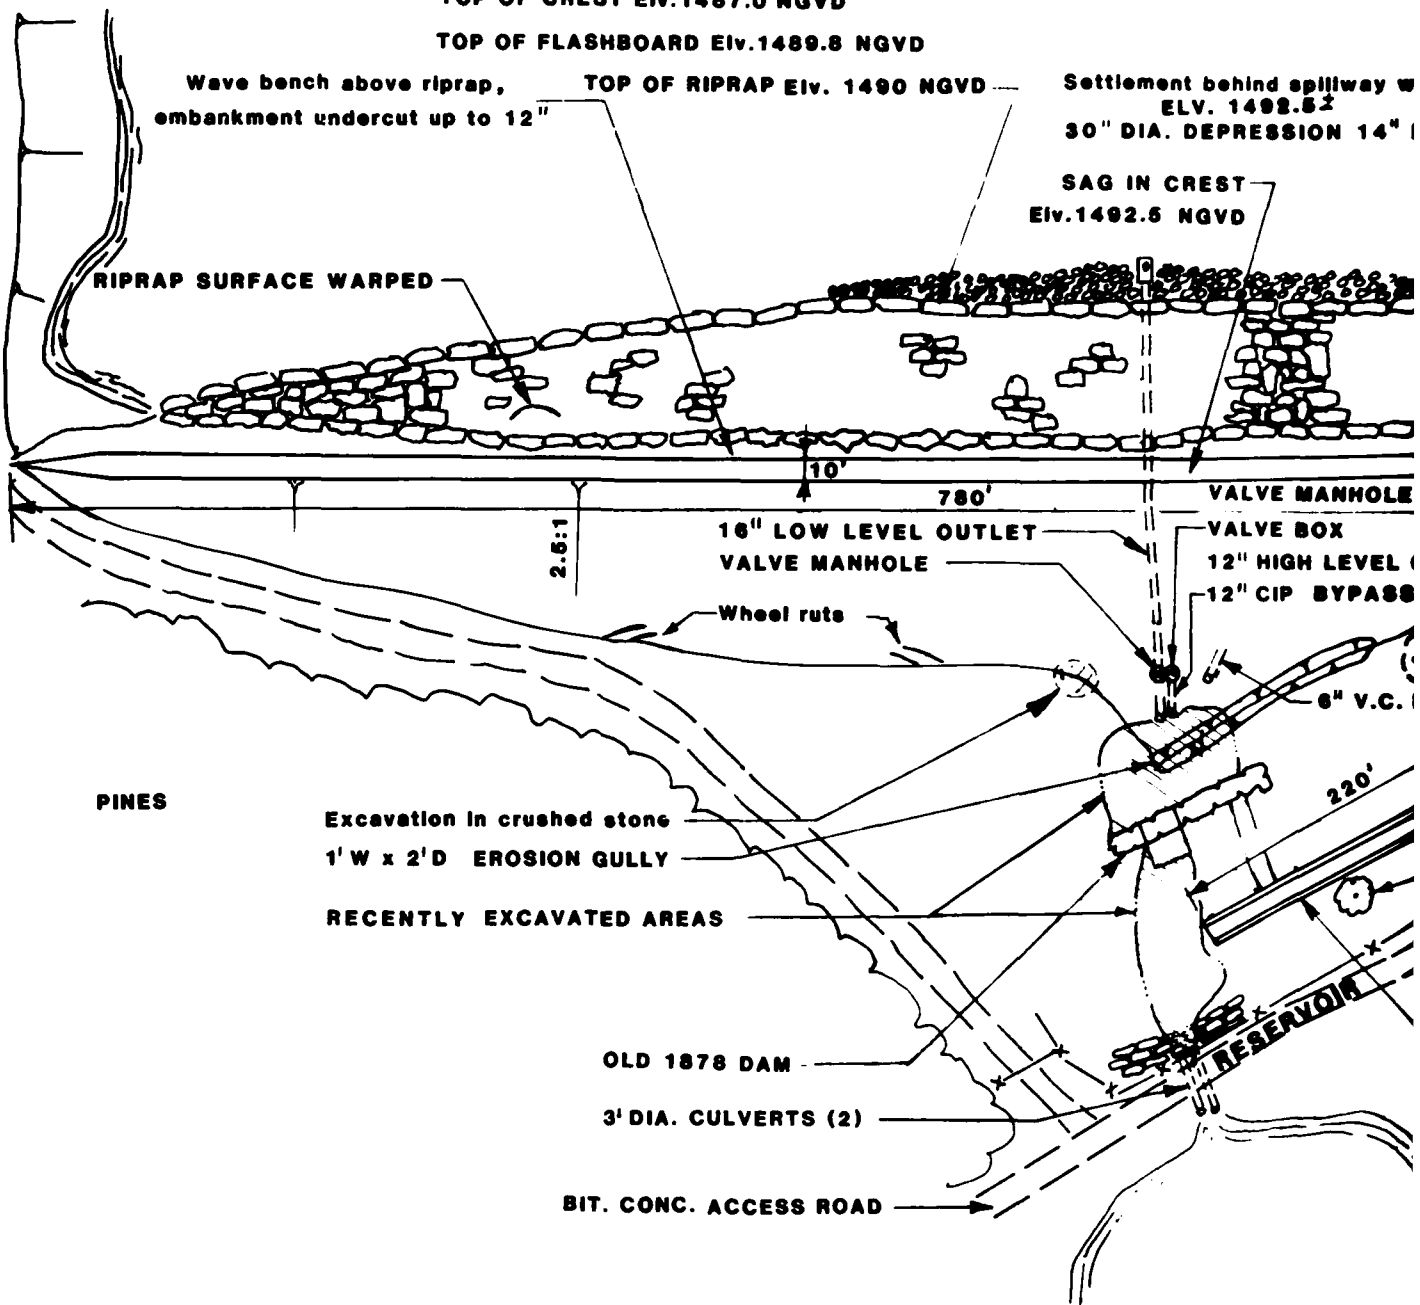
APPENDIX B FIGURE 1
GENERAL PLAN

SAG IN CREST
EIV. 1492.5 NGVD

RIPRAP SURFACE WARPED

Excavation in crushed stone
1' W x 2' D EROSION GULLY

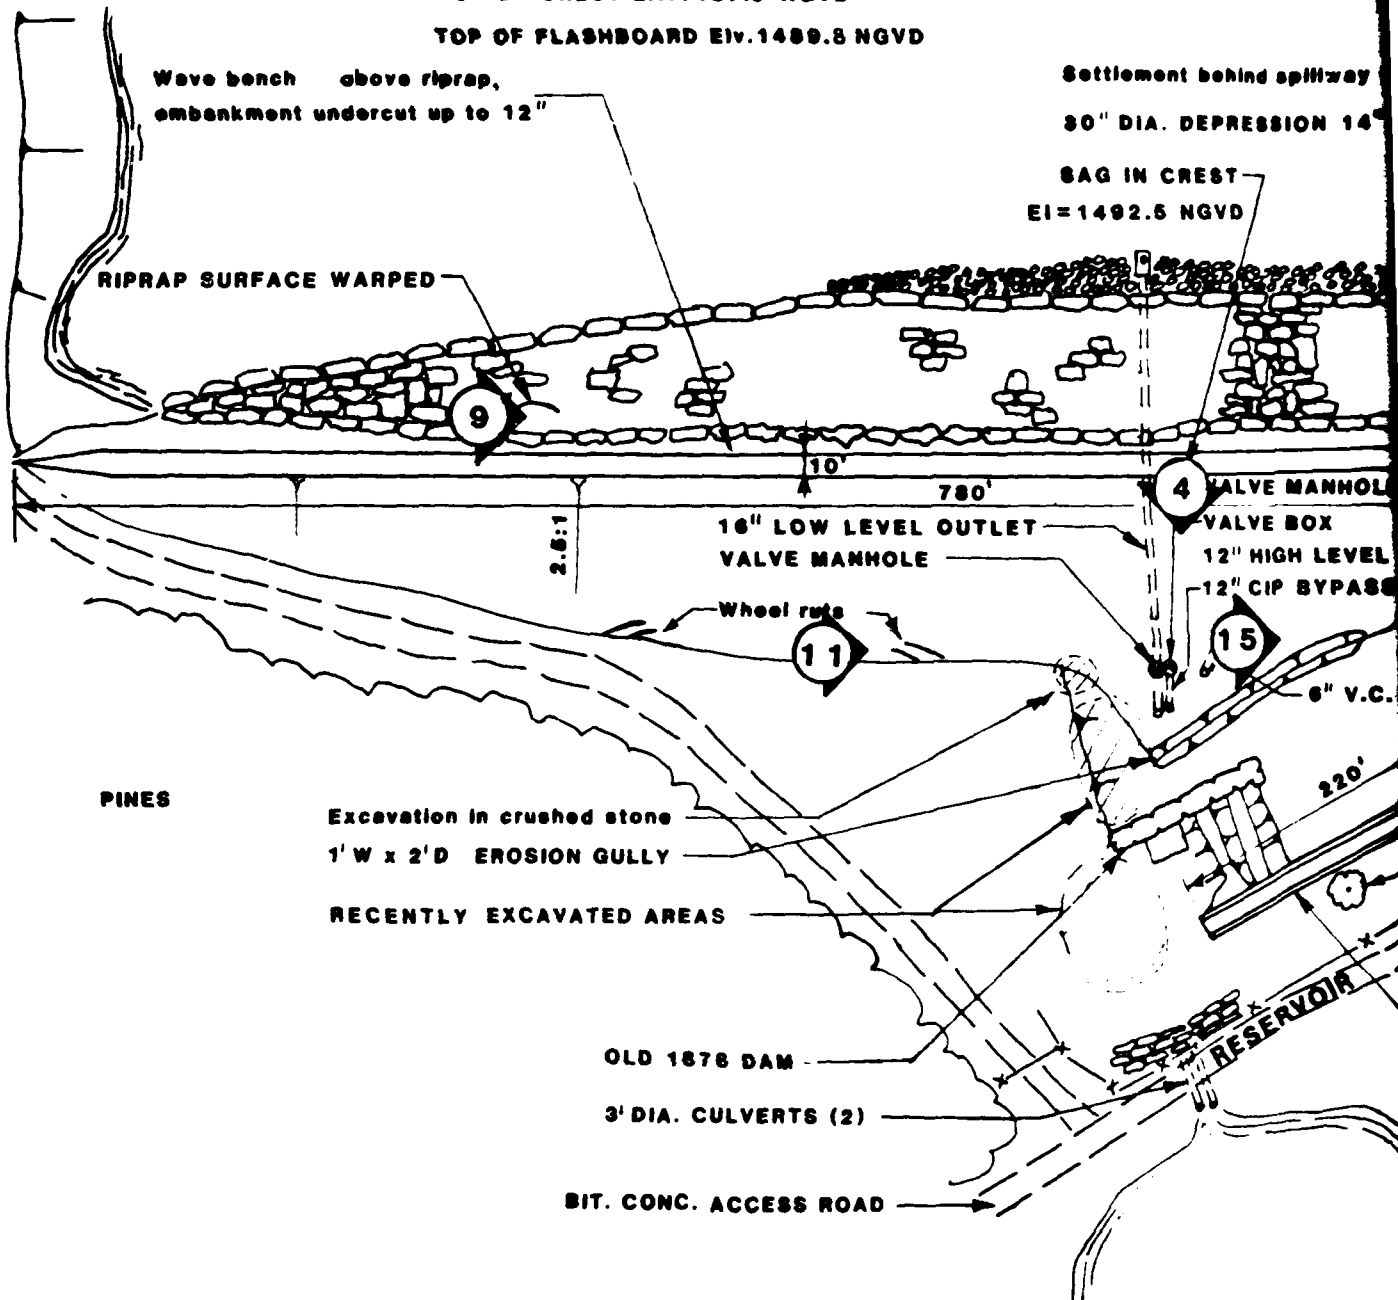
Wave bench above riprap,
embankment undercut up to 12"

RIPRAP SURFACE WARPED

Excavation in crushed stone
1' W x 2' D EROSION GULLY

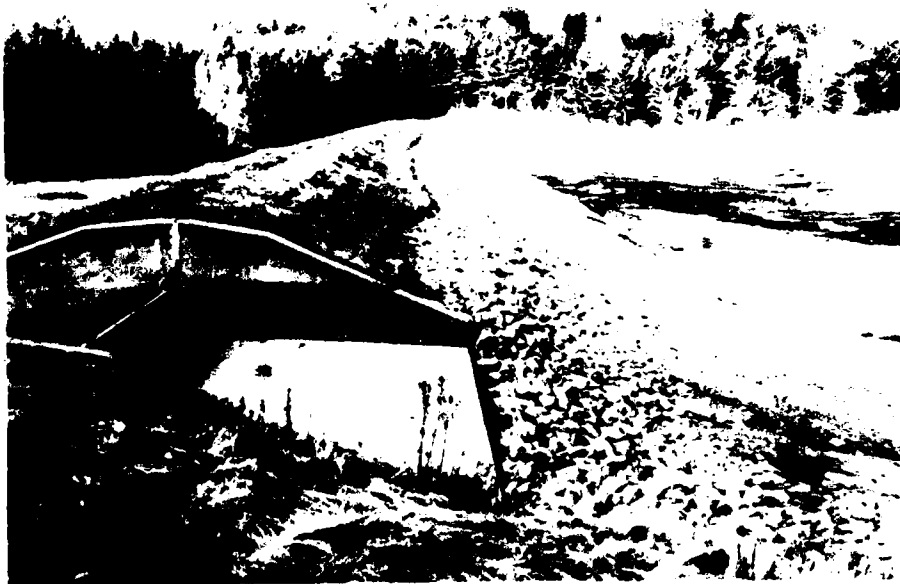
The riprap on the upstream face overall is in good condition except that there is an area to the west of the dam center where the riprap surface appears warped, possibly as a result of down-slope creep. The warped area is about 40 feet by 75 feet. The top of riprap is approximately at the same elevation as the top of flashboards and there is a wave bench above the riprap where the water has undercut the embankment crest by up to about 12 inches during times when the water level is at or above the top of flashboards (see Photograph 2, Appendix C).

The approach channel for the spillway is satisfactory with no obstructions noted. The riprap floor for spillway approach is about 1 foot lower than the concrete spillway crest (see Photograph 2, Appendix C). The riprap should be graded up to the concrete to form a smoother transition at this point.

Photograph 2 - Upstream slope, crest and spillway approach looking west. Note level of water mark in relationship to top of riprap elevation.

- Design methods to extend the slope protection to a higher elevation on the upstream slope in order to halt undercutting of the crest.
- Investigate the condition and adequacy of the existing toe drainage system, particularly in light of recent construction activity in this area.

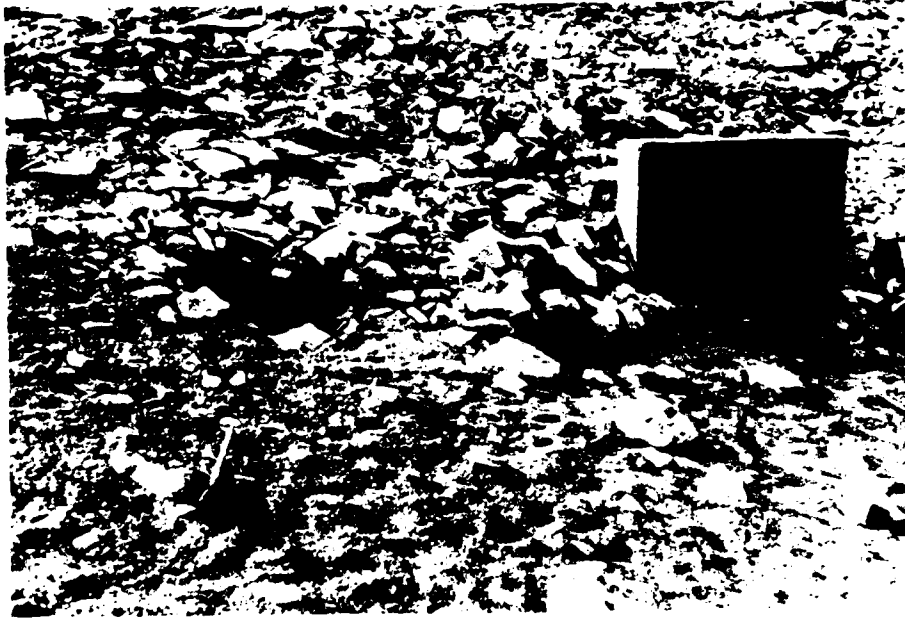
Approximately 7 feet to the north of the headwall for the 12-inch high level outlet at the upstream face of the dam, there is a localized depression 30" diameter and 14 inches deep (see Photographs 7 and 8, Appendix C). This feature appears to be near the intersection of the original ground and the embankment fill slope. The owner reports that this condition is undergoing engineering study at present.

Photograph 7 - View of headwall at inlet to 12" high level conduit. Note depression to left of headwall.

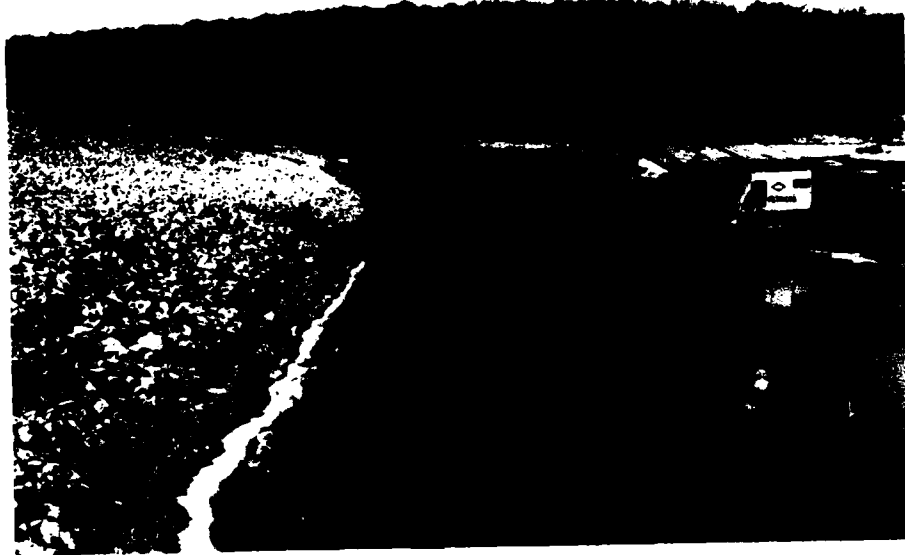
Photograph 10 - View of upstream slope showing inlet for 16-inch low level conduit. A 5' riser has since been added at this inlet.

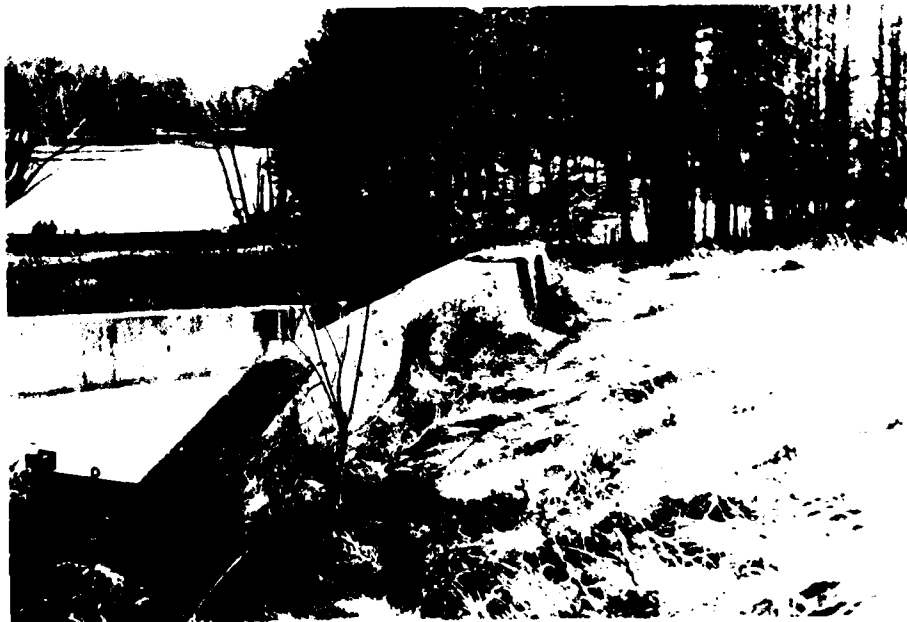
Photograph 12 - Typical low area behind spillway walls. Areas are approximately 1 foot lower than the top of dam. There are no cutoffs or projections of the spillway walls.

- Design repairs to restore the crest elevation to a uniform grade, particularly low areas adjacent to the spillway walls. Repairs of wheel ruts on the downstream should be designed.
