BARRE RESERVOIR DAM AND DIKE
MA 00094

**PHASE I INSPECTION REPORT
NATIONAL DAM INSPECTION PROGRAM**

DEPARTMENT OF THE ARMY
NEW ENGLAND DIVISION, CORPS OF ENGINEERS
WALTHAM, MASS. 02154

JUNE 1980

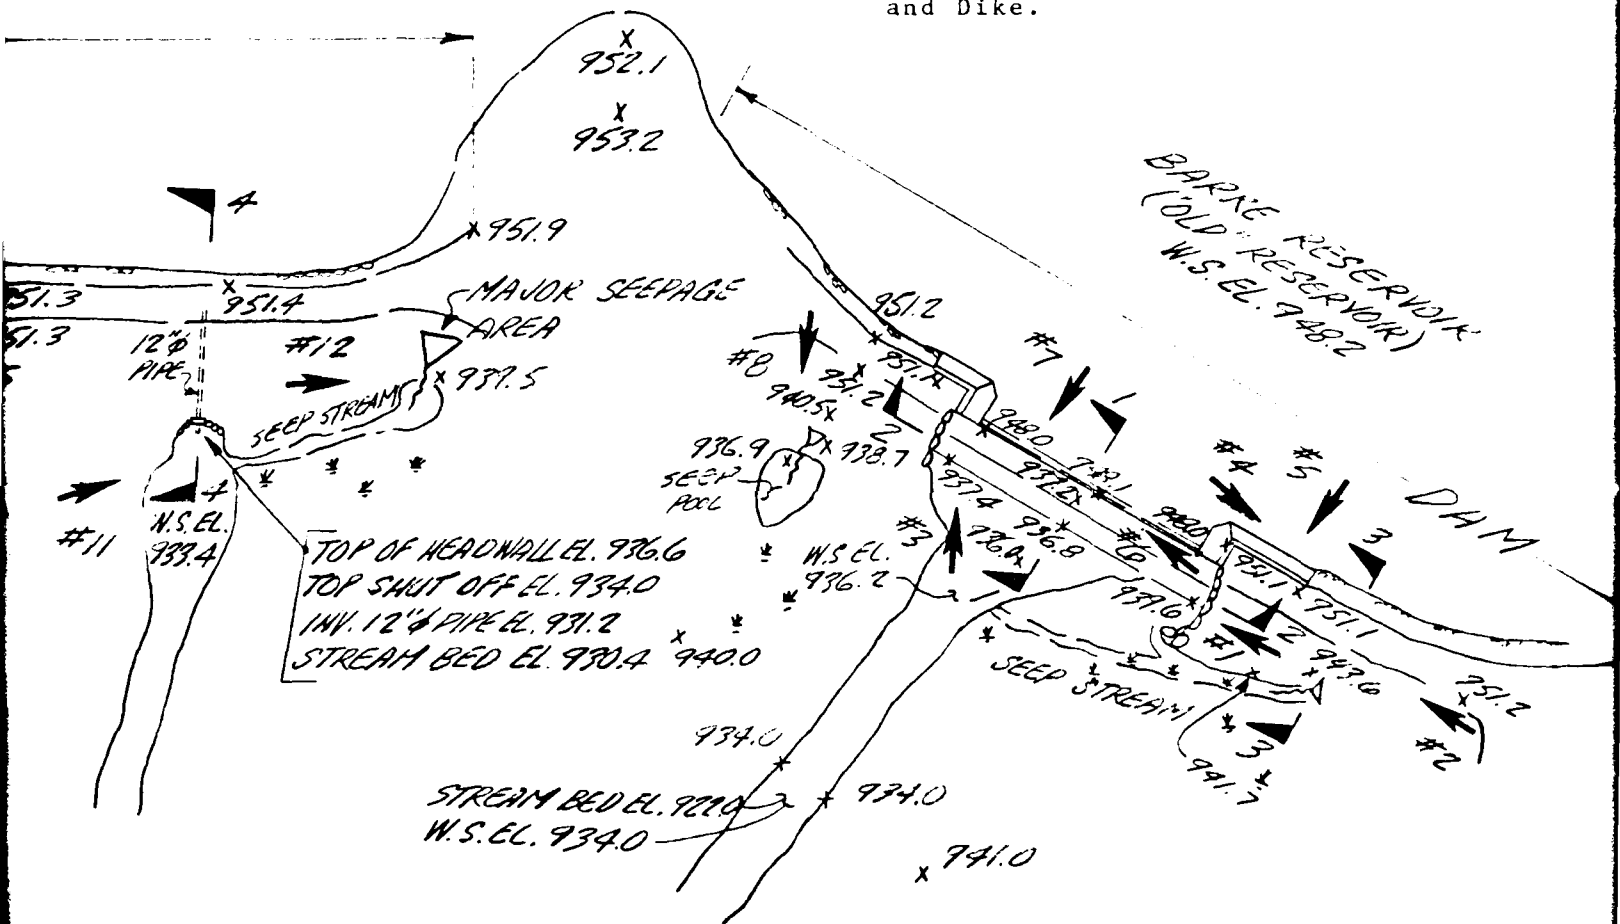
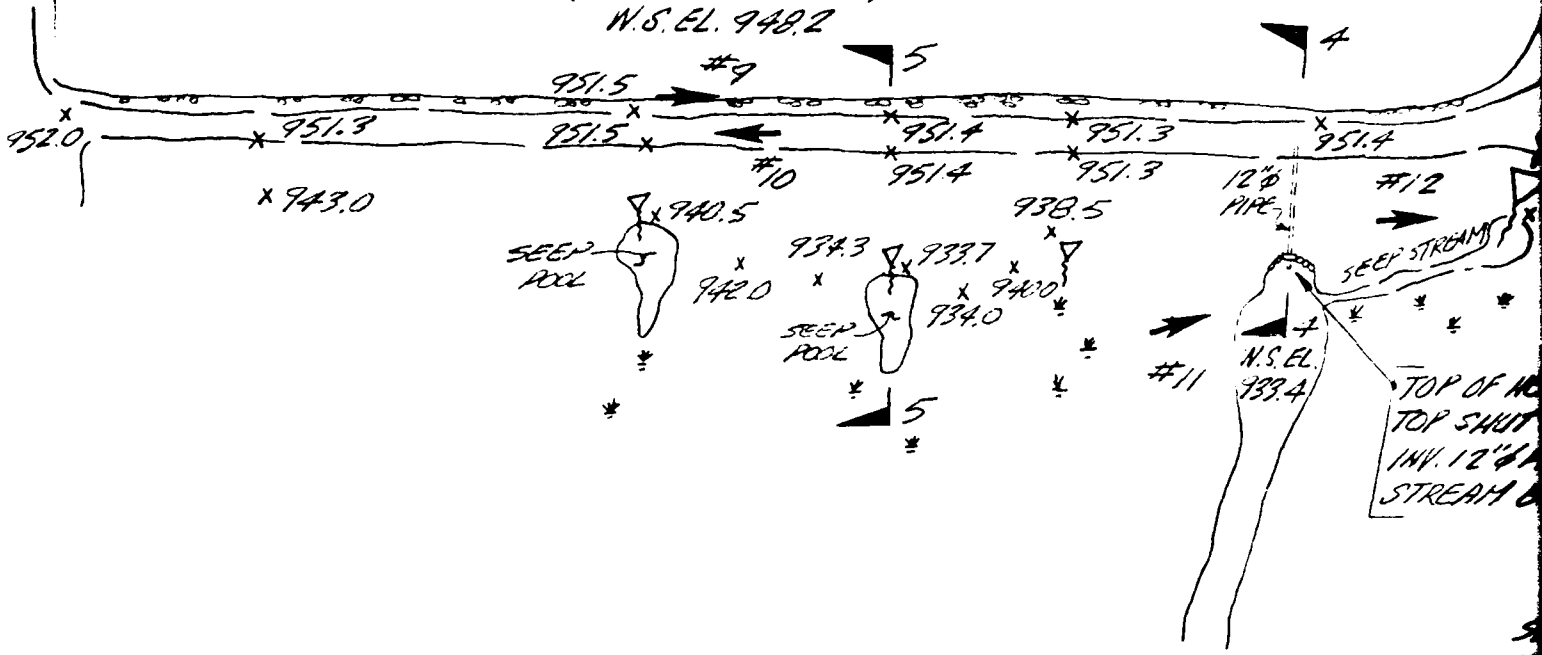
MTCAL & SONS, INC.	
NATIONAL PROGRAM OF INSPECTION	
BARRE RESERVOIR	
FIGURE B-1 PLAN	
TRIBUTARY WARE RIVER	
SCALE: AS SHOWN	DATE

- c. Dike. The dike is an earthfill structure with a low-level outlet. Evidence of seepage was noted in four locations along the downstream toe. The most severe seepage occurs at the toe of the left abutment with a maximum estimated flow of 10 to 15 gpm (see Photo No. 12). As indicated on Figure B-1, pools, streams, and marshy areas are all evident at the seepage points.

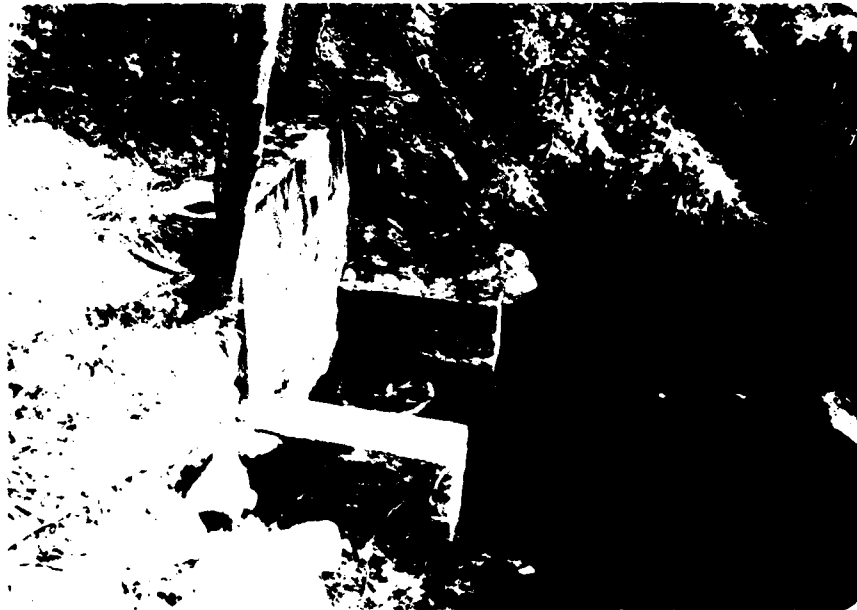
The headwall of the low level outlet is constructed of concrete and is in good condition, with minor erosion of the concrete surface below the water level. The wheel which operates the valve is slightly rusted, but the valve is submerged and could not be inspected.

NO. 11 LOW LEVEL OUTLET CONTROL AND HEADWALL
BELOW DIKE
