TIHONET POND NO. 2 DAM

MA 00030

PHASE I INSPECTION REPORT
NATIONAL DAM INSPECTION PROGRAM

JULY 1981

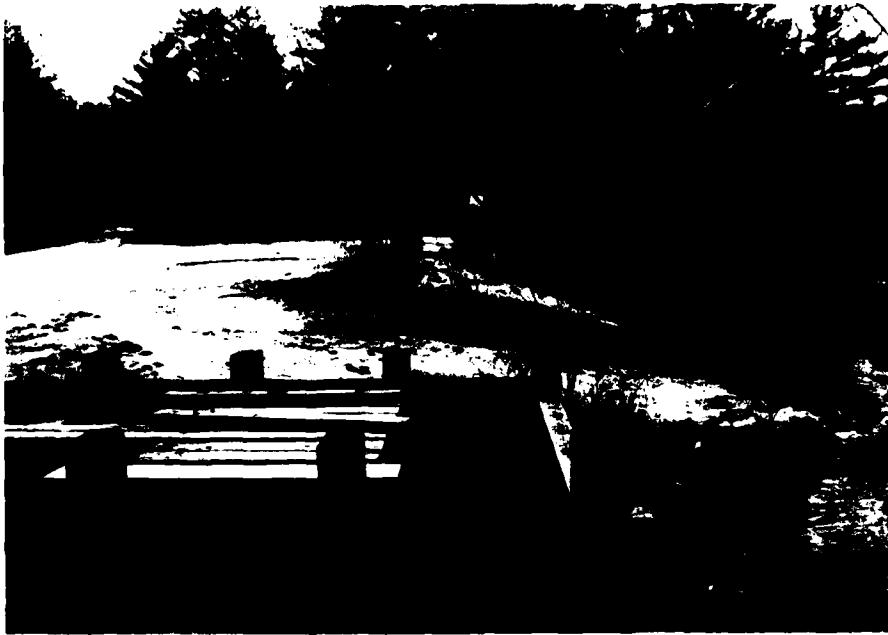
Photo # 10 Crest - Tihonet Pond #1 Dam

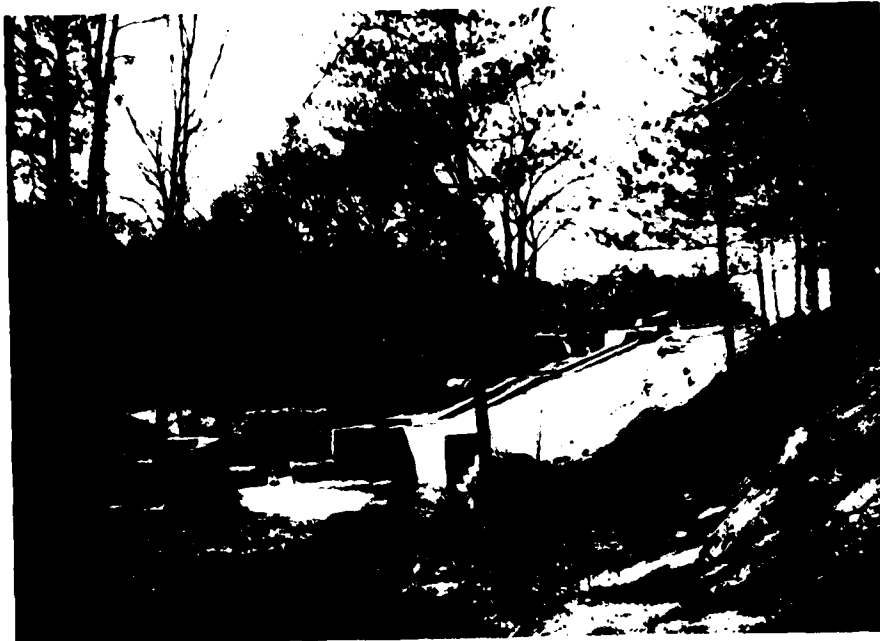
Photo # 11 Downstream Slope Tihonet Pond #1 Dam
