TECHNICAL REPORT NO. 6-570

# DURABILITY AND BEHAVIOR OF PRESTRESSED CONCRETE BEAMS

Report 6

## POSTTENSIONED CONCRETE BEAM INVESTIGATION, SUPPLEMENTAL LABORATORY TESTS OF BEAMS EXPOSED FROM 1961 TO 1982

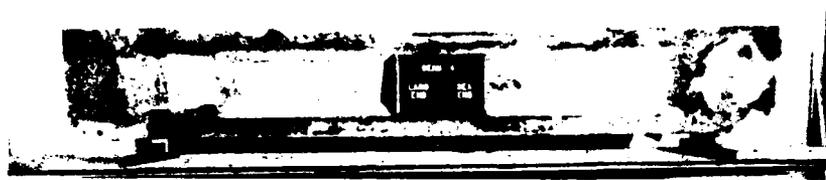
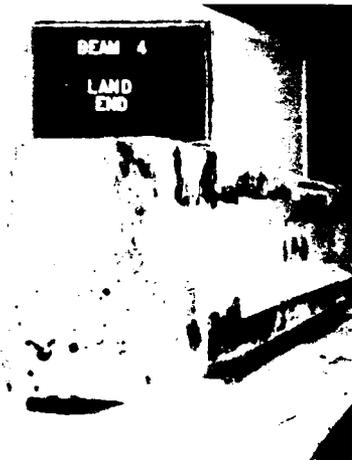
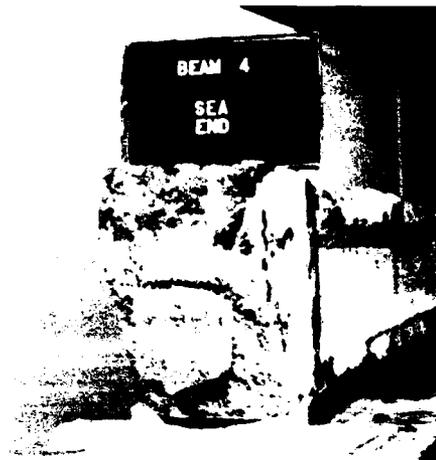
Figure 3. As-received and failure conditions of beam 4

17. The as-received condition of beam 4 is shown in Figure 3. Concrete had spalled on some edges exposing the conventional reinforcement to attack by seawater. Sixty percent of the conventional reinforcement was exposed on one top edge. Several small places on the other top edge and one bottom edge showed exposed reinforcement. The exposed reinforcement on the seaward end, bottom edge, was corroded completely through. All exposed reinforcement was heavily rusted and deteriorated. The lower half of the seaward end had spalled from the end of the beam, exposing part of the epoxy concrete end protective plug and end anchor. The plug covering the end anchorage was still in place over the end anchor. At the landward end, there was a 1/2-in.-wide by 1/2-in.-deep gap between the beam and the end cap. Otherwise, the landward end epoxy concrete cap was in good condition.

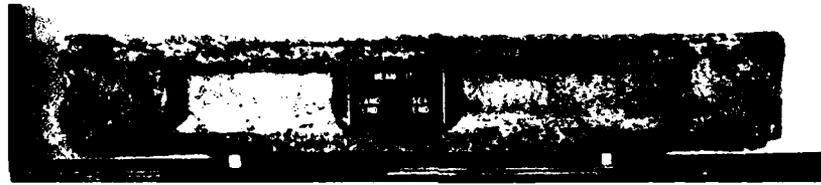
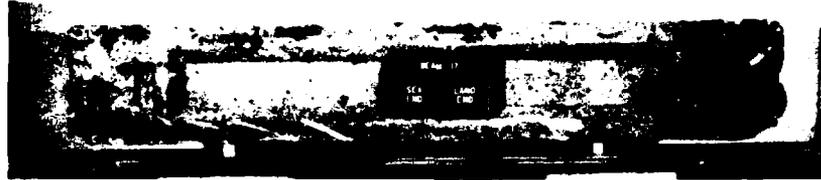
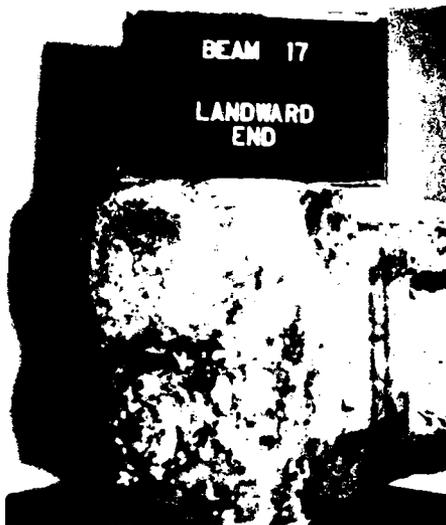
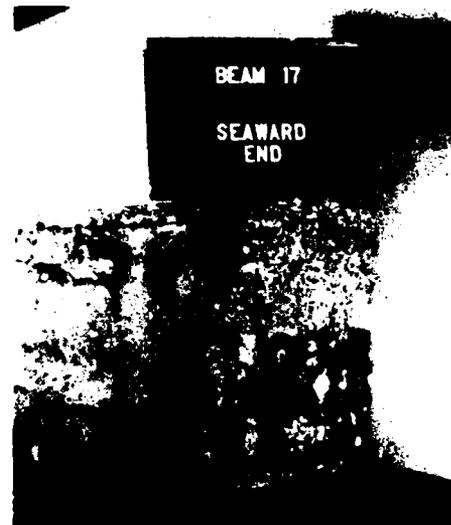
Figure 4. As-received and failure conditions of beam 17

23. The "as-received" condition of beam 17 is shown in Figure 4. The concrete was spalled away at the edges on much of the beam, exposing the conventional reinforcement. On one side of the beam, the top edge had reinforcement exposed the whole length of the beam proper. The bottom edge had exposed reinforcement in two small spots. The exposed reinforcement was badly deteriorated. The steel exposed on the bottom edge of the landward end had been completely corroded through its cross section. Both protective end caps were missing, exposing the end anchorages to seawater. The concrete along the edges had spalled, exposing conventional reinforcement on both edges of the landward end of the beam and on one edge of the seaward end.

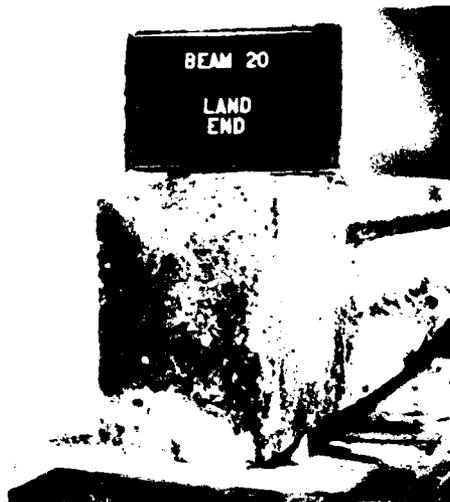
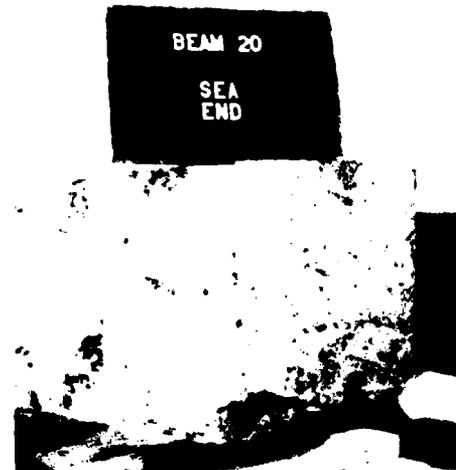
Figure 5. As-received and failure conditions of beam 20

30. The "as-received" condition of beam 20 is shown in Figure 5. Concrete was spalled away at the edges on much of the beam exposing some conventional reinforcement. On one top edge, the reinforcement was exposed along the total length. Both bottom edges had some exposed reinforcement. All exposed reinforcement was heavily corroded. Reinforcement in one area on the bottom edge had been completely corroded through its entire cross section. The landward protective end cap was in place and in generally good condition. This epoxy concrete end cap was anchored to the beam through the aid of reinforcing bars that protruded from the end of the beam into the cap. The end cap was separated from the beam proper by a 1/2-in. gap that was 1/2 in. deep (Photo 10). The reinforcement that held the end cap to the beam at this end of the beam was heavily covered with rust. There were two pieces of reinforcement that connected the cap to the beam. One piece was not reduced in cross section by the corrosion, but the other was reduced at the point where the 1/2-in. gap occurred, until the diameter of the bar was only 3/16 in. The seaward epoxy concrete end cap was also in place, but 4 in. of the bottom of the end cap had spalled away. This end cap was also partially separated from the beam by a 1/2-in. gap that was 4 to 8 in. deep (Photo 11). This end cap did not have reinforcing bars anchoring the cap to the beam.

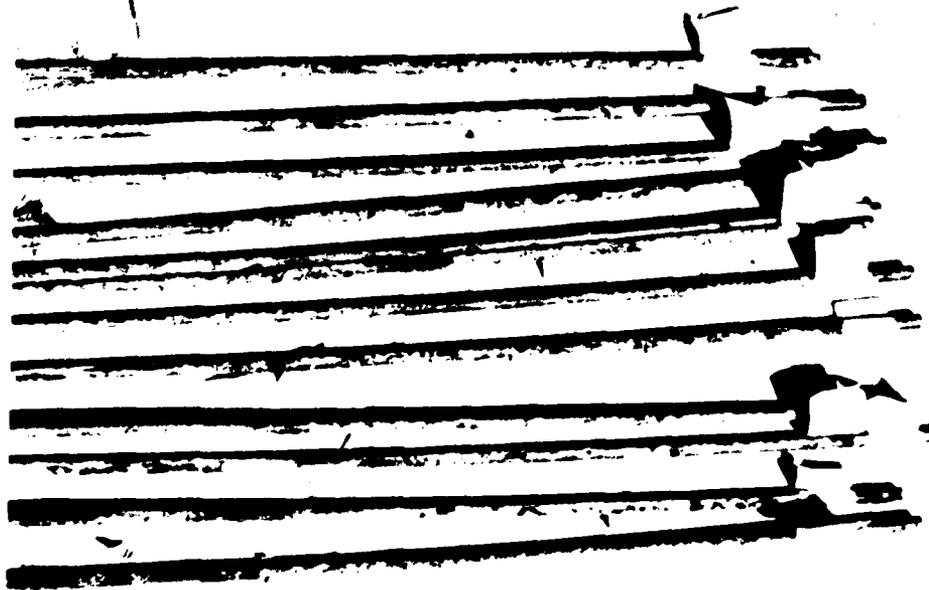
28. Most of the 12 posttensioning wires were lightly to moderately corroded along all of the seaward half and on 65 percent of the landward half. The heaviest rusting occurred within 15 in. of the landward end of the wires (Photo 8). All 12 wires were described as heavily rusted on the outermost 15 in. of their landward end. Two wires were described as heavily rusted from 3 in. to about 15 in. along their seaward end. Streaks of rust from 3 to 15 in. long where wires appeared to have been touching each other were found on 6 of

Photo 8. Twelve wires of beam 17 showing heavy rusting on  
landward ends

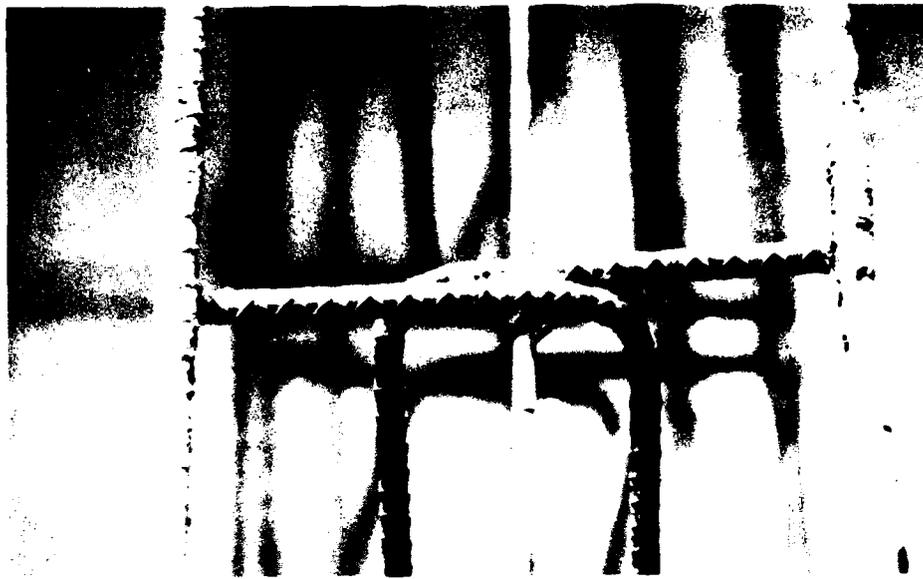
Photo 19. Stirrup of beam 4 showing rust around weld point

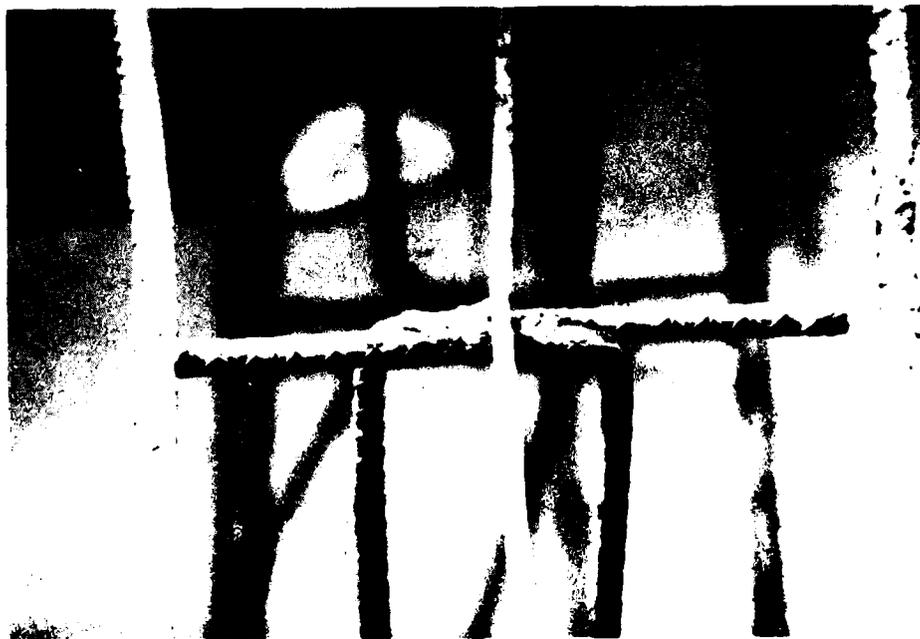
Photo 20. Stirrup of beam 17 showing rust around weld point

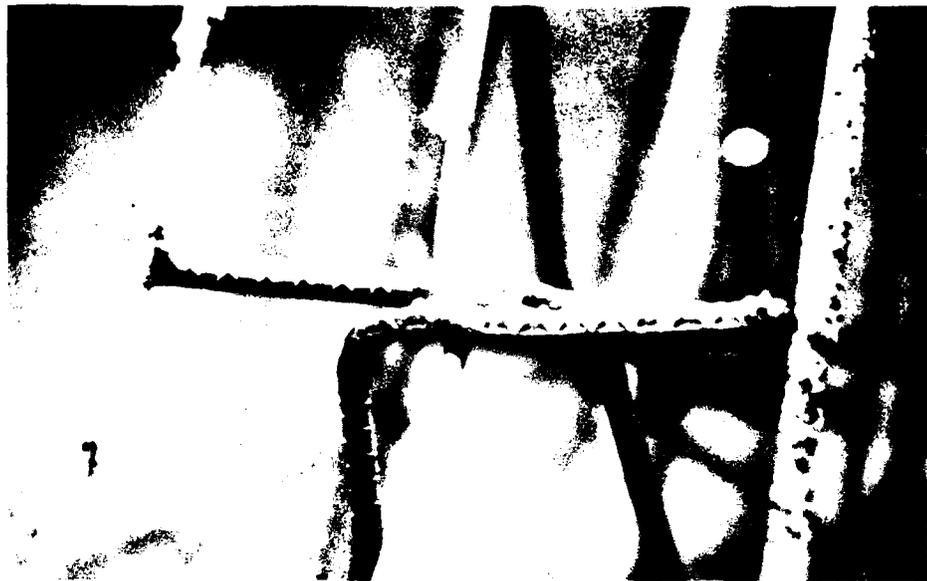
Photo 21. Stirrup of beam 20 showing rust around weld point

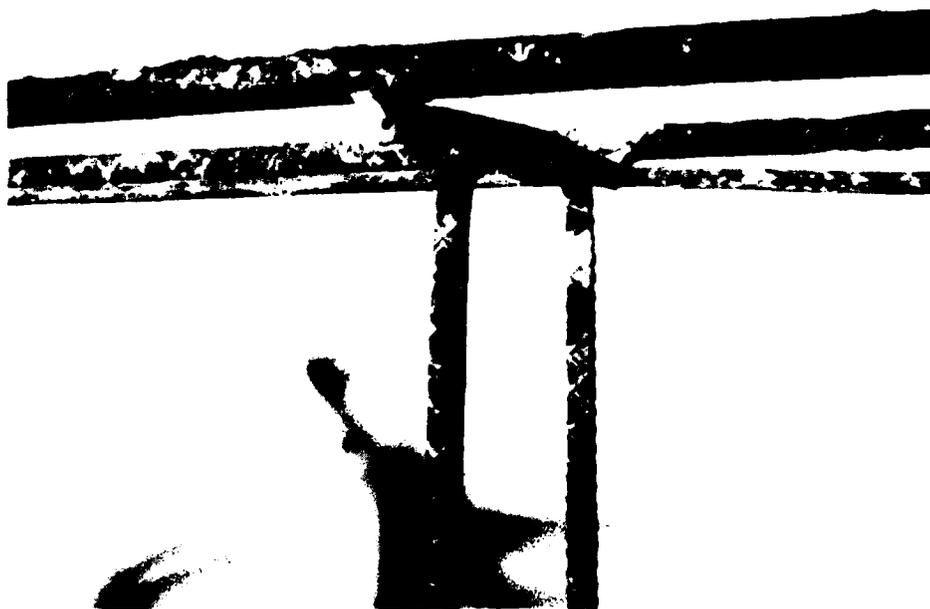
Photo 22. Stirrup of beam 4 showing spot of light surface rust
