PTPD REPORT NO. 84-R-02
AFPEA PROJECT NO. 84-P-111
AD NO. 538026

BI-PAC F-15 EXTERNAL FUEL TANK CONTAINER MODIFICATION

HQ AFLC/DSTZ
AIR FORCE PACKAGING EVALUATION AGENCY
Wright-Patterson AFB OH 45433-5999

September 1984

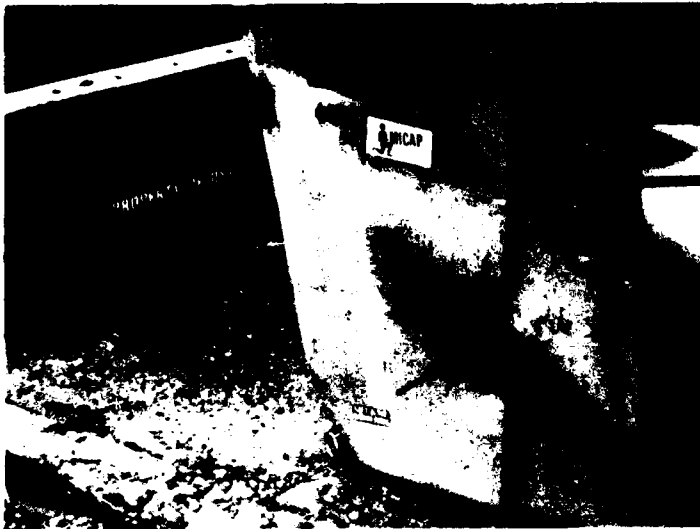
Figure 2, Container Damage,
Side View

- a. Figure 2, Damage noted to side of *Container No. 1.
- b. Figure 3, Seam of strap broken, Container No. 1.
- c. Figure 4, Rotation of fuel tanks, Container No. 1.
- d. Figure 5, Loose strap, corner post stowage, Container No. 1.
- e. Figure 6, Loose strap, tank forward end, Container No. 1.
- f. Figure 7, Loose angle iron in forklift entry, **Container No. 2.
