NRL Memorandum Report 5598

# Flashover Failures from Wet-Wire Arcing and Tracking

December 17, 1984

NAVAL RESEARCH LABORATORY  
Washington, D.C.

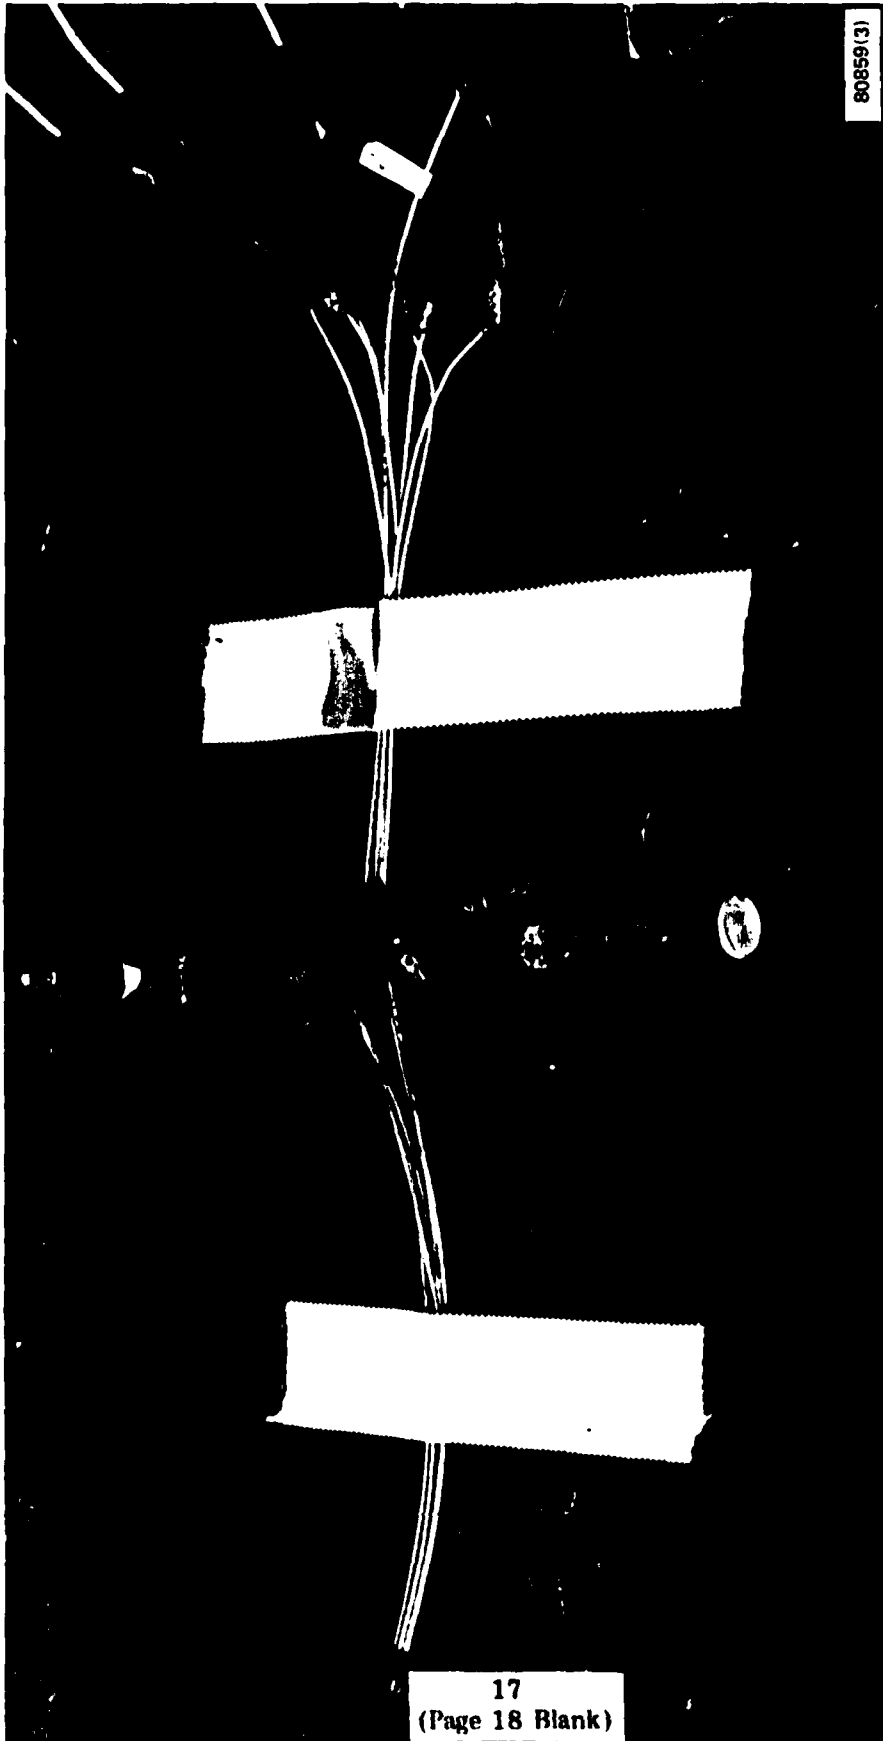
In order to illustrate this sequence more completely a videotape was prepared that shows each of the above steps, from the preparation of the bundle to the after effects of the flashover. Two of the frames were photographed from this film in order to capture the fast moving action. Figure 3 shows the arcing which occurs as it becomes more severe (6 min, 1 sec from the start), and Figure 4 shows the intense flash, with streaks of molten copper and aluminum coming out of the burning area (6 min, 41 sec.). A photo of the remains is shown in Figure 2, where the wire surfaces are covered with char, and the tips of the conductors and the aluminum rod show evidence of melting and cratering from the blast of the flashover.

Figure 2: Close-up photo of the failed Kapton bundle after the flashover, showing the melted wires and crater in the grounded aluminum rod resulting from the intense heat of the flashover blast.

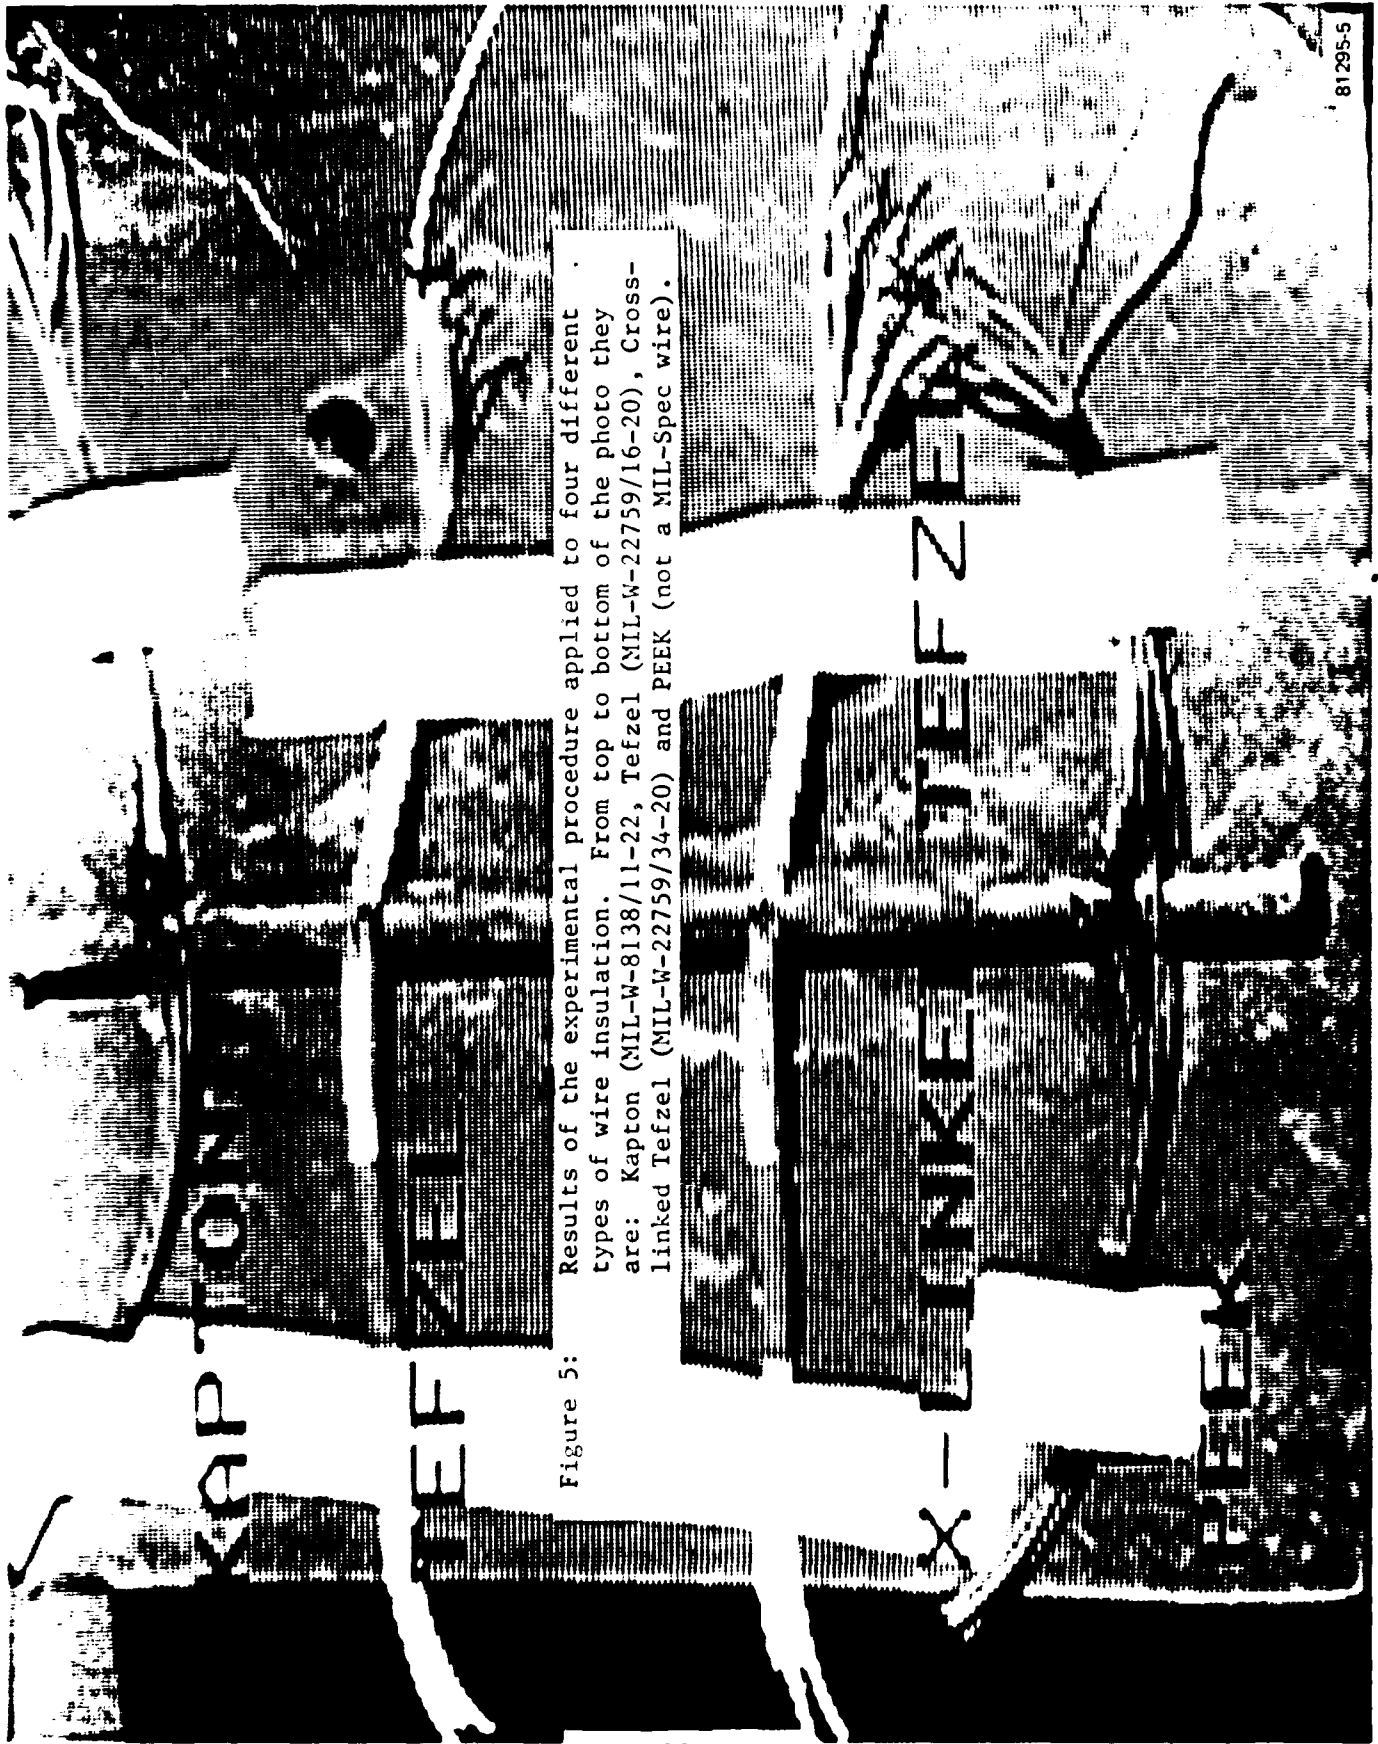
The same experimental procedure was applied to three other types of insulated wire that have been proposed as replacement for the MIL-W-81381 type in future aircraft wiring assemblies. These were as follows: ETFE (ethylene tetrafluoroethylene) commercially available as TEFZEL (MIL-W-22759/16), Crosslinked ETFE (MIL-W-22759/34) and Poly-ether-ether-ketone, PEEK (not a MIL-Spec wire at present). The results of these experiments on the experimental wire bundles are displayed together in Figure 5. Both the Tefzel and the X-linked Tefzel wires reacted about the same to the deteriorating process of the salt water/voltage potential of the experiment. However, flashover did not occur because there was no carbonization buildup resulting from the arcing and tracking. Although arcing did occur, it was much less intense than that described above for Kapton wires, and the current pulses were too small to be observed on the ammeter scale. After several hours it was noticed that the conductor of the intentionally bared wire on top of the bundle had corroded in two due to the acid formation from the electrolytic reaction of the salt water. A grayish-green deposit was collecting on the adjacent wires, but it did not contribute to the arcing and tracking. As discussed in the Introduction the Tefzel is a polymer of the type that decomposes into gaseous products under high temperatures so it was not expected to carbonize to form a conductive, flashover path.

The PEEK insulated wires were tested in bundles by the same procedure. These also exhibited intense arcing and tracking very quickly with flashover

taking place in the range of one to ten minutes. This was expected to occur since the polymer chain is also one that is highly aromatic which forms carbon when pyrolyzed.

Figure 5: Results of the experimental procedure applied to four different types of wire insulation. From top to bottom of the photo they are: Kapton (MIL-W-8138/11-22, Tefzel (MIL-W-22759/16-20), Cross-linked Tefzel (MIL-W-22759/34-20) and PEEK (not a MIL-Spec wire).
