AFWAL-TR-84-2048

DAMAGE CAUSED TO POLYURETHANE FOAMS BY AGING,
SIMULATED SUNLIGHT EXPOSURE, HEAT AND FIRE

JULY 1984

FINAL REPORT FOR PERIOD 15 JANUARY 1983 - 30 SEPTEMBER 1983

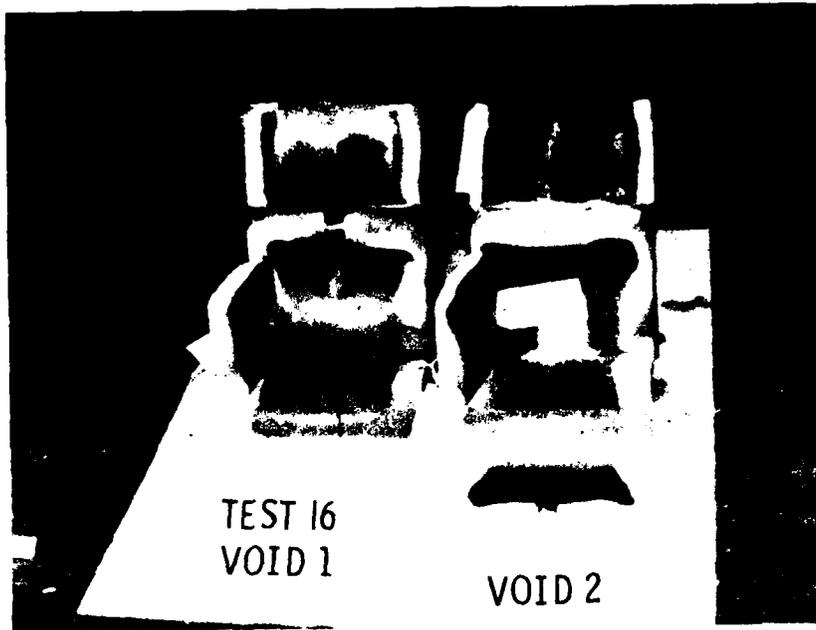
Figure 21. Red foam damage pattern, Test 16.

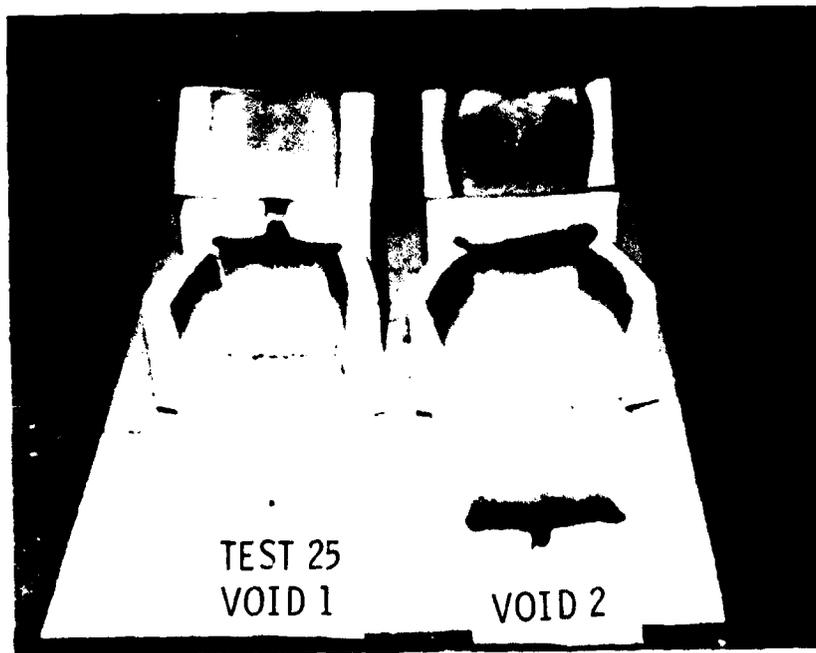
Figure 22. Yellow foam damage pattern, Test 25.

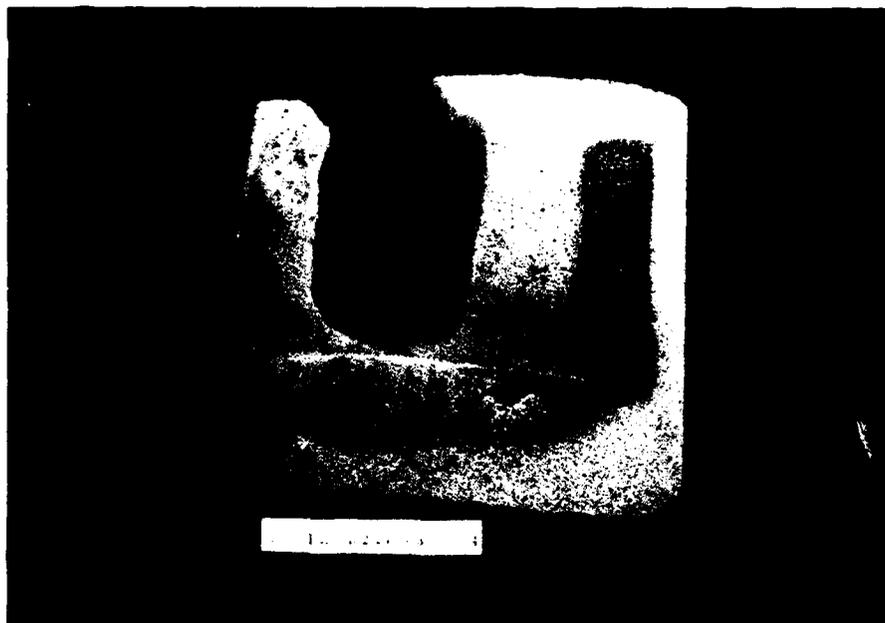
All three specimens (Specimens 1-3; see Figures 28-30) exhibited surface degradation in an irregular pattern. Pieces of char adhered to the affected surface. In most of the affected areas, foam damage did not extend deep below the surface (see Figure 31). Consequently, it is concluded that this damage was caused by burning of the foam.

Figure 28. Fuel vent tank foam, left half,
A/C 78-717 (Specimen No. 1).

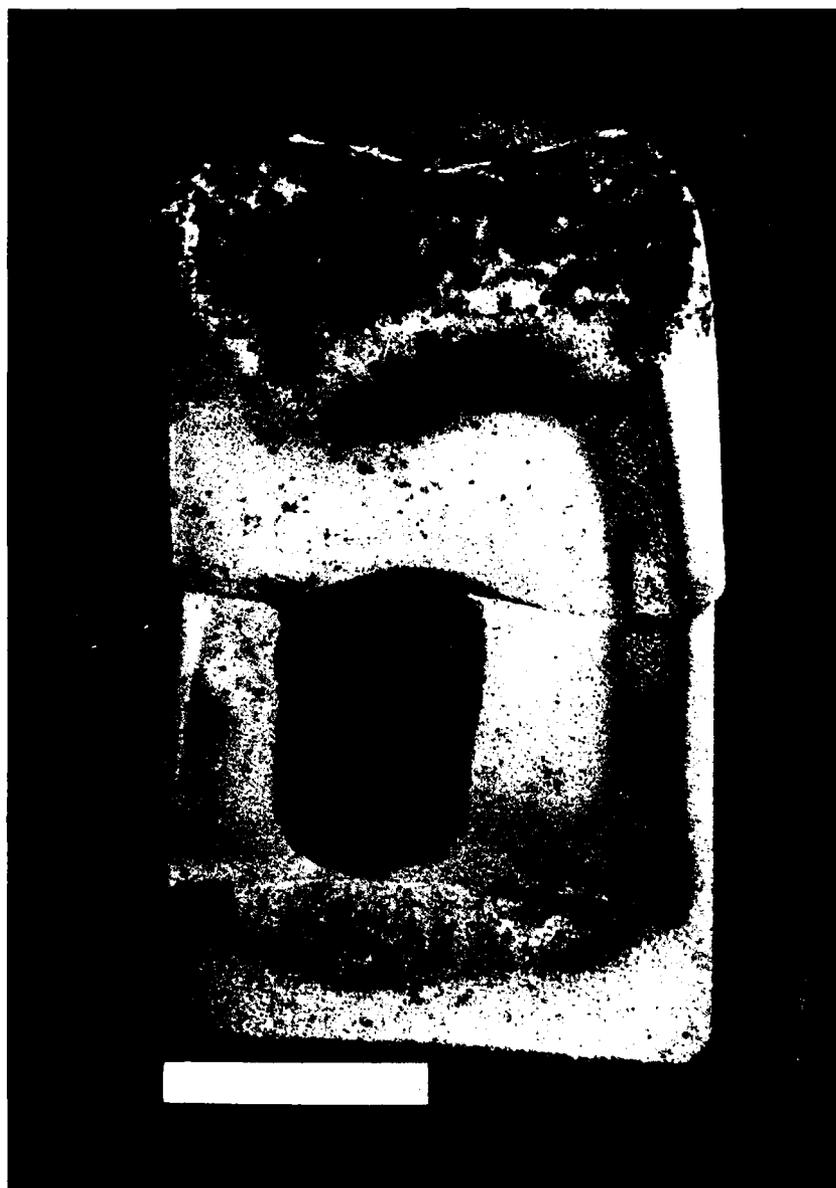
Figure 32. Two halves of fuel vent tank foam from A/C 78-717 (Specimens Nos. 1 and 2) placed together.

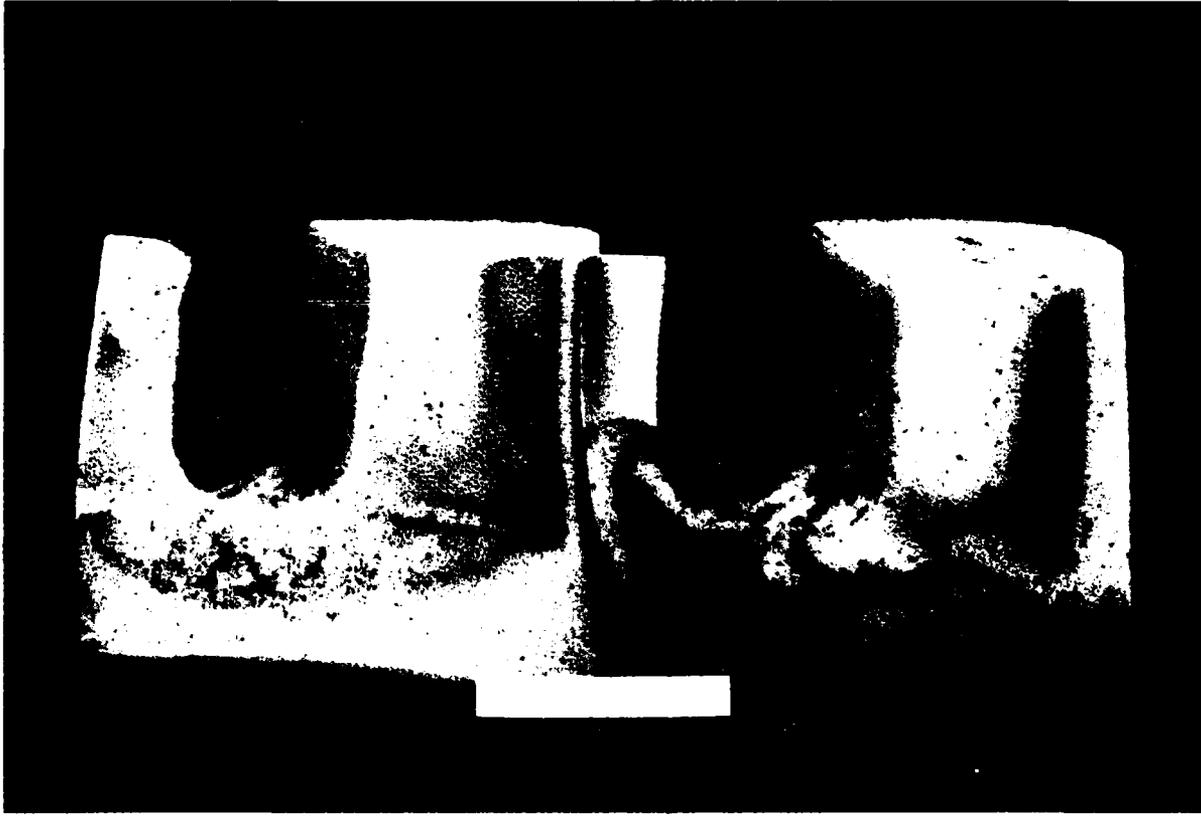
Figure 34. Left halves of fuel tank foam
from A/C-s 78-704 and 78-717.

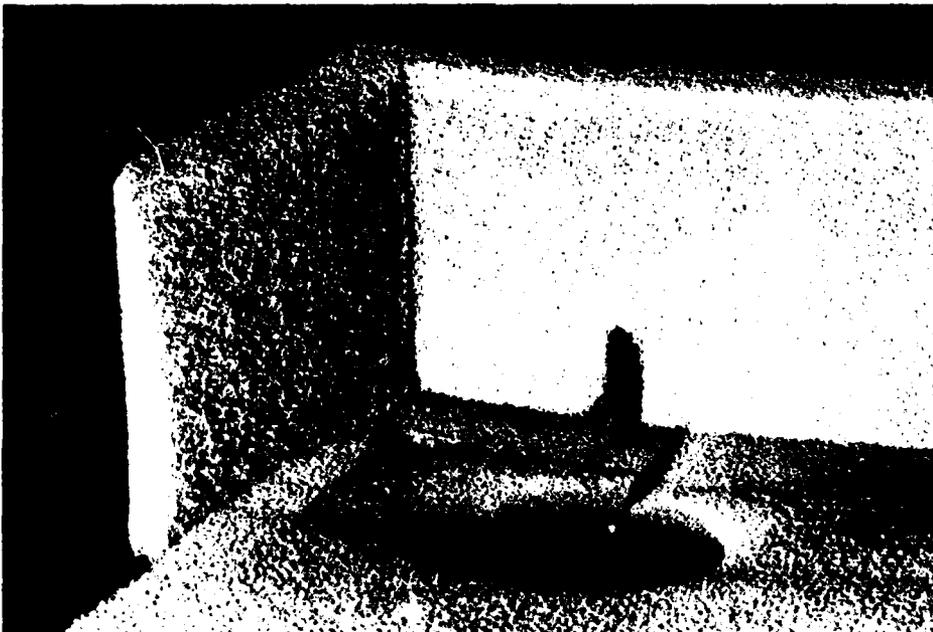
The inside surface of the depicted assembly of void filling foam (Specimen No. 4; see Figures 35 to 37) had been exposed to flash fire(s) of short duration. The surfaces of foam pieces were singed. The damage did not extend into the foam.

Figure 36. Fire-damaged surface of fuel
tank foam (Specimen No. 4).

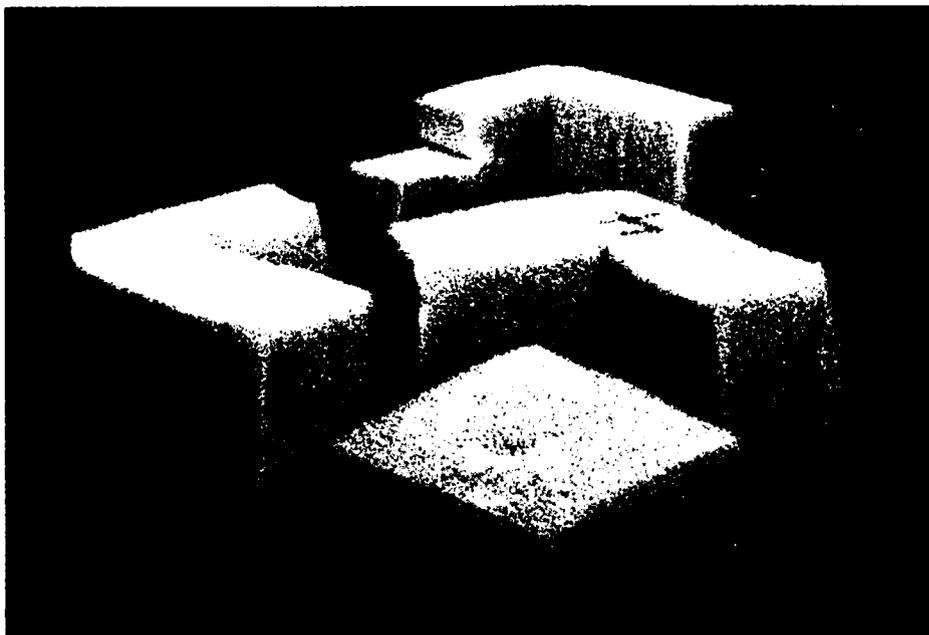
Figure 38. Foam pieces from the wing tank of A/C 78-717 (Specimens Nos. 5-8).

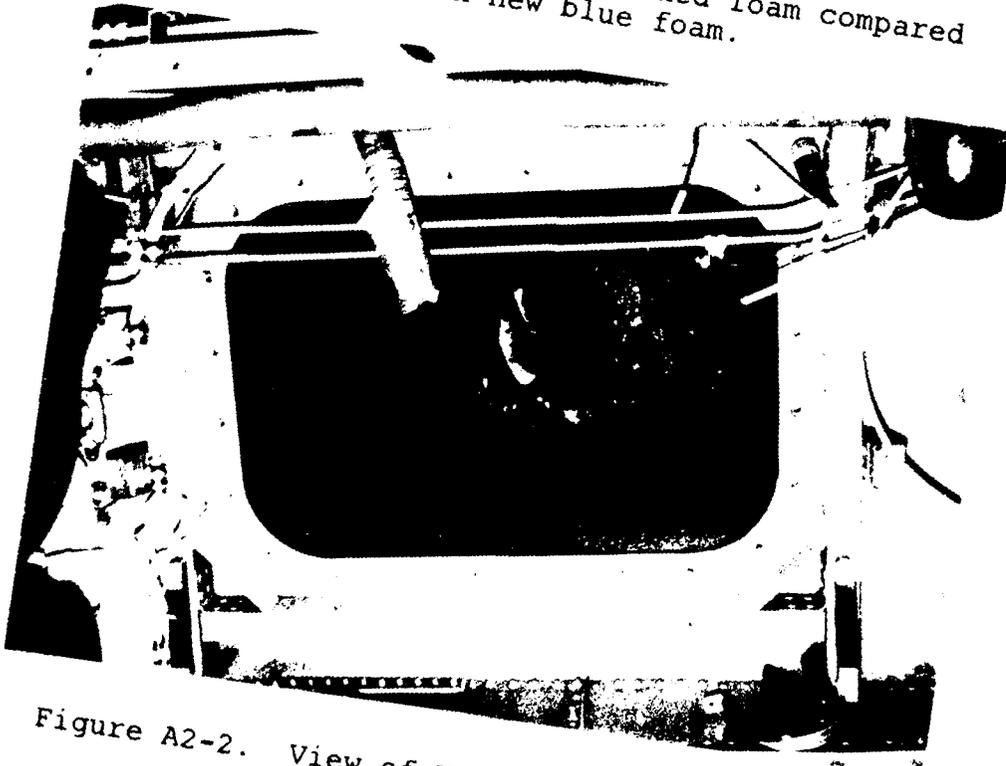
Figure A2-2. View of F-4 brown-stained foam in the fuel cell.
