WILLIAMS LAKE DAM

MA 00451

MERRIMACK RIVER BASIN MARLBOROUGH, MASSACHUSETTS

PHASE I INSPECTION REPORT NATIONAL DAM INSPECTION PROGRAM

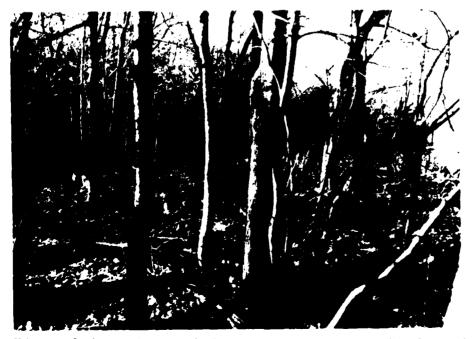
Abundant brush and tree growth extends along the entire length of the dam. (see Appendix C, Photo Nos. 1 & 2). The downstream stone wall is tilting in the downstream direction and a section of the wall has moved outward and is essentially demolished (see Appendix C, Photo Nos. 3 & 4). At the time of the inspection, there was no seepage observed along the downstream toe of the wall area. The upstream slope of the dam is irregular and and overgrown with trees. The crest of the dam shows signs of trespassing as there is a footpath which passes along the entire length of the dam.

. View of deteriorated downstream stone wall from left abutment.

- (1) Replace the dislodged stone in the spillway channel.
- (2) Repair the downstream rubble masonry walls.
