MINNEWAWA DAM

N.H. 00104

PHASE I INSPECTION REPORT
NATIONAL DAM INSPECTION PROGRAM

SEPTEMBER 1978

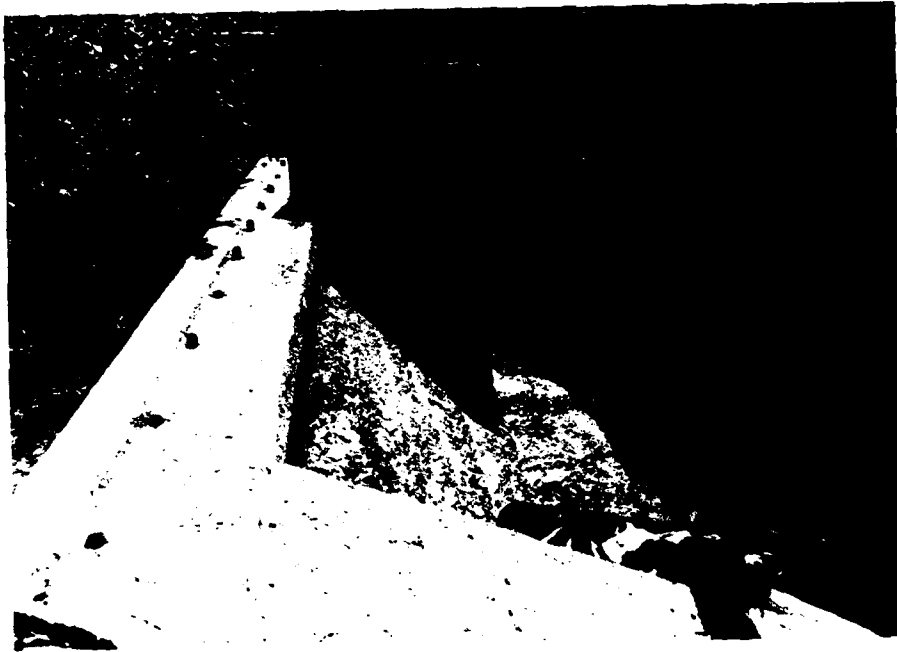
FIG. 26 Spillway

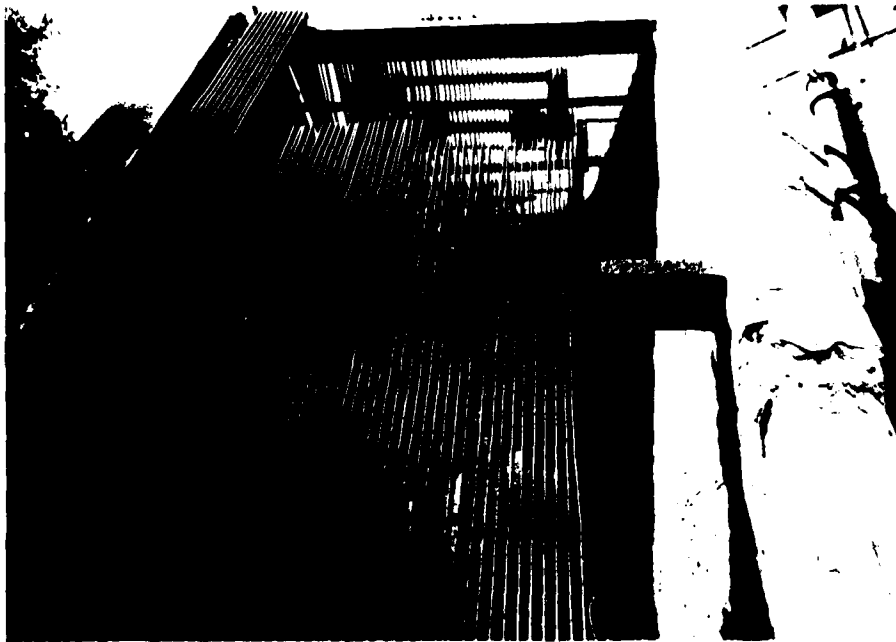
FIG. 24 Trash Rack

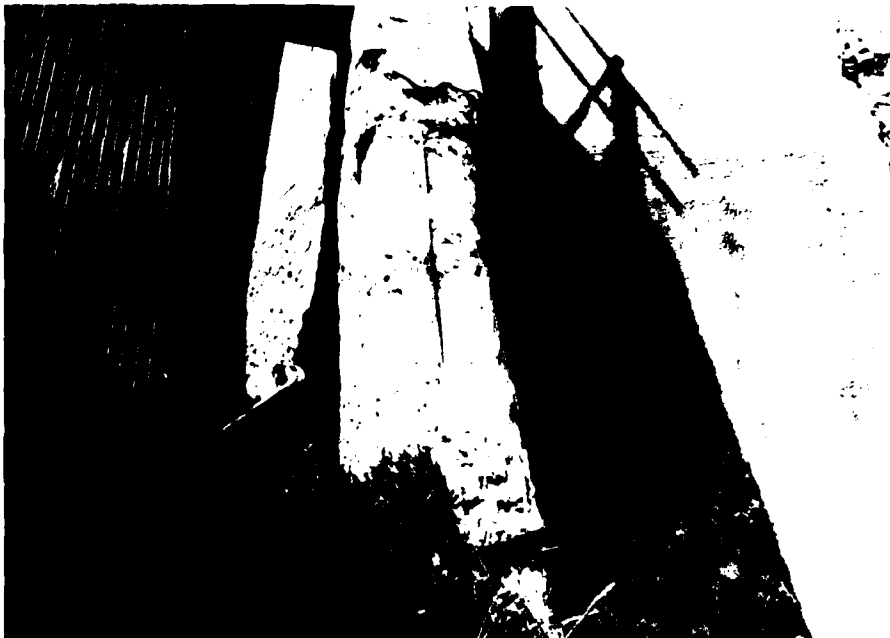
FIG. 25 Detail of Exposed Steel and Debris at Inlet
