QUINEBAUG RIVER BASIN
SOUTHBRIDGE, MASSACHUSETTS

**NO. 5 RESERVOIR
MA 00693**

**PHASE I INSPECTION REPORT
NATIONAL DAM INSPECTION PROGRAM**

JUNE 1981

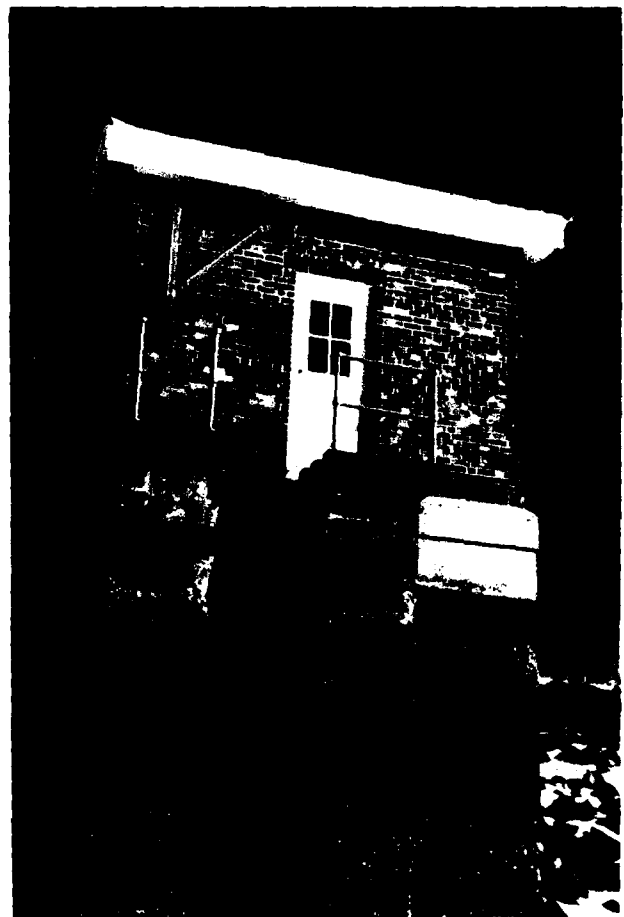
gates was fully opened and the 20-inch raw water outlet gate was open for discharge to the water supply system. Steel trash screens are located at the intake end of the structure and are in good condition. The hoisting arm and bracket for removal of the steel trash screens is well maintained.

PHOTO NO. 8
VIEW OF UPSTREAM SIDE OF GATE
HOUSE - NOTE BAR SCREEN FOR RAW
WATER INTAKE LINES
