KELLEYS FALLS DAM

MAY 1979

KELLEY'S FALLS
DAM

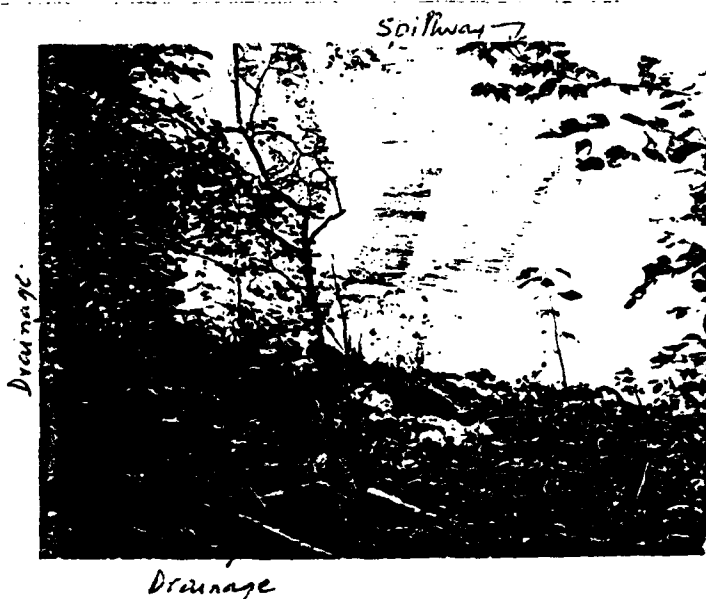
I inspected the area on September 19, 1973, and found that the water seeping beside the rip-rap of which Mr. Morse complained, is the spring water draining from the steep hill on the northwest side of Kelley's Falls dam.

Downstream side of the dam. Arrows show the spring on the northwest side.
