UPPER AMMONOOSUC DAM

AUG 1981

The dam is in FAIR condition at the present time. It is recommended that the owner retain the services of a qualified registered professional engineer to conduct a detailed hydraulic and hydrologic study to further define the need for and means to increase the project discharge capacity and the ability of the dam to withstand overtopping; to conduct a detailed inspection of the spillway under low flow conditions; and to evaluate the condition of the left abutment and make recommendations for its restoration. Remedial measures to be undertaken by the owner include implementing annual maintenance and inspection programs, and developing a plan for dam surveillance during flood periods and a formal, written system for warning downstream residents and appropriate officials in the event of an emergency. These engineering studies and remedial measures should be implemented by the owner within one year of receipt of this Phase I Inspection Report.

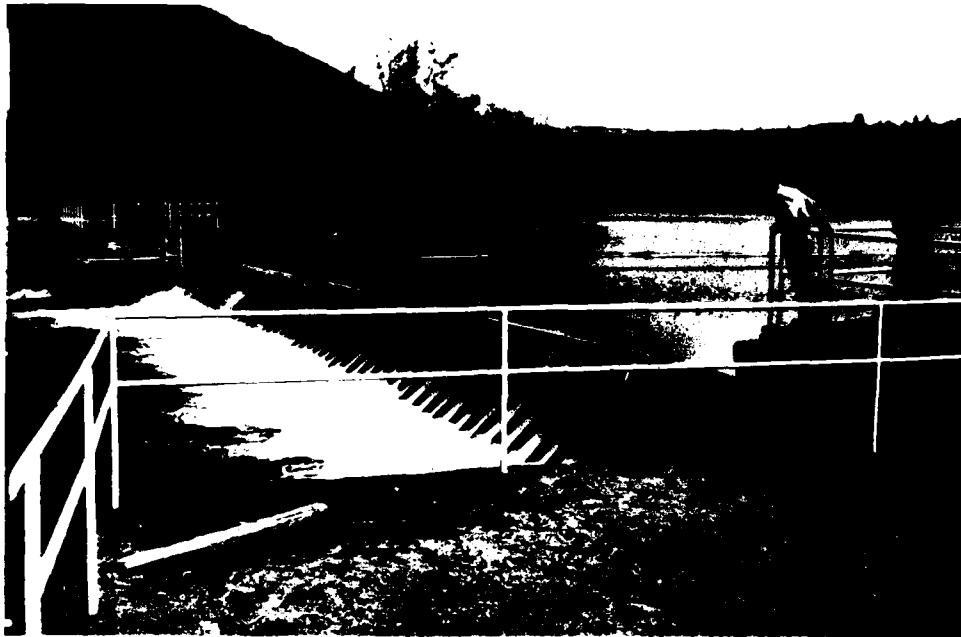
1. Spillway from Left Abutment
Note: Sink Hole at Lower Left

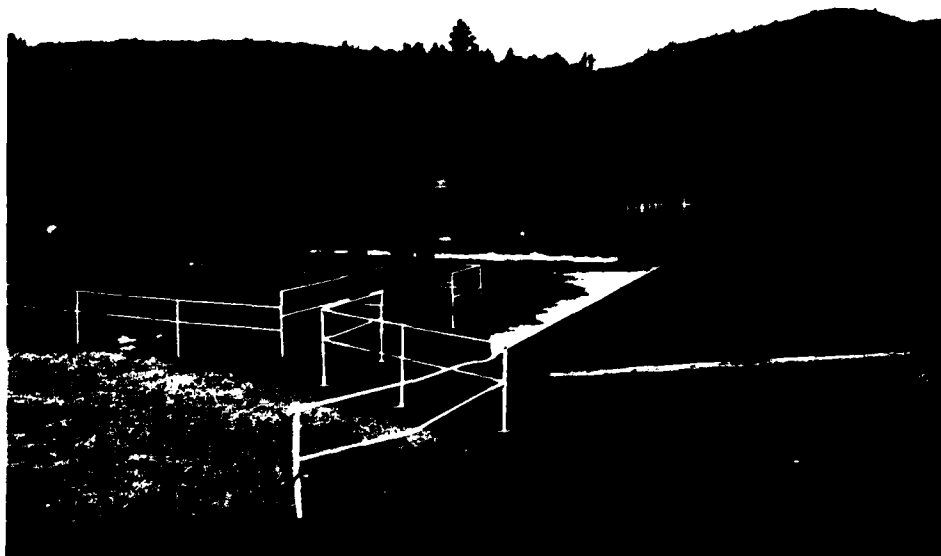
2. Overview from Upstream Left

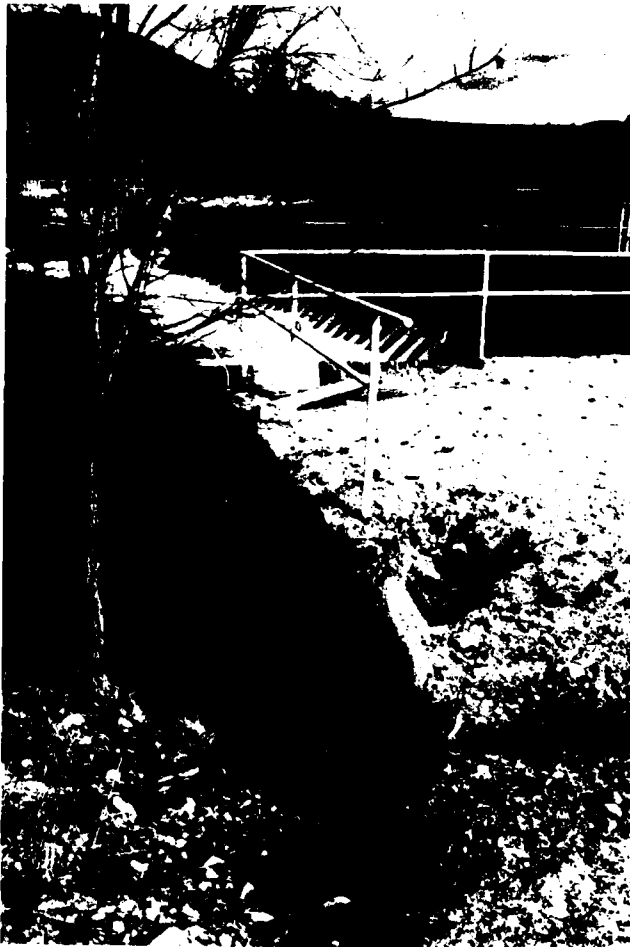
The spillway, the right abutment, and all gates, including the operating mechanisms, appear to be in good condition. The only problem area noted during the visual inspection was the partial decay of the timber cribs and erosion at the left abutment. The spillway structure should be inspected under low flow conditions, and the operation of each gate should be inspected over its full range.

3. Sheeted Section at Left Abutment
Note: Sinkholes and Erosion

(b) Evaluate the condition of the timber crib and earthfill at the left abutment and prepare plans for its restoration.

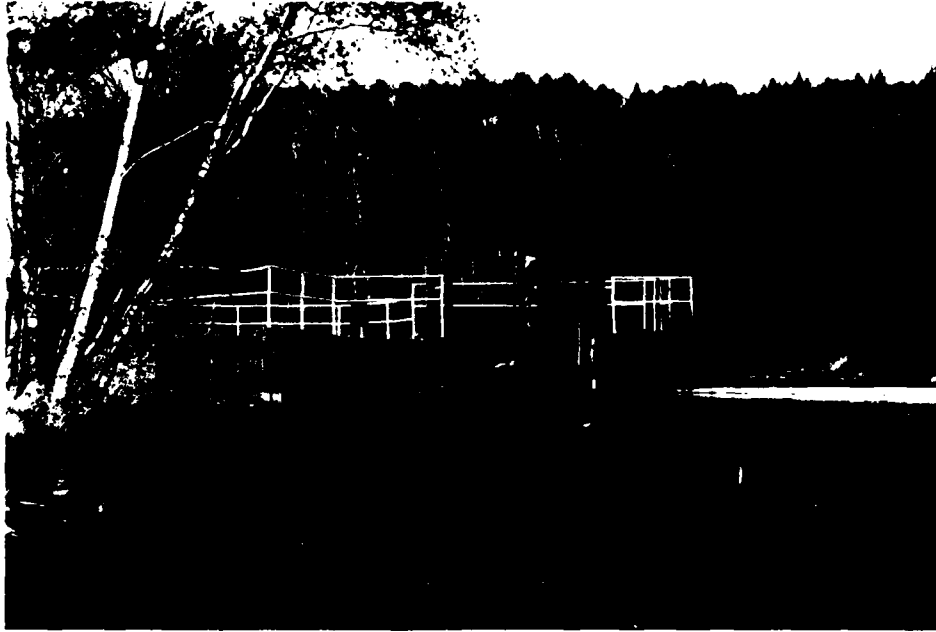
7. Upstream Side of Left Gate Structure

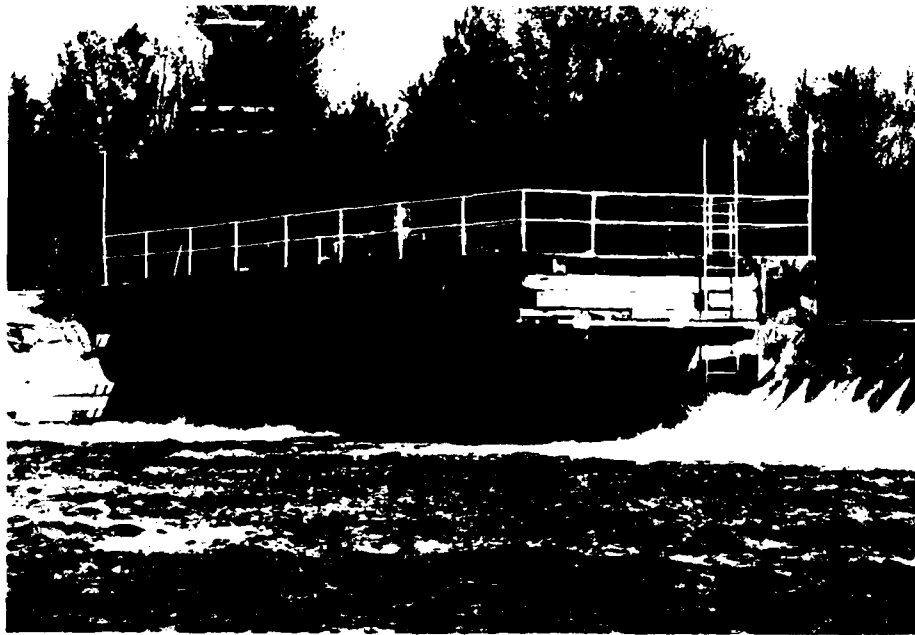
8. Downstream Side of Right Gate Structure

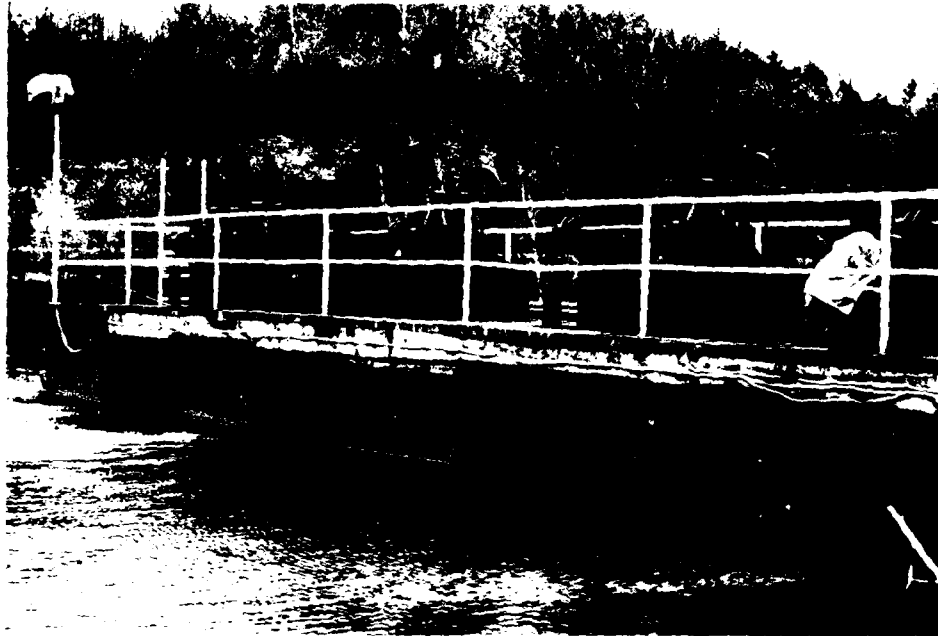
9. Upstream Side of Right Gate Structure

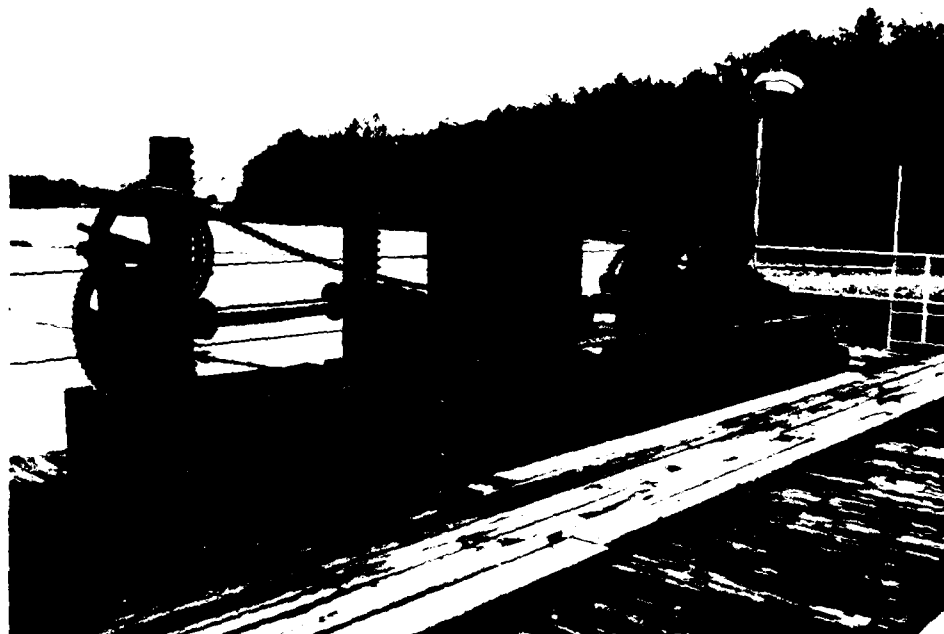
Two electric motors are installed to service two gates each. These motors can be attached by chain drive to provide assistance for lifting the gates. They appear to be in good condition.

10. Operating Mechanism at Right Gate Structure. Note: Box Houses Electric Motor

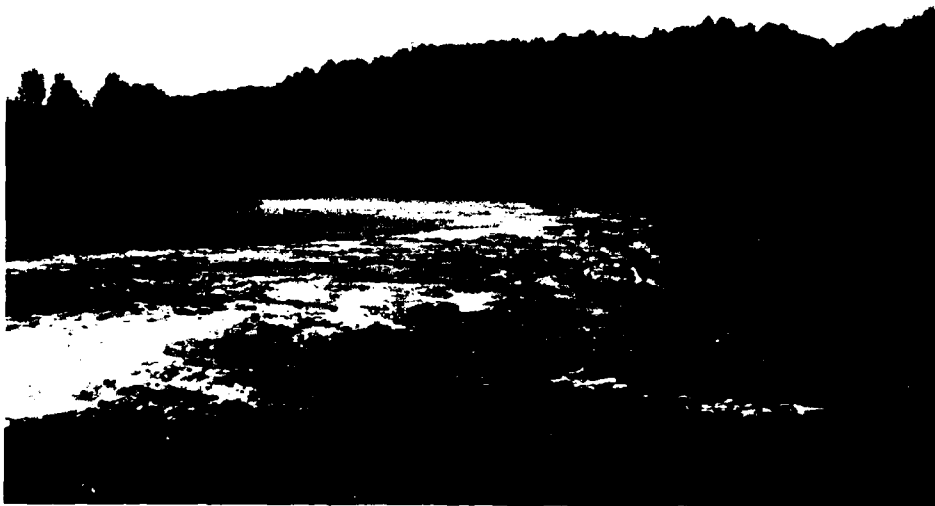
12. Downstream Channel
