CONNECTICUT RIVER BASIN
HOLYOKE, MASSACHUSETTS

McLEAN RESERVOIR
MA 00539

PHASE I INSPECTION REPORT
NATIONAL DAM INSPECTION PROGRAM

MARCH 1979

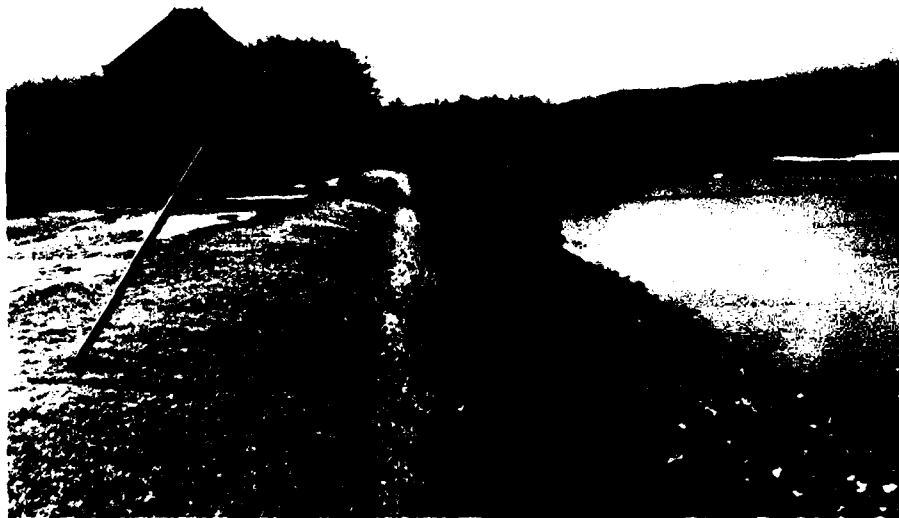
PHOTO NO. 1 - Crest and upstream face of dam.

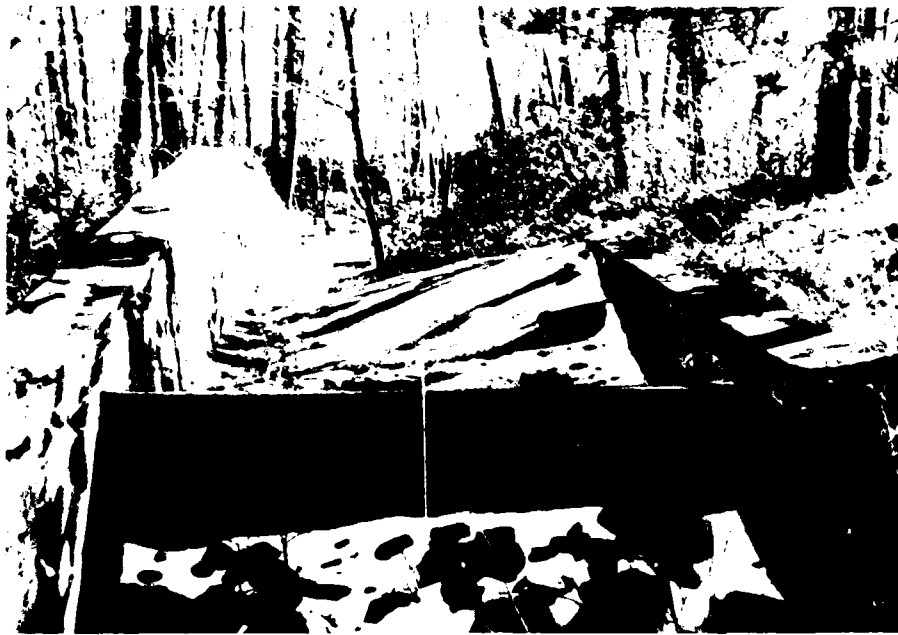
PHOTO NO. 3 - Spillway weir and outlet channel.

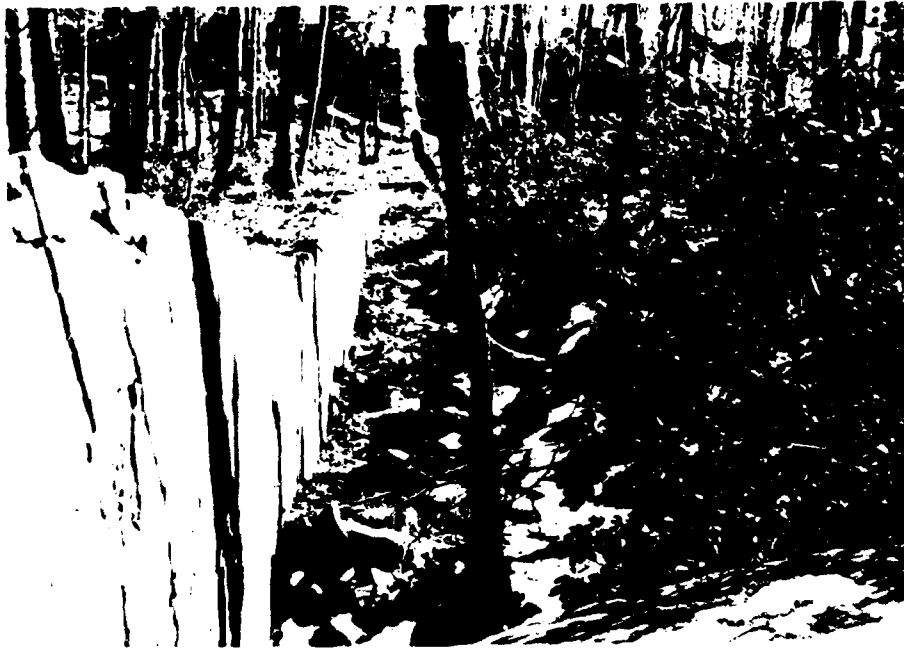
PHOTO NO. 5 - Outlet channel viewed from crest of weir.
