CONNECTICUT RIVER BASIN
SHUTESBURY, MASSACHUSETTS

LAKE WYOLA
MA 00510

PHASE I INSPECTION REPORT
NATIONAL DAM INSPECTION PROGRAM

MARCH 1979

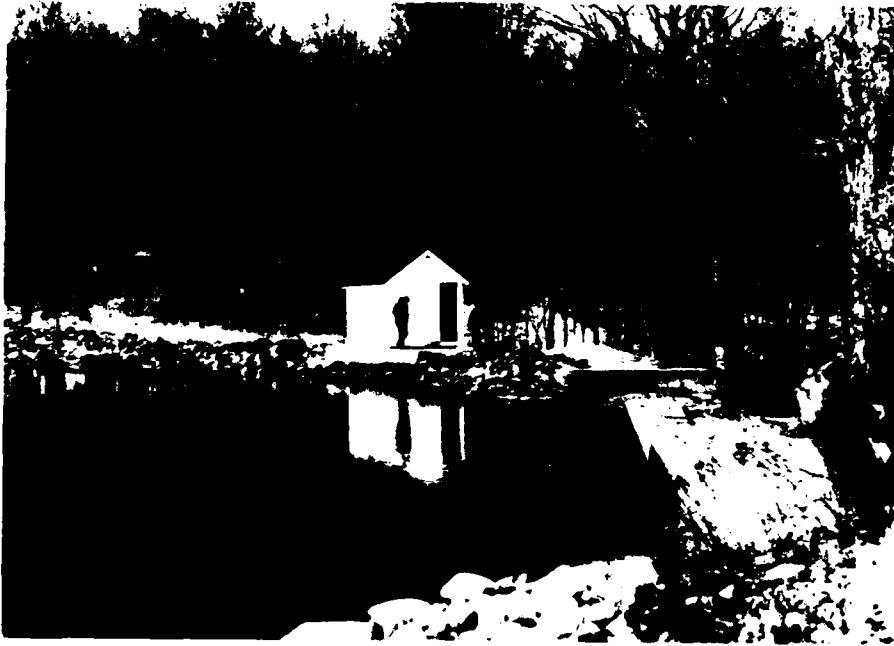
PHOTO NO. 1 - Upstream portion of dam as viewed from right abutment area.

- (1) Vegetation on the upstream slope should be removed. All trees within 20[±] feet of the downstream face should be removed. These trees are shown by Photos 1,3,4,5,7,8, & 13 and their approximate locations are indicated on the Plan view in Appendix B of this report.
- (2) The wet areas noted in this inspection report should be observed during routine maintenance to determine evidences of soil transport.
- (3) Riprap should be placed on the discharge channel opposite the spillway apron and on the channel floor for a downstream distance of 20 feet.
- (4) This dam should be inspected every two years by qualified personnel who can identify areas of concern which, if left unchecked could jeopardize the safety of the dam.
- (5) A formal warning system should be developed for warning downstream residents in case of emergency.

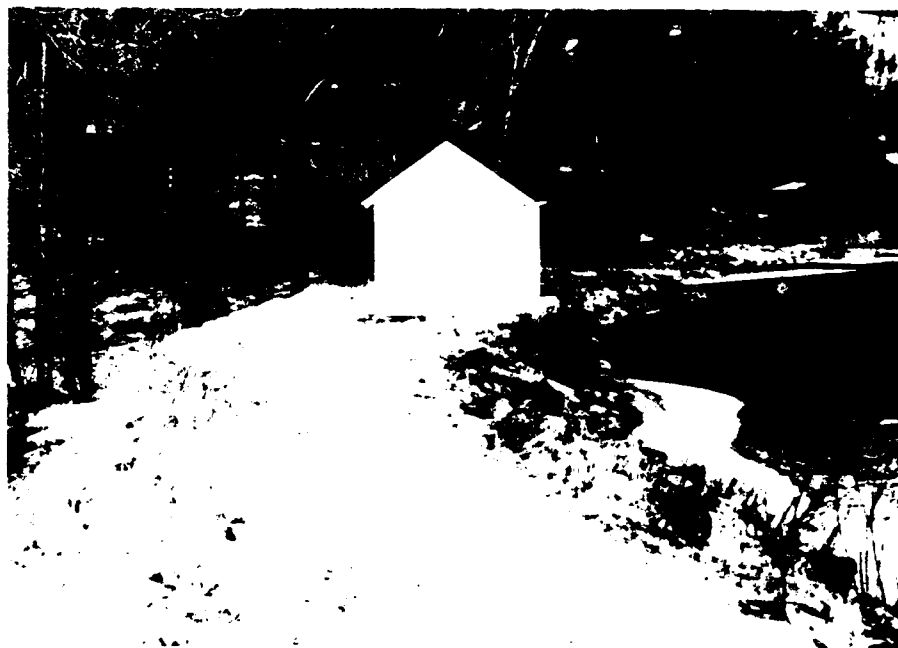
PHOTO NO. 7 - Crest of dam as viewed from left abutment
area.
