LITTLE RIVER UPPER DAM  
ME 00289

PHASE I INSPECTION REPORT  
NATIONAL DAM INSPECTION PROGRAM

NOVEMBER 1979

Identification No.: ME00289  
Name of Dam: Little River Upper Dam  
Town: Belfast  
County and State: Waldo, Maine  
Stream: Little River  
Date of Inspection: September 17, 1979

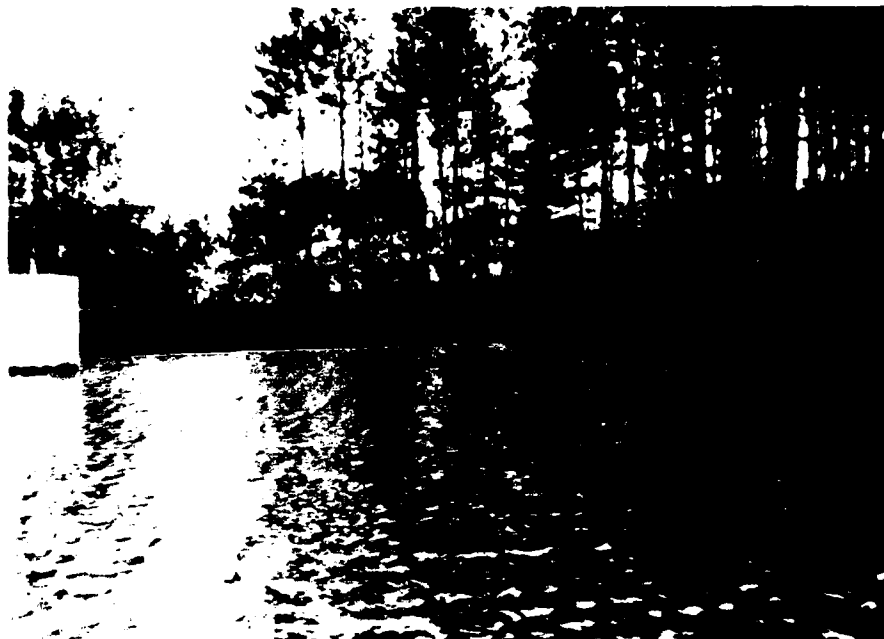
September 17, 1979  
Figure 3 - View of upstream face of Little River  
Upper Dam.
