MASSACHUSETTS COASTAL BASIN
GLOUCESTER, MASSACHUSETTS

FERNWOOD LAKE EAST DAM
MA 01336

FERNWOOD LAKE WEST DAM
MA 01337

PHASE I INSPECTION REPORT
NATIONAL DAM INSPECTION PROGRAM

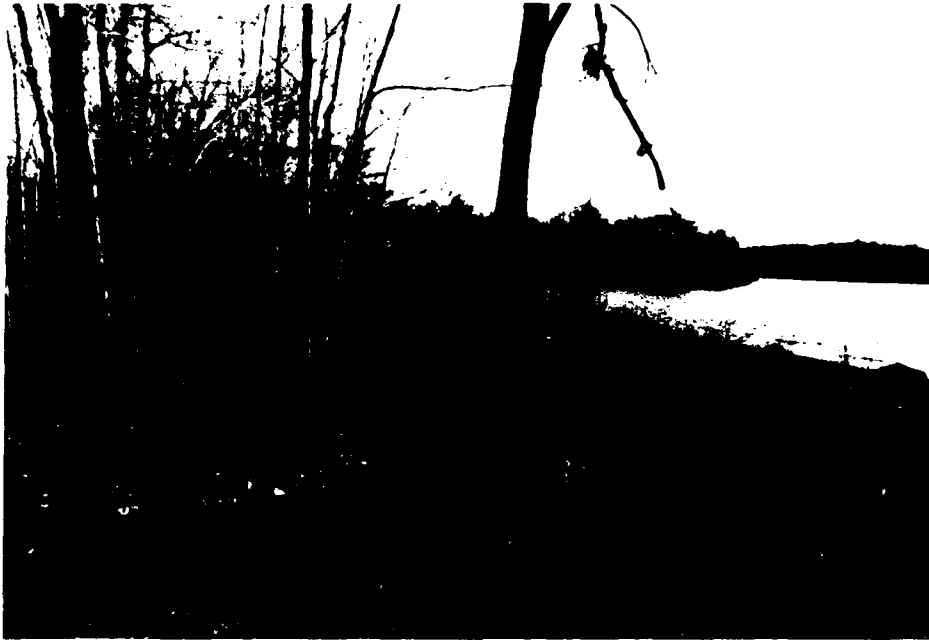
19. Trees and roots on downstream side near left abutment (2 May 1980)

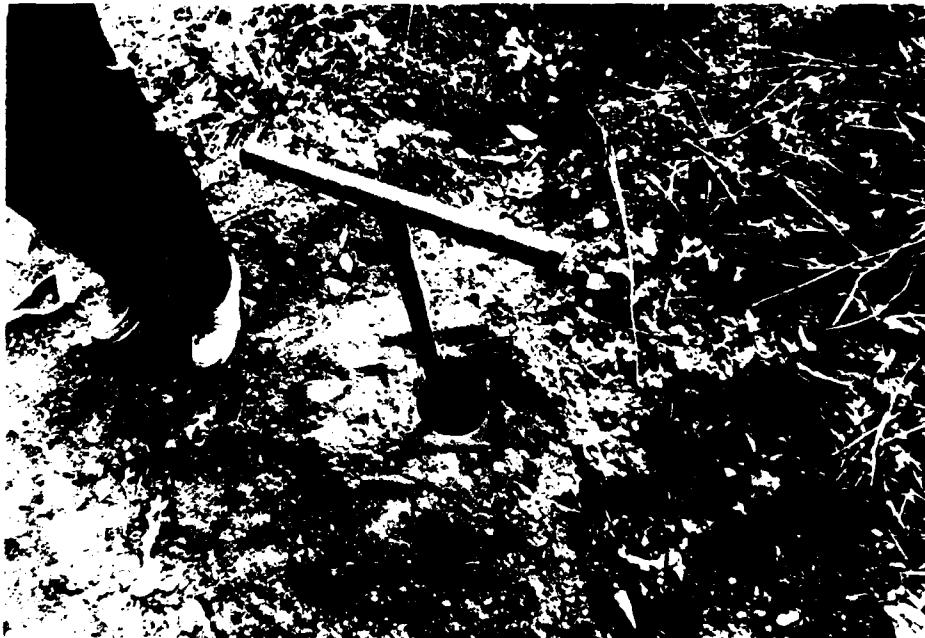
20. Handle for operating outlet gate valve inserted through opening in buried manhole cover (2 May 1980)
