MERRIMACK RIVER BASIN  
CHELMSFORD, MASSACHUSETTS

RUSSELL MILL POND  
MA 01219

PHASE I INSPECTION REPORT  
NATIONAL DAM INSPECTION PROGRAM

MARCH 1980 06 6 034

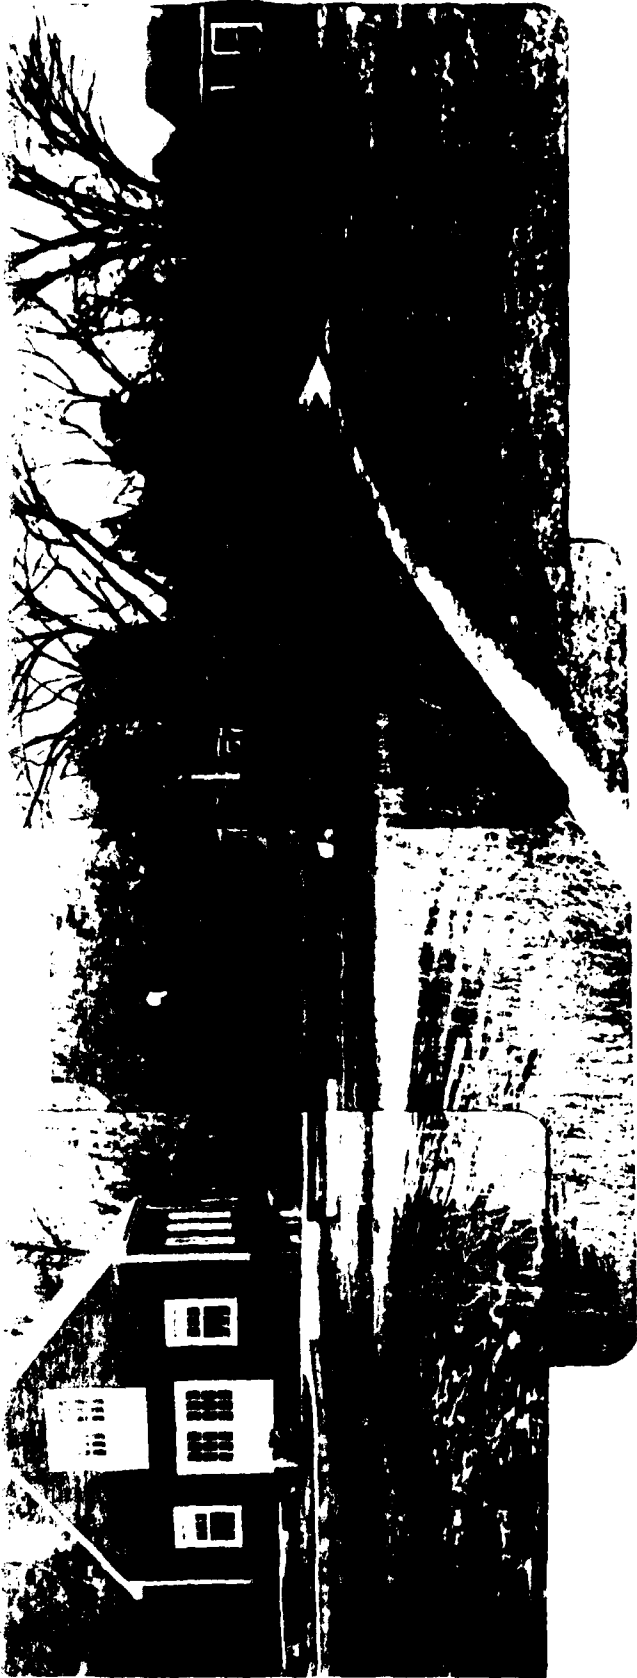
PHOTO NO. 1 - View of upstream face of Dam. Shown are the spillway, the 3 x 6 foot sluiceway below the small wood shed at the far left of the spillway, and the 4 foot pipe sluiceway to the right of the spillway, below the wood deck area. Beyond the spillway is the outlet channel area of Photo No. 3.

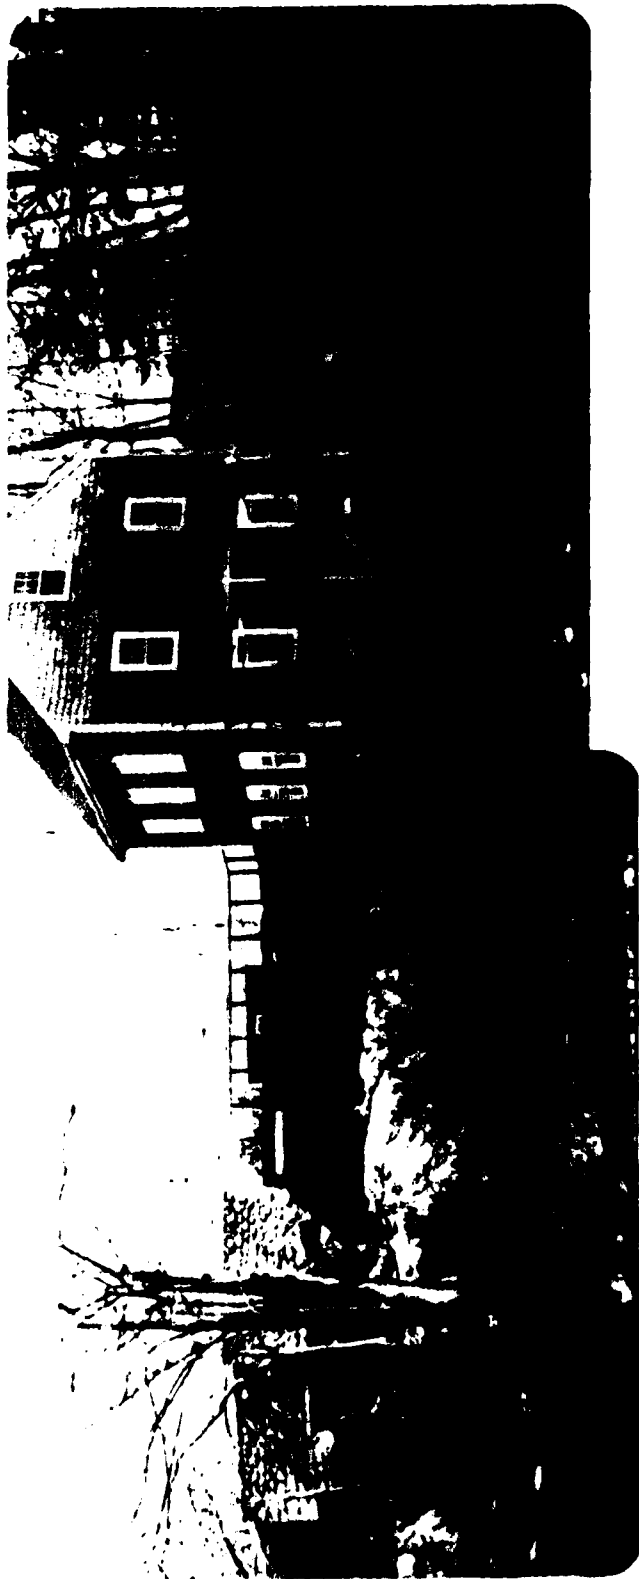
PHOTO NO. 2 - View of downstream face of Dam. At the left is the 4 foot outlet pipe. The spillway is at the center area. The discharge channel from the 3 x 6 foot sluiceway outlet is on the right of the mill building. Much of the stone masonry Dam has been rebuilt, as evidence in this photo by the use of granite slabs at the 4 foot outlet pipe.

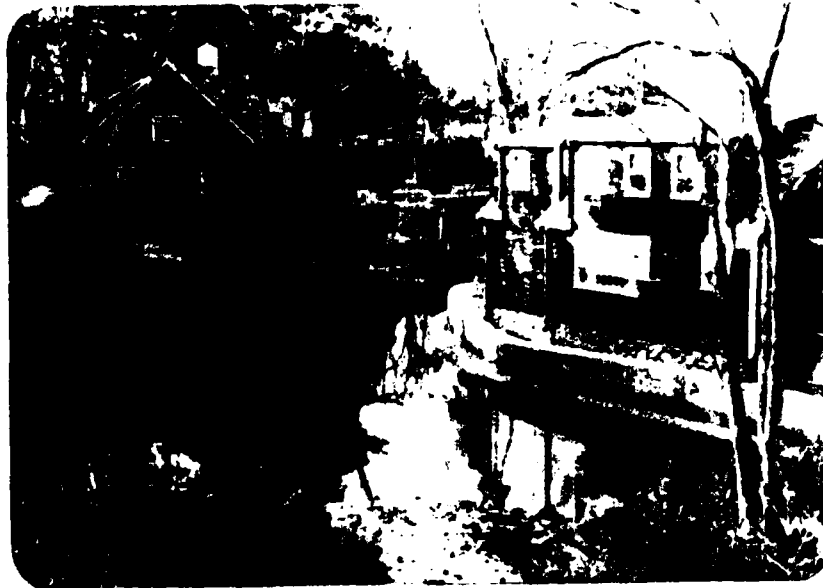
No significant obstructions were observed in the downstream channel, photograph 3.

PHOTO NO. 3 - Outlet channel area immediately downstream of the Dam.

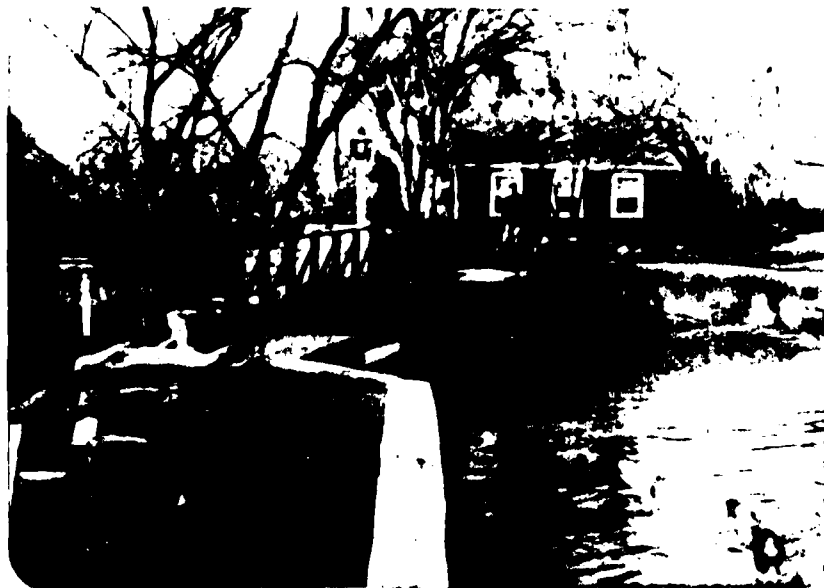
The visible portion of the concrete wall forming the upstream face of the dam is in good condition. Brush growth was observed next to the upstream face between the spillway and right outlet works, photograph 4.

PHOTO NO. 4 - This view shows the upstream face of the spillway and the location of the 4 foot pipe in Photo No. 5. Flashboards are in place at the spillway, which vary in height. Much of the pond is silted-in, as evidenced by the growth of weeds at the spillway.

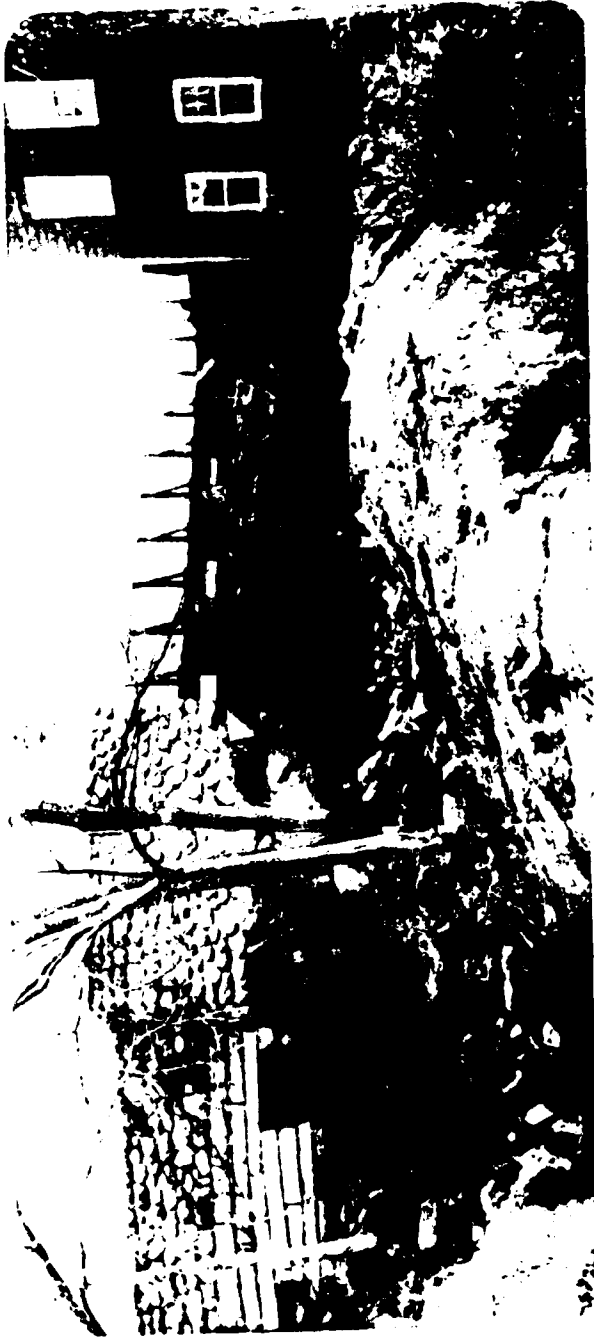
The crest of the dam is in good condition, photograph 9. No evidence of cracking or misalignment of the crest that could be attributed to movement of the dam was observed.

PHOTO NO. 9 - Panoramic view of the downstream face of the Dam from the right abutment to the left end of the spillway.

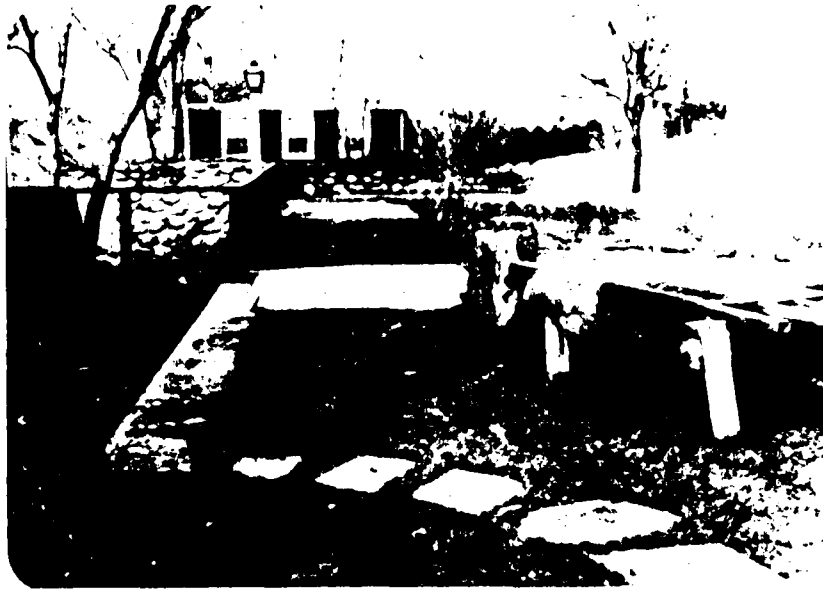
PHOTO NO. 14 - Crest of Dam as viewed from the left  
outlet structure.
