**HOUSATONIC RIVER BASIN
DALTON, MASSACHUSETTS**

**EGYPT RESERVOIR DAM
MA 01063**

**PHASE I INSPECTION REPORT
NATIONAL DAM INSPECTION PROGRAM**

MARCH, 1981

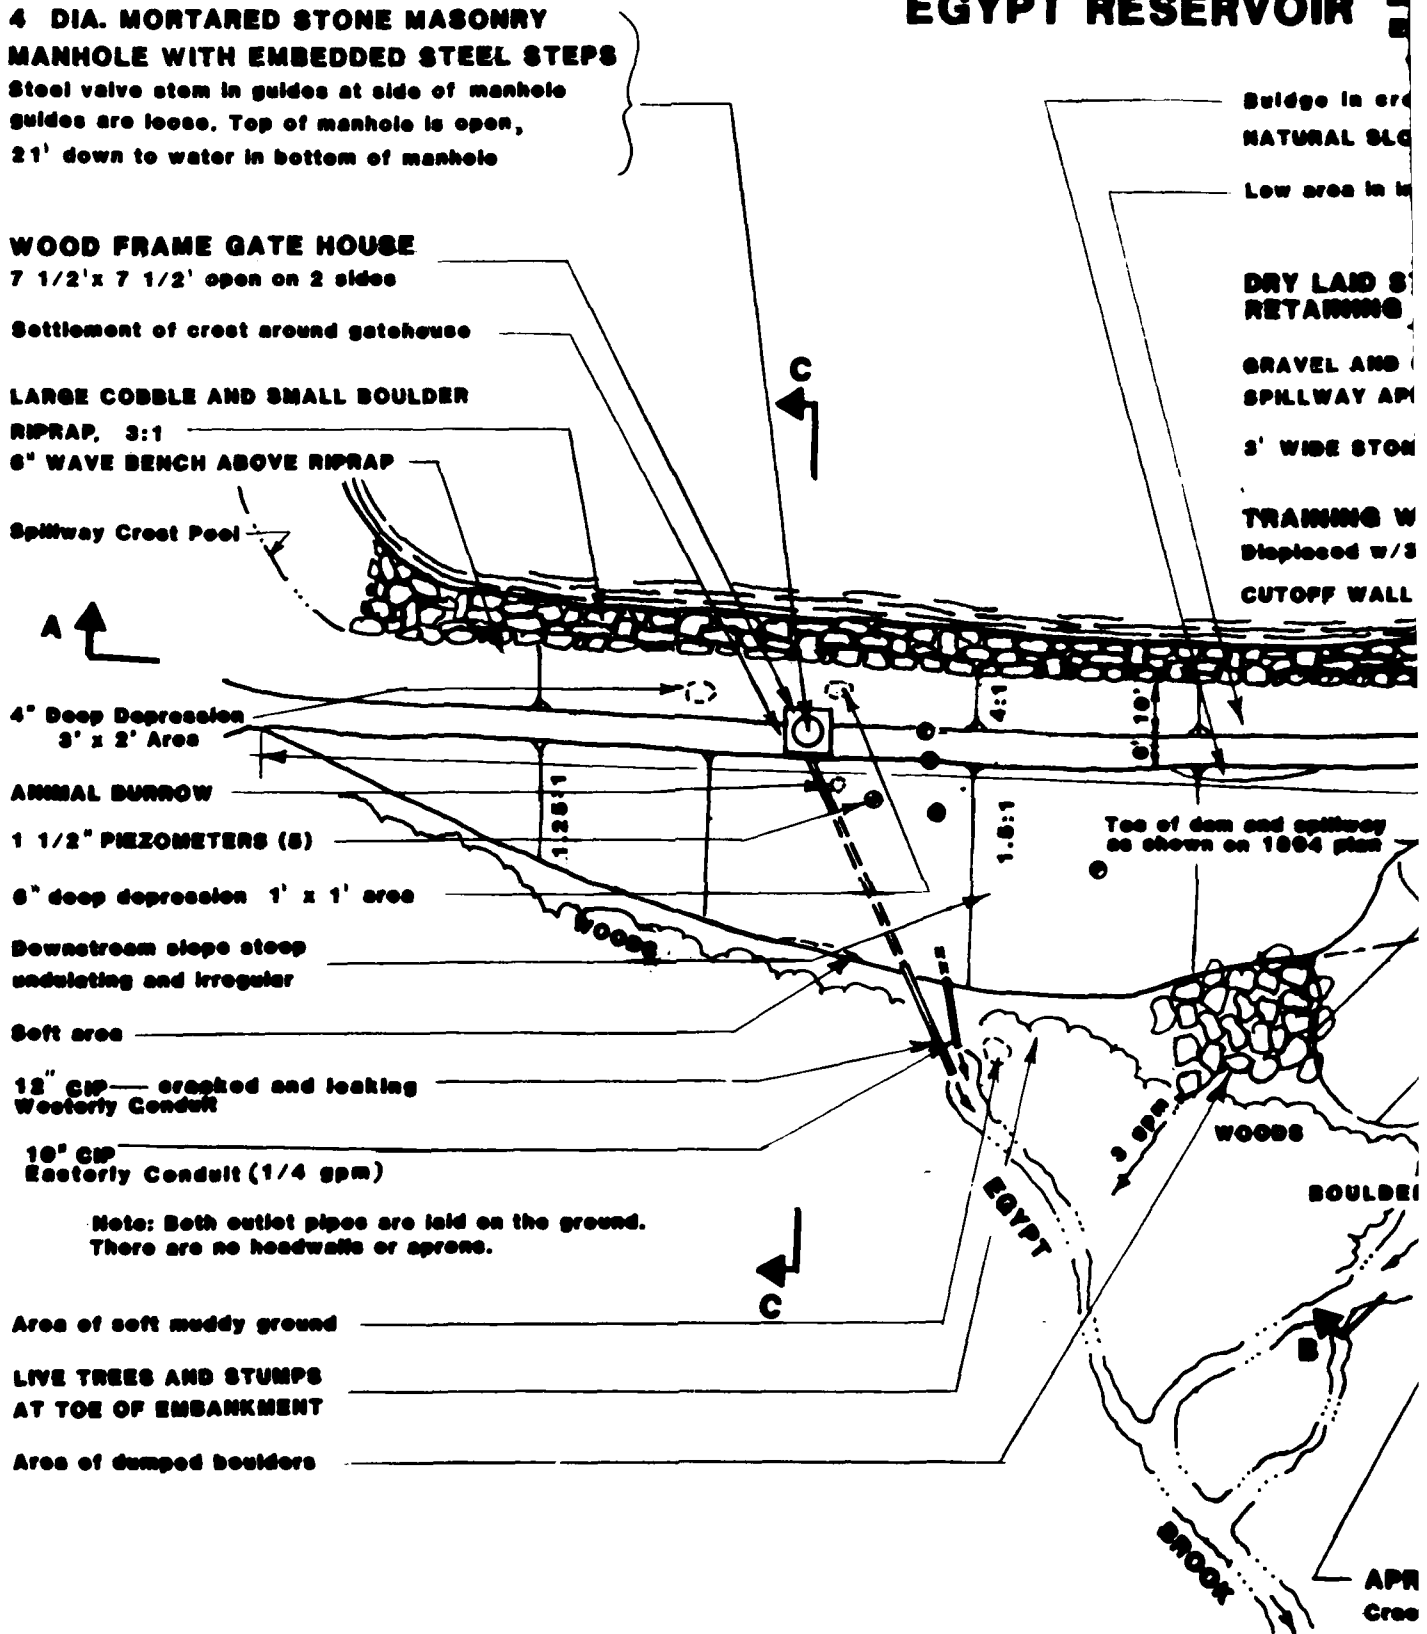
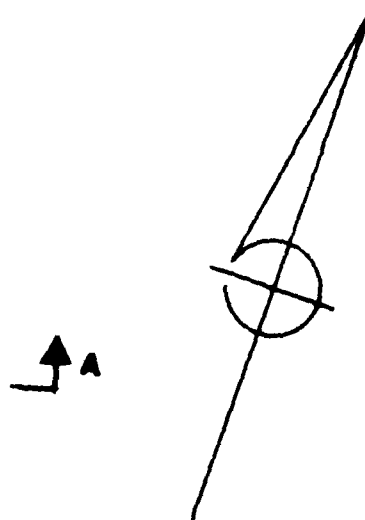
**APPENDIX B FIGURE 1
 GENERAL PLAN**

Bulge in crest toward downstream
 NATURAL SLOPE STEEP AND WOODED

Cracked, with separated masses of concrete

SPILLWAY CHUTE
 Walls cracked,
 eroded, displaced, and
 separated from floor.
 Floor is cracked,
 undermined, uplifted
