NATIONAL PROGRAM FOR INSPECTION OF NON-FEDERAL DAMS
NOYES BROOK DAM (ME 0...U) CORPS OF ENGINEERS WALTHAM
MA NEW ENGLAND DIV SEP 81

REPORT DOCUMENTATION PAGE		READ INSTRUCTIONS BEFORE COMPLETING FORM
1. REPORT NUMBER ME 00347	2. GOVT ACCESSION NO.	3. RECIPIENT'S CATALOG NUMBER
4. TITLE (and Subtitle) Noyes Brook Dam NATIONAL PROGRAM FOR INSPECTION OF NON-FEDERAL DAMS		5. TYPE OF REPORT & PERIOD COVERED INSPECTION REPORT

Inclosed is a copy of the Noyes Brook Dam (ME-00347) Phase I Inspection Report, prepared under the National Program for Inspection of Non-Federal Dams. This report is based upon a visual inspection, a review of the past performance and a brief hydrological study of the dam. I approve the report and support the findings and recommendations described in Section 7 and ask that you keep me informed of the actions taken to implement them. This follow-up action is vitally important.

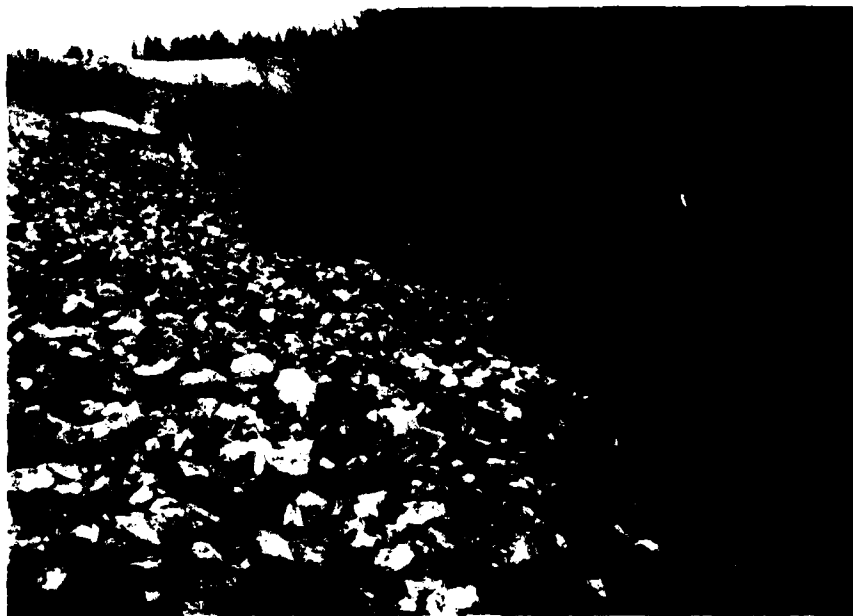
(4) Downstream toe - The downstream toe is generally dry with no boils or seeps observed except at the toe drain (Photo 3). On the right side of the riprapped toe drain near sta. 25+00, a 1 1/2 gal/sec seep was issuing from the riprap. The flow carried no sediment or suspended fines (Photo 6).

- a. Condition - The visual inspection indicates that Noyes Brook Dam is in good condition. The inspection revealed that there is a seepage of about 1.5 gallons per second at the downstream toe of the dam near Station 25+00.
- b. Adequacy of Information - The lack of in-depth engineering data did not allow for a definitive review. Therefore, the adequacy of this dam could not be assessed from the standpoint of reviewing design and construction data but is based primarily on visual inspection, past performance history and sound engineering judgment.
- c. Urgency - The recommendations and remedial measures presented below should be implemented by the owner within two years of receipt of this Phase I Inspection Report.

Photo 3
Downstream Toe
Seepage Area
& Toe Drain Detail

The operating and maintenance procedures are limited for this project. The owner should establish procedures to inspect the structures regularly, to monitor the seepage at the toe of the dam, to keep the embankment free of brush and trees, and to monitor the project during periods of intense rainfall. The owner should arrange to have a technical inspection made on a bi-annual basis and establish a warning system to follow in the event of emergency conditions.

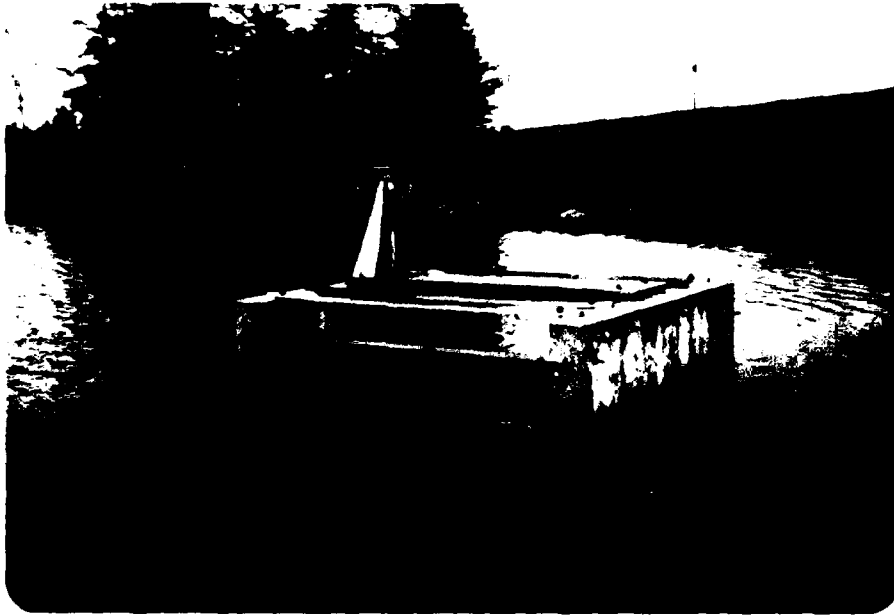
(1) Principal Spillway - The principal spillway intake (Photo 4) was observed from shore. The exposed concrete and trashrack steel appeared in good condition.

Photo 4
Principal Spillway

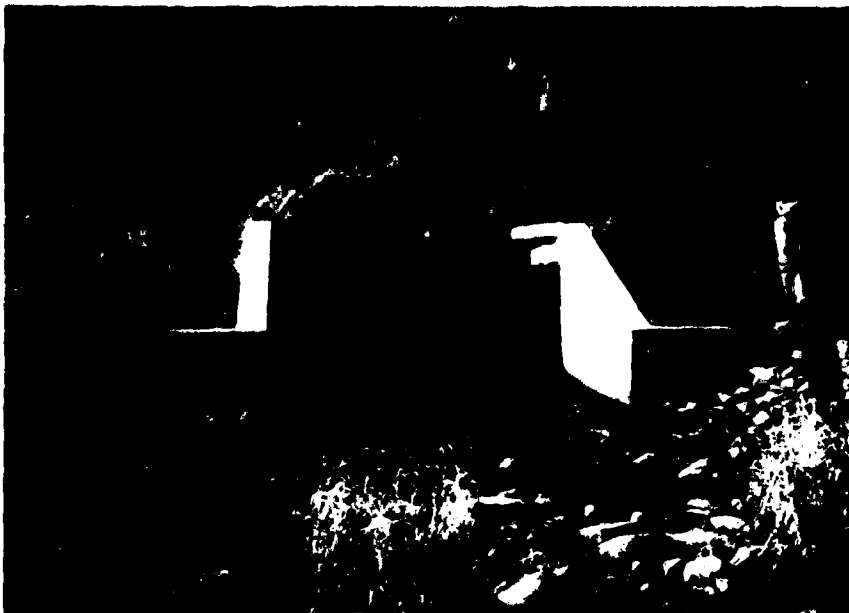
(2) Outlet works - The outlet impact basin (Photo 5) was found in good condition. All construction joints were tight. No spalling was observed. The reservoir drain inlet was submerged and could not be inspected. The outlet conduit could not be inspected. It was reported by the Project Operator (Limestone Town Manager) that the drain had not been recently operated.

Photo 5
Impact Basin &
Underdrain Outfalls

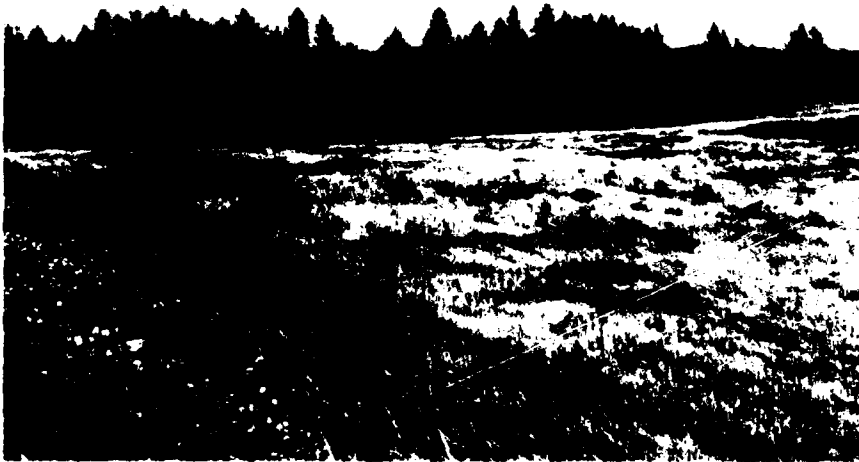
Photo 11

(3) Emergency spillway - The emergency spillway was clear of debris and in good condition with a well developed grass cover.

Emergency Spillway
viewed from left
embankment looking
downstream.
