**MILL POND RESERVOIR NORTH DIKE
MA 01122**

**MILL POND RESERVOIR SOUTH DIKE
MA 01123**

**PHASE I INSPECTION REPORT
NATIONAL DAM INSPECTION PROGRAM**

JANUARY 1980

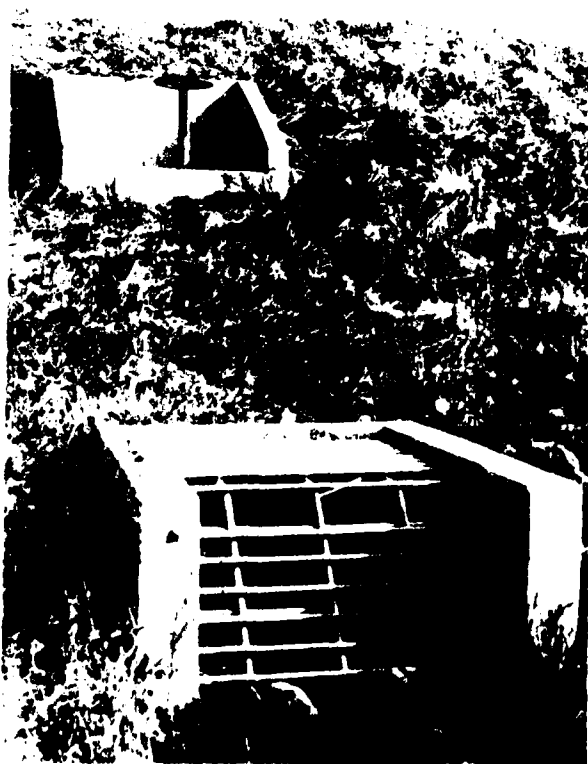
No cracks or open joints were observed in the gate valve structures or trash rack inlet structures shown in Photos 6 and 11. Some trash and debris was observed at the South Dike inlet. The concrete outlet structure on the right abutment of the North Dike was in good condition.

PHOTO NO. 6 - The inlet structure for the 24 inch drainpipe shown in this photo. It is located on the downstream side of the embankment.

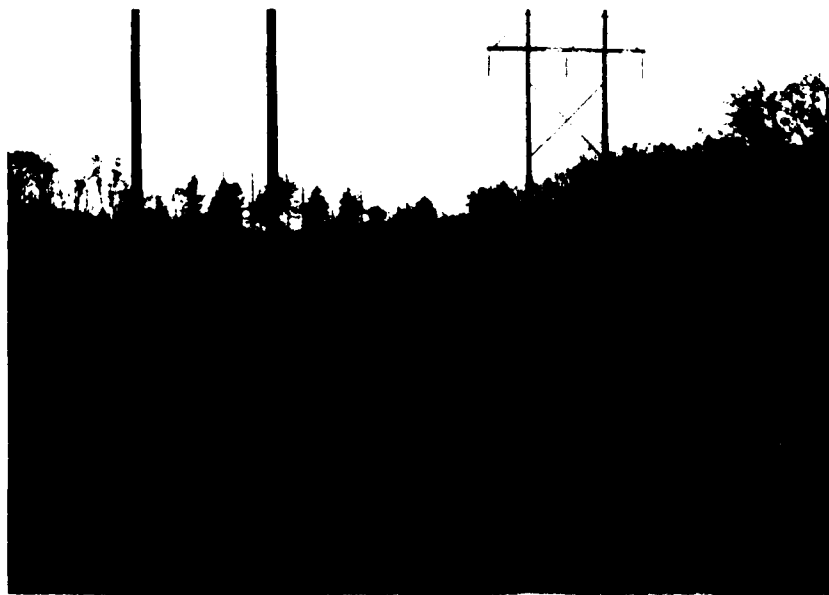
PHOTO NO. 8 - The only structures within the downstream valley are the power transmission lines. There are no residential or other structures. Development adjacent to the valley is at elev. 150+.

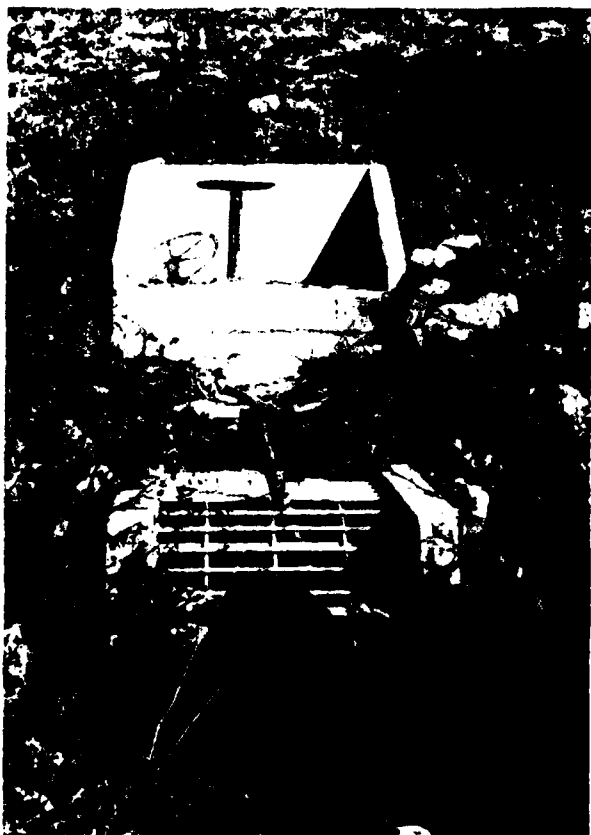
is shown in Photo 11. A path on the downstream slope from the toe to the crest was observed to the right of the inlet structure.

PHOTO NO. 11 - This photo shows the inlet structure for the 42 inch drainpipe, located on the downstream side of the embankment.
