CONNECTICUT RIVER BASIN
MONSON, MASSACHUSETTS

ZERO MANUFACTURING COMPANY DAM
MA 00551

PHASE I INSPECTION REPORT
NATIONAL DAM INSPECTION PROGRAM

APRIL 1981

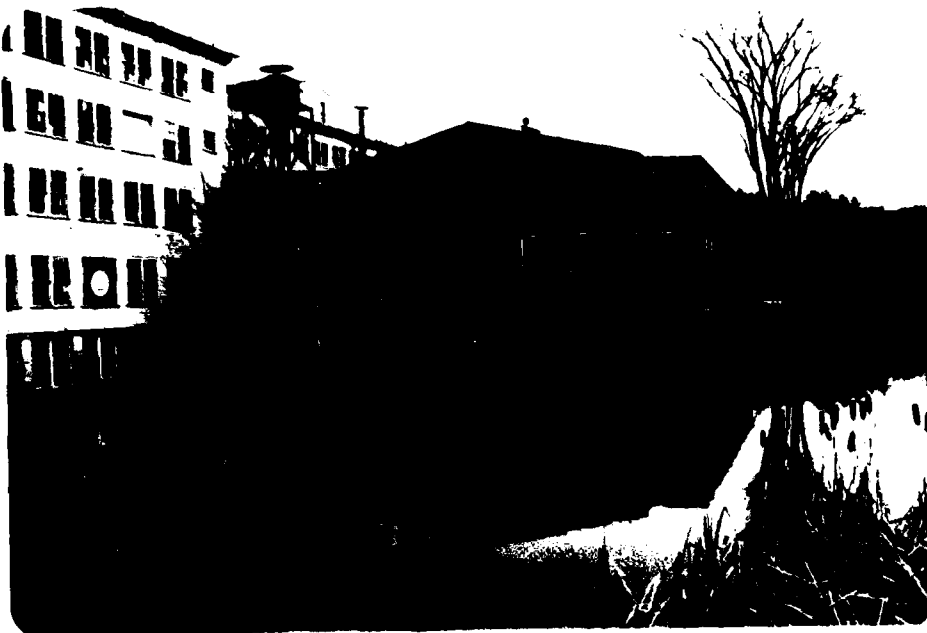
NO. 1 TOP OF DAM AT INTAKE AREA

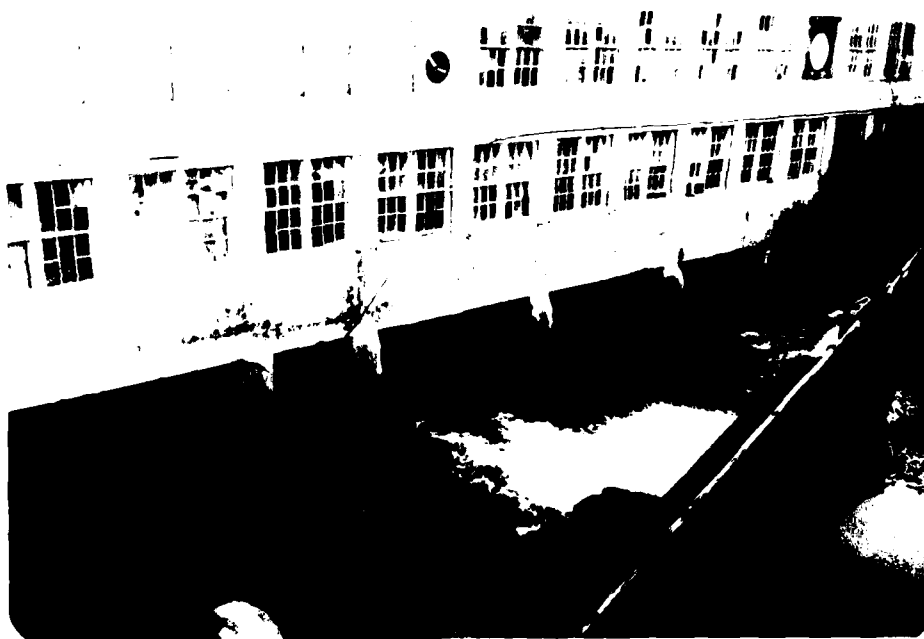
**NO. 2 STRUCTURE OVER CHICOPEE BROOK DOWNSTREAM
OF SPILLWAY**

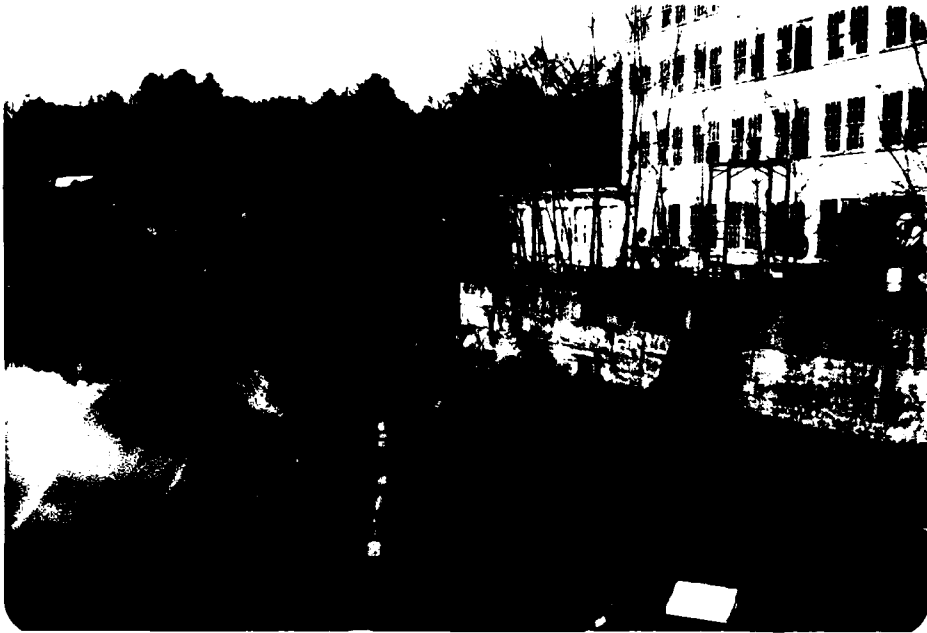
Outlets Nos. 2 and 3 each control flow to 16 inch diameter pipelines which were used to transmit water to boilers at separate heating plants. The pipe controlled by the second hand wheel operator (Outlet No. 2) was reportedly cut and sealed downstream of the dam. The third hand wheel operator (Outlet No. 3) is used to provide water to boilers for Zero Corporation's Main Street heating plant and is continuously open. Outlet No. 3 has a trash rack and screen at the upstream end. The rack consists of vertical steel slats that are heavily rusted and the steel screen, which is immediately downstream of the trash rack, is also heavily rusted. The trash rack and screen at Outlet No. 3 are cleaned periodically.

NO. 5 INTAKE AREA – HAND WHEEL OPERATORS FOR LOW LEVEL OUTLET AND WATER SUPPLY PIPES

- a. Operating and Maintenance Procedures. It is recommended that the Owner accomplish the following:
 - (1) Repair the operating mechanism on the low-level outlet and on Outlet No. 3 to restore them to working condition. Investigate a means of sealing Outlet No. 2 at the upstream end, so as to remove pressure in the conduit.

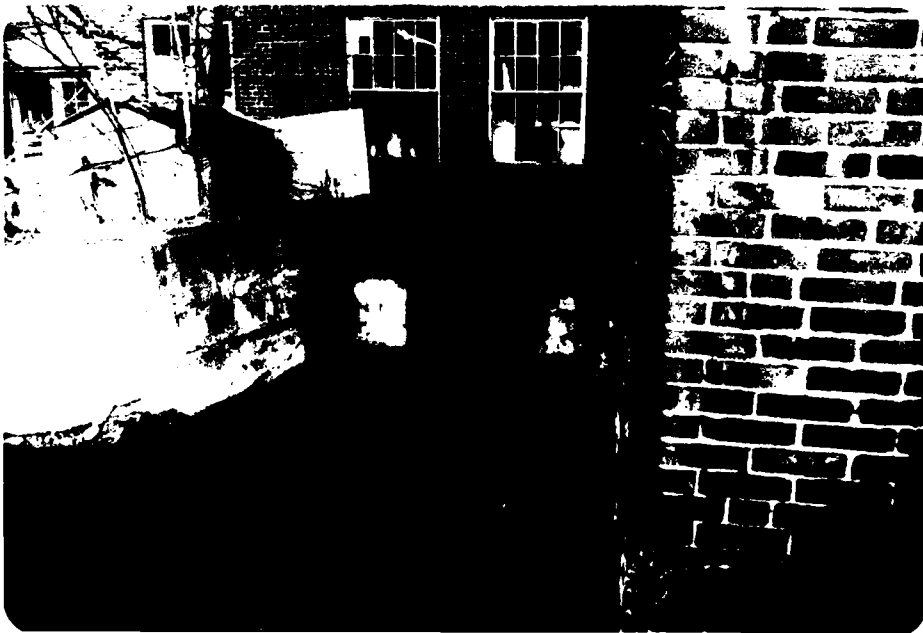
NO. 6 INTAKE AREA – CONTROL MECHANISM FOR SLIDE GATE
